# NEW CAR ASSESSMENT PROGRAM FORWARD COLLISION WARNING CONFIRMATION TEST NCAP-DRI-FCW-20-19

2020 Toyota Corolla LE

#### DYNAMIC RESEARCH, INC.

**Final Report**

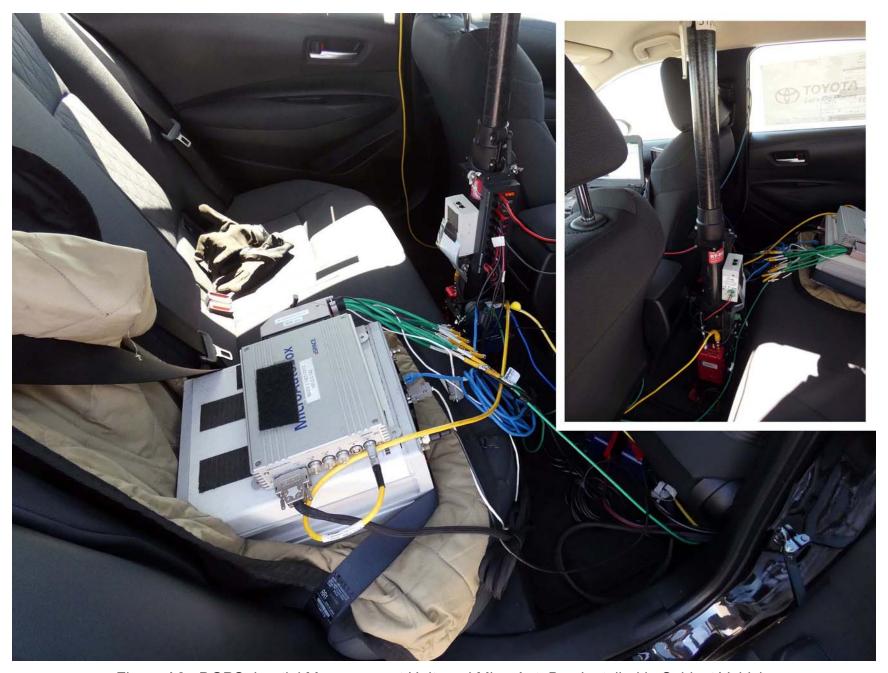
Figure A8. DGPS, Inertial Measurement Unit, and MicroAutoBox Installed in Subject Vehicle

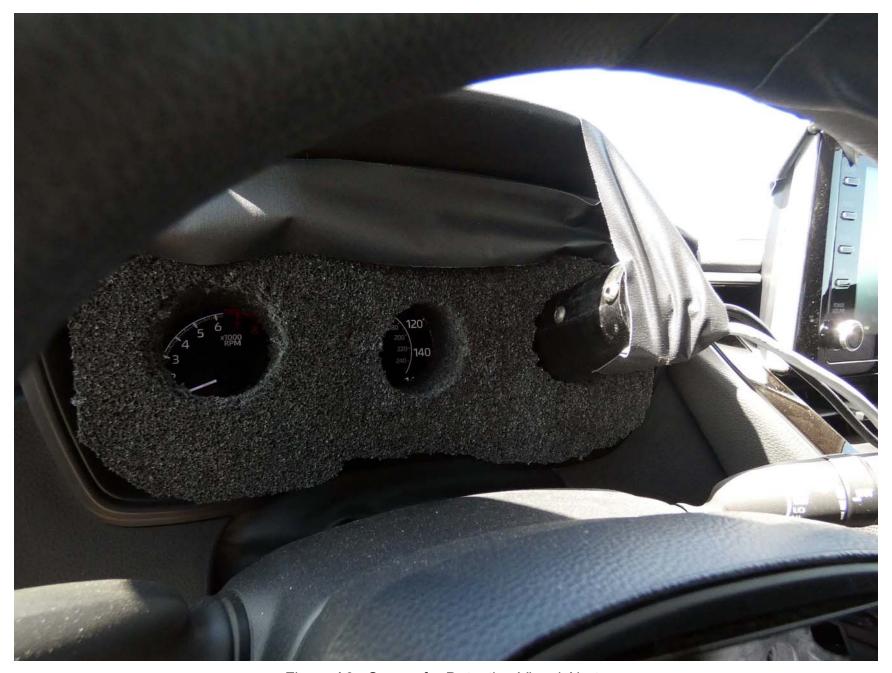
Figure A9. Sensor for Detecting Visual Alerts

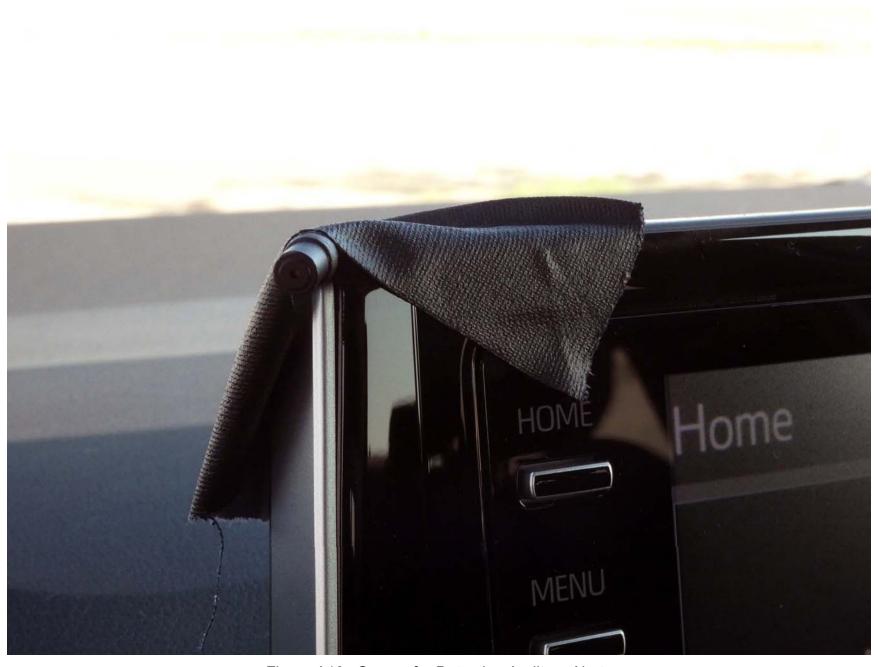
Figure A10. Sensor for Detecting Auditory Alerts

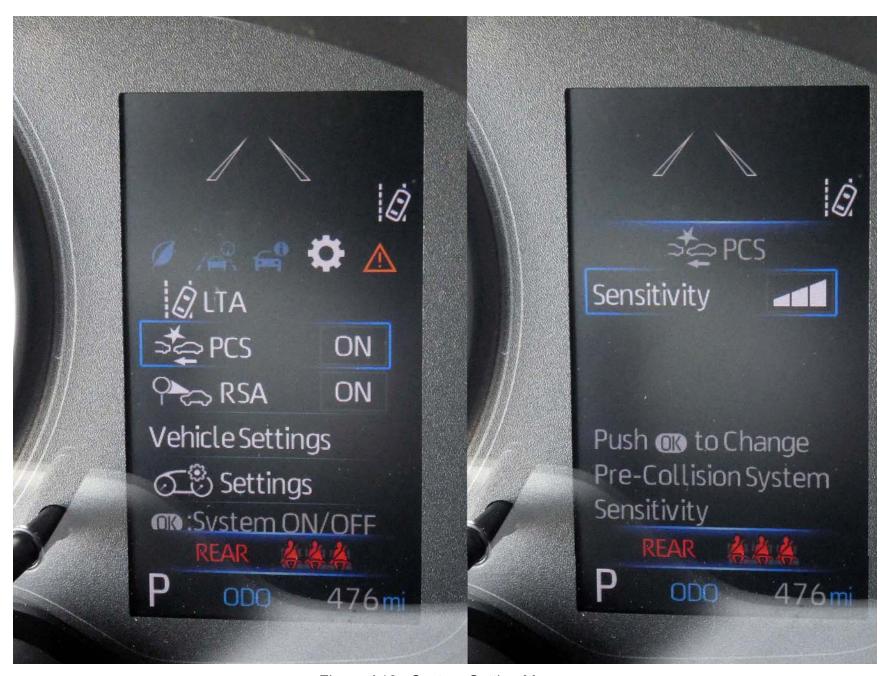
Figure A13. System Setting Menus

| Is the vehicle equipped with a switch whose purpose is to render FCW inoperable? | | Yes |
|---|---|---|
| See Appendix A, Figures A13 and A14, also Appendix B, Page | es B-20 ar | <u>nd B-21.</u> |

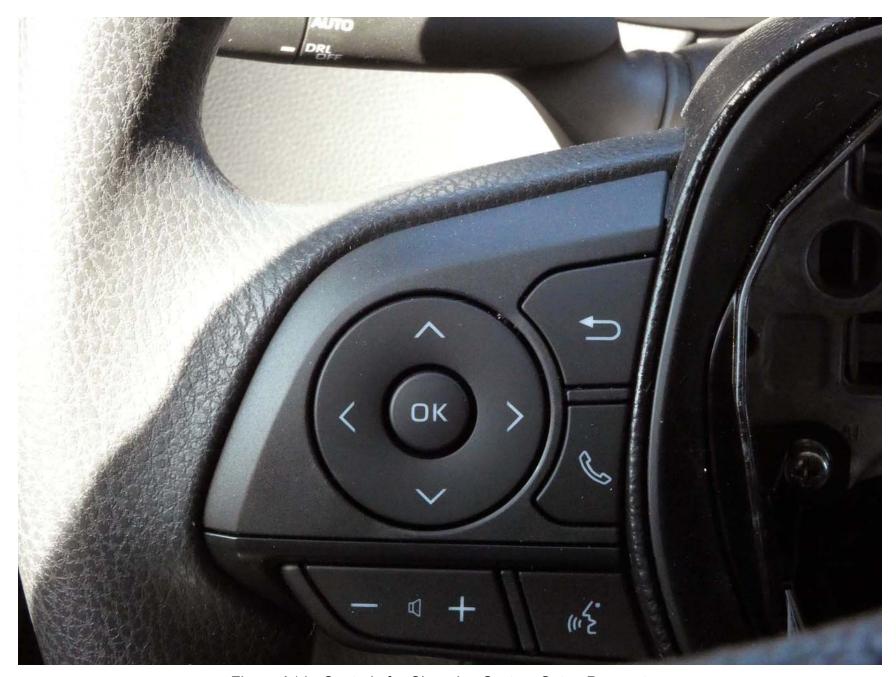
Figure A14. Controls for Changing System Setup Parameters
