RE: Collins Bus Corporation  
Petition for Determination of Inconsequential Noncompliance

### **I. Summary of the Noncompliance**

# Part 573 Safety Recall Report

# 20V-215

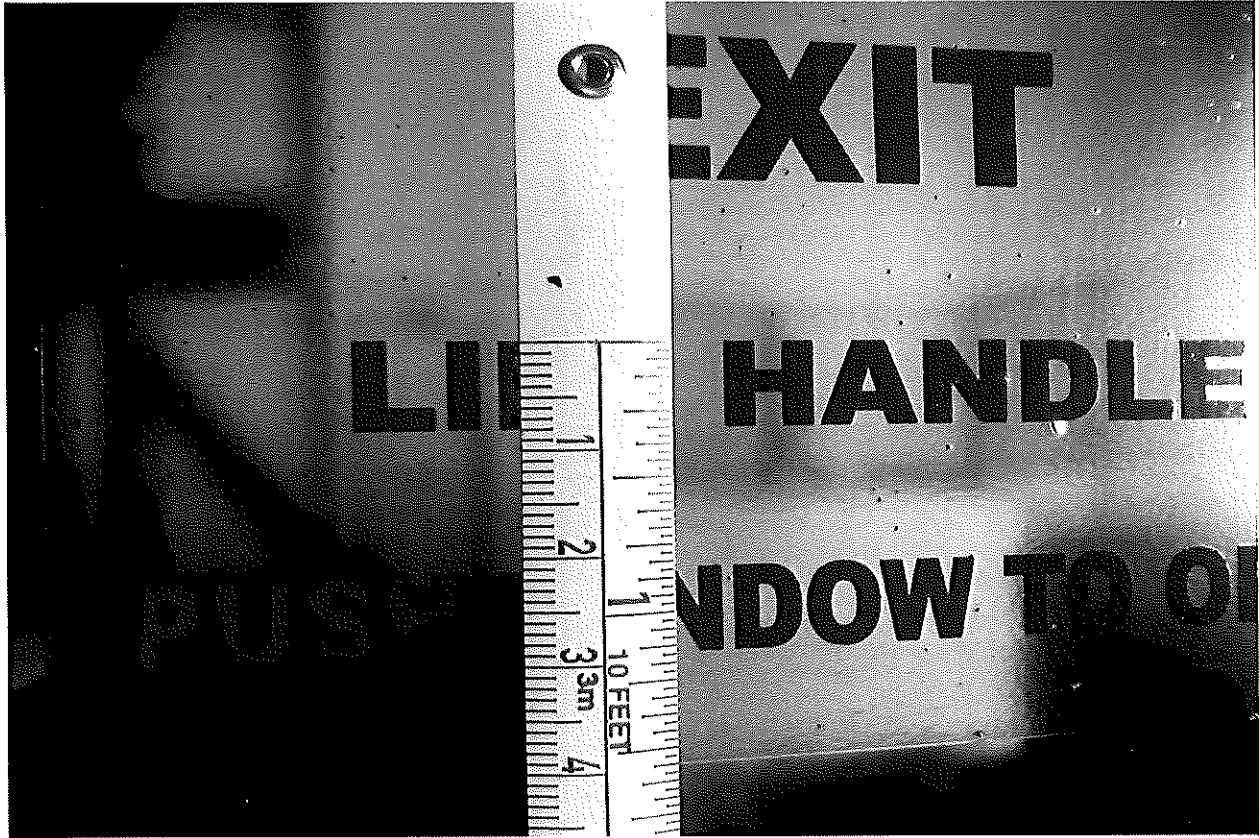
Specifically, in the affected buses the required operating instructions describing the motions necessary to unlatch and open the emergency window exit are eight (8) millimeters in height rather than the required ten (10) millimeters. The following picture showing the noncompliance was provided to Collins by a NHTSA safety and compliance engineer as part of a Laboratory Notice of Test Failure:<sup>3</sup>

The 2-millimeter deficiency in the letter height is inconsequential to motor vehicle safety. The actual height of the emergency window exit operating instructions letters – eight (8) millimeters, as shown in the pictures in Exhibit 2 – is 80% of the height required by FMVSS 217 (ten (10) millimeters). The NHTSA has previously granted inconsequential noncompliance petitions for labeling defects across various motor vehicle safety standards, including for more significant lettering height deficiencies:

Further, the instruction label includes the words “Emergency Exit” in letters with a height of 11 millimeters, which not only meets but substantially exceeds the 1-centimeter requirement. *See* 67 Fed. Reg. at 72026 (noting that some of the letters did meet the minimum height requirements in finding that insufficient height of other letters did not have an adverse effect on vehicle safety).

Further, the discrepancy does not compromise the conspicuity of the instructions. As shown in the pictures in Exhibit 2, the instructions are not only in a color that sharply contrasts with their background (red) as required by FMVSS 217, the letters are additionally in bold and block capital letters, which is not required by the standard but which preserves the 8-millimeter height across the width of the words and increases the visibility of the instructions. *See* 81 Fed. Reg. at 92964 (finding the use of all capitalized letters, where not required, provided “a more pronounced indicator”). And as noted above, some of the words in the label (i.e. “Emergency Exit”) not only meet but exceed the minimum height requirement, thereby increasing the visibility of the instructions.

is not aware of any injuries associated with the size or visibility of the instructions. Collins has corrected the noncompliance in all buses remaining within its possession.

Identify How/When Recall Condition was Corrected in Production : Collins had a meeting April 8, 2020 to determine the decal was not in compliance with FMVSS217. Collins Bus has addressed the noncompliance with production to make sure the new decal is installed in the proper location with the correct lettering height requirements to meet all FMVSS217 standards.
