#### NEW CAR ASSESSMENT PROGRAM LANE DEPARTURE WARNING CONFIRMATION TEST NCAP-DRI-LDW-20-05

2020 Ford F-150 4X4 SuperCrew

DYNAMIC RESEARCH, INC. 355 Van Ness Avenue, STE 200 Torrance, California 90501

**Final Report**

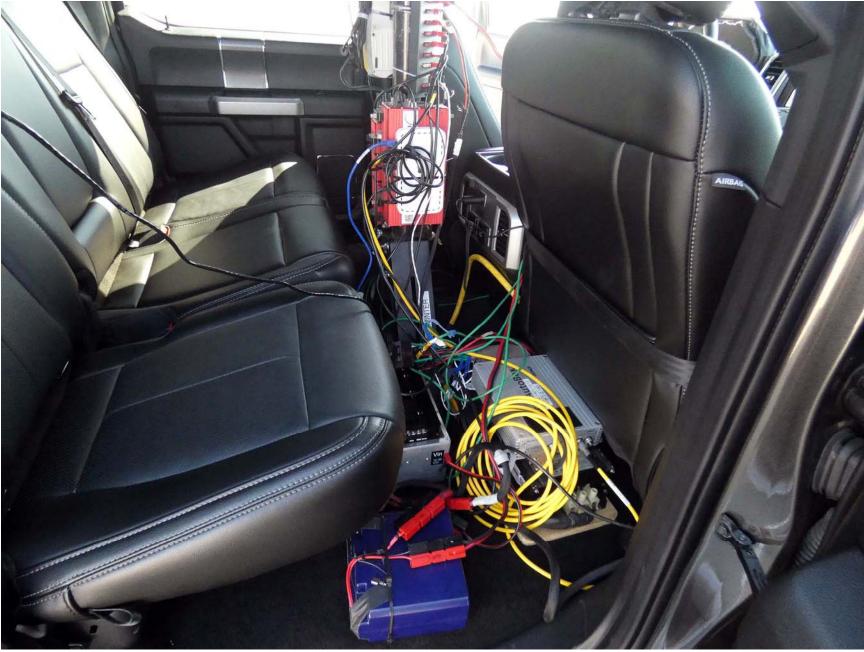
Figure A6. DGPS, Inertial Measurement Unit, and MicroAutoBox Installed in Subject Vehicle

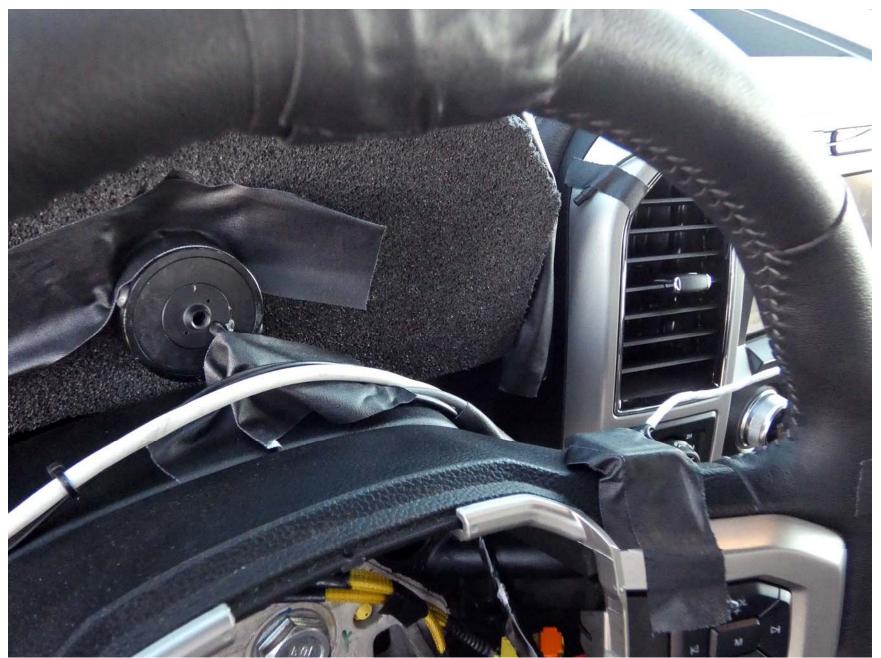
Figure A7. Sensors for Detecting Visual and Haptic Alerts

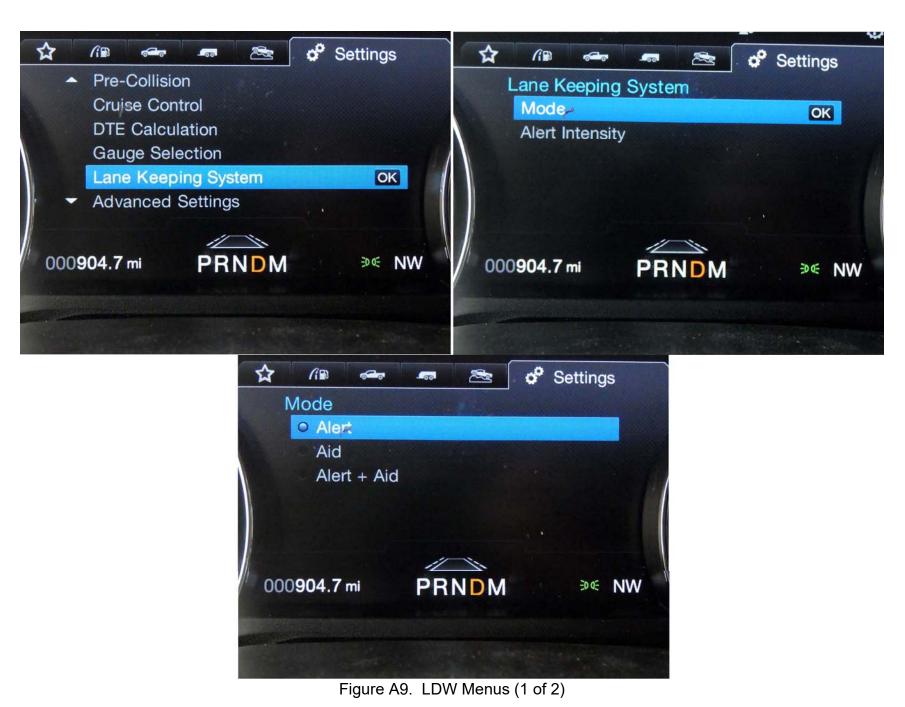
Figure A10. LDW Menus (2 of 2)

<u>The Lane Departure functionality can be modified through the cluster menu,</u> <u>accessed by means of buttons on the steering wheel. The hierarchy is:</u> <u>Settings</u> <u>Lane Keeping System</u> <u>Mode</u> <u>Select Alert, Aid, or Alert + Aid</u> <u>Alert Intensity</u> <u>Select High, Normal, Low</u> <u>See Appendix A, Figures A9 and A10.</u>

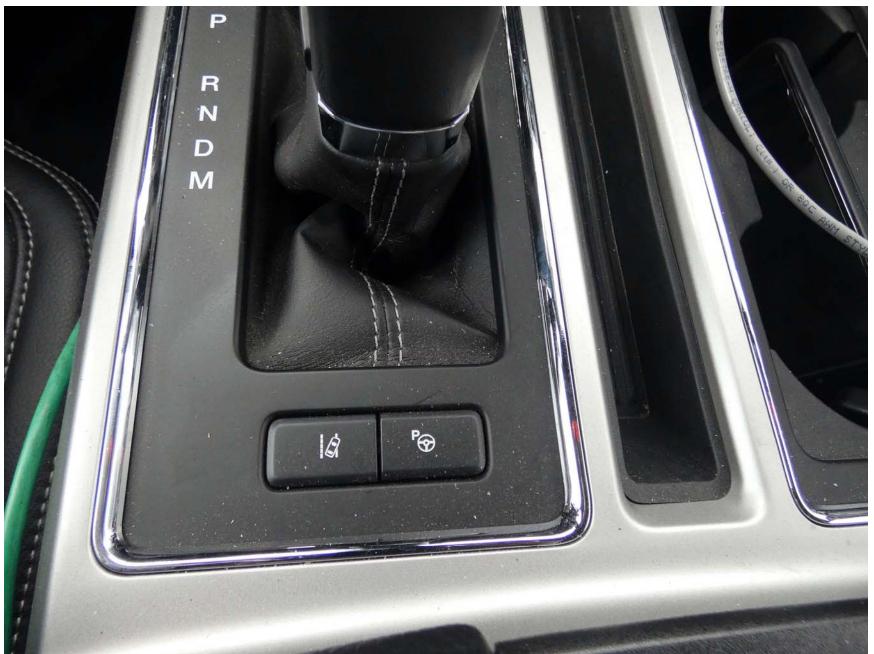
Figure A11. LDW On/Off Switch

<u>The system On/Off switch in located near the shift lever as shown in Appendix</u> <u>A, Figure A11.</u>
