# NEW CAR ASSESSMENT PROGRAM LANE DEPARTURE WARNING CONFIRMATION TEST NCAP-DRI-LDW-21-08

#### 2021 Kia K5 EX

## **DYNAMIC RESEARCH, INC.**

## **Final Report**

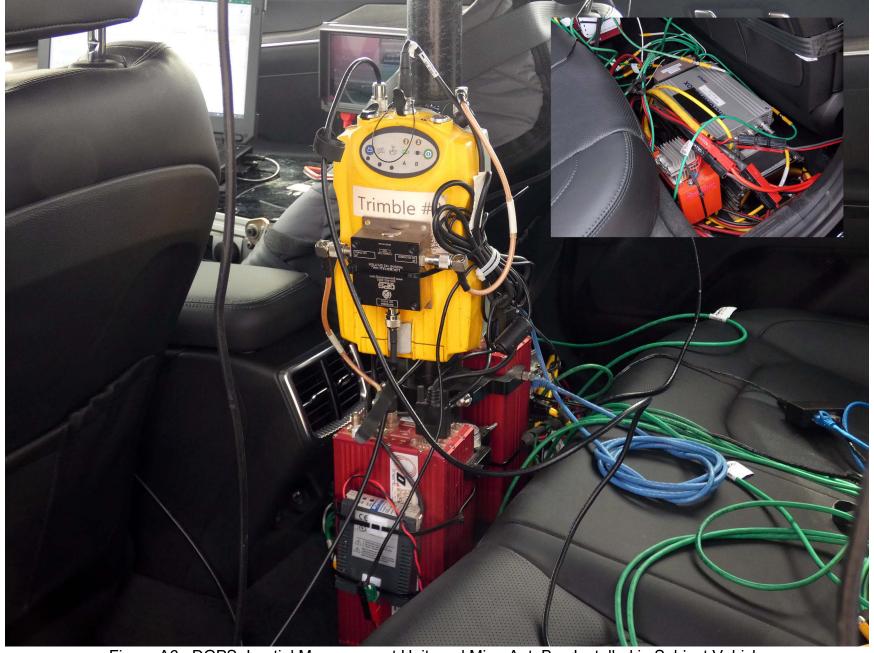
Figure A6. DGPS, Inertial Measurement Unit, and MicroAutoBox Installed in Subject Vehicle

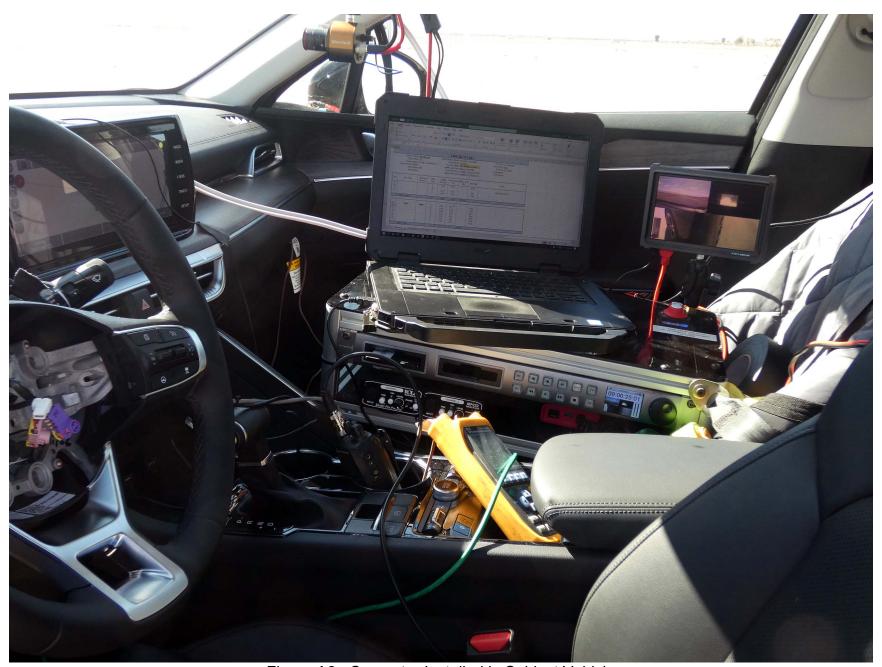
Figure A8. Computer Installed in Subject Vehicle

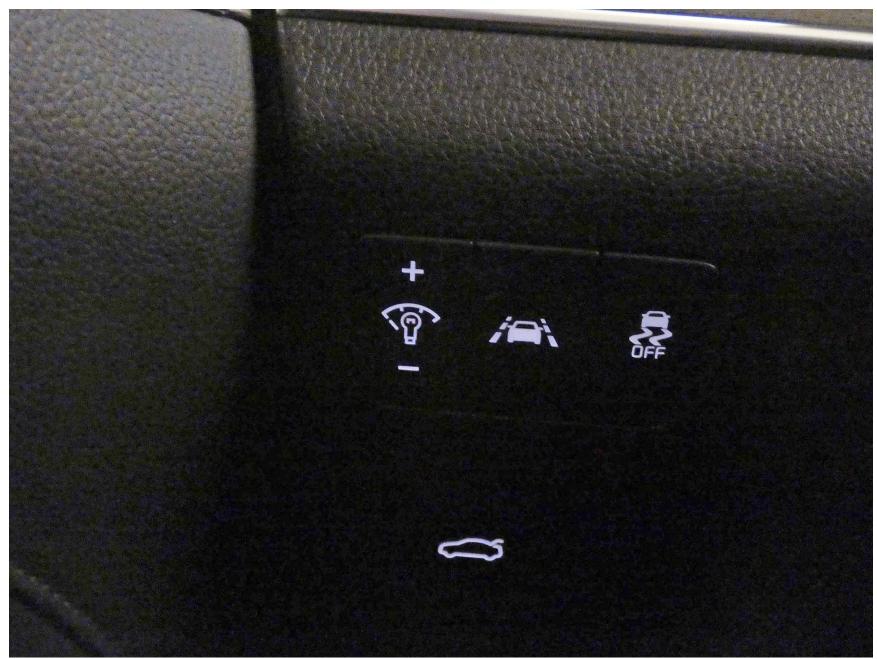
Figure A12. LDW On/Off Switch

Is the vehicle equipped with a switch whose purpose is to render LDW inoperable?	X Yes
parpose to to remain 22 th inteperation	No
If yes, please provide a full description including the operation, any associated instrument panel indicator	
The system can be disabled in two ways. A swite column can be used to turn the system on or off.	
The system can also be disabled using the syste	
The menu hierarchy is:	m menas in the center display.
<u>Setup</u>	
Vehicle Settings	
Driver Assistance	
Lane Safety,	
Toggle Off or On.	
See Appendix A, Figures A9 and A10.	
Is the vehicle equipped with a control whose purpose is to adjust the range setting or otherwise influence the operation of LDW?	Yes No
If yes, please provide a full description.	
The timing can be adjusted using the menus in the hierarchy is:	ne center display. The menu
<u>Setup</u>	
<u>Vehicle Settings</u>	
<u>Driver Assistance</u>	
<u>Warning Timing</u>

Select Normal or Late	2
See Appendix A, Figures A9 and A10.

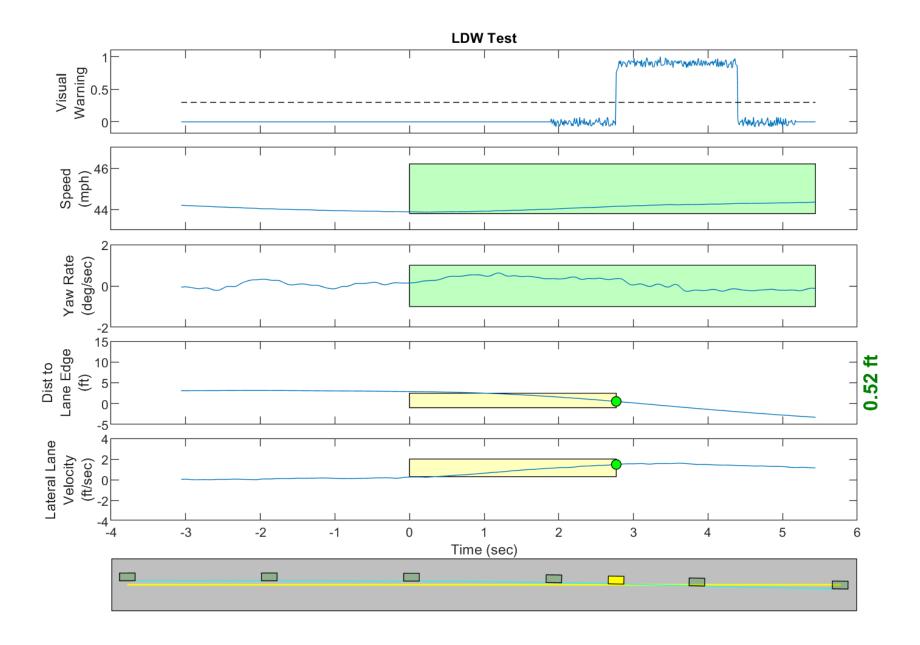
Figure D1. Example Time History for Lane Departure Warning Test, Passing

A set of time history plots is provided for each valid run in the test series. Each set of plots comprises time varying data from the Subject Vehicle, as well as pass/fail envelopes and thresholds. The following is a description of data types shown in the time history plots, as well as a description of the color code for data envelopes.

Examples of time history plots (including passing, failing and invalid runs) are shown in Figure D1 through Figure D3. Actual time history data plots for the vehicle under consideration are provided subsequently.

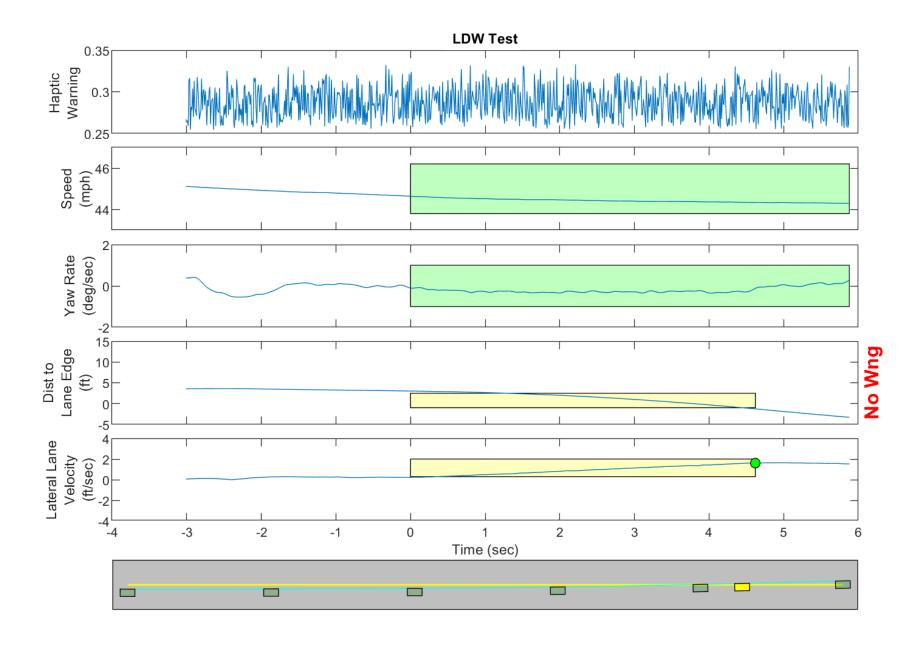
Figure D2. Example Time History for Lane Departure Warning Test, Failing, No Warning Issued

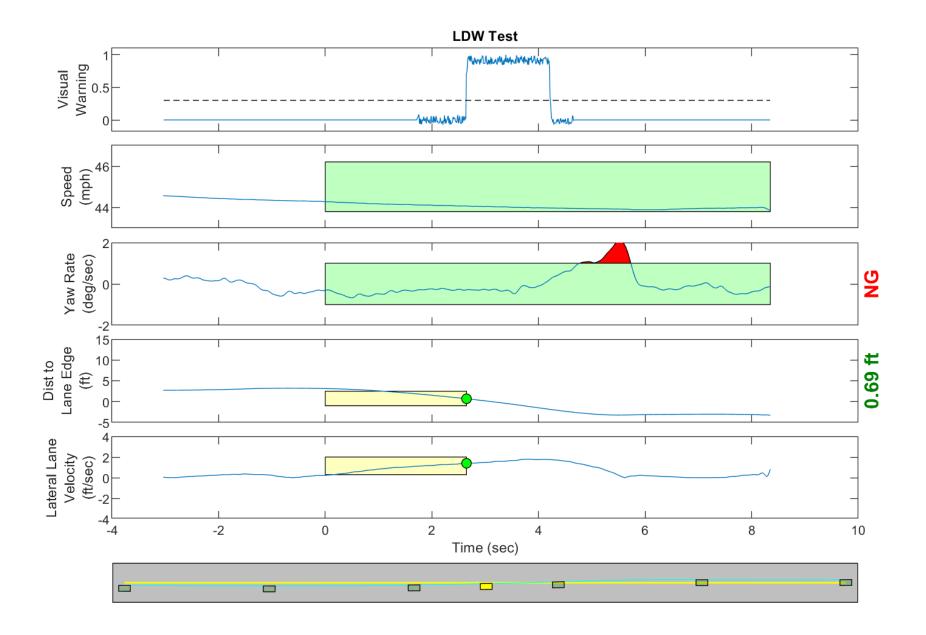
Figure D3. Example Time History for Lane Departure Warning Test, Invalid Run Due to Subject Vehicle Yaw Rate

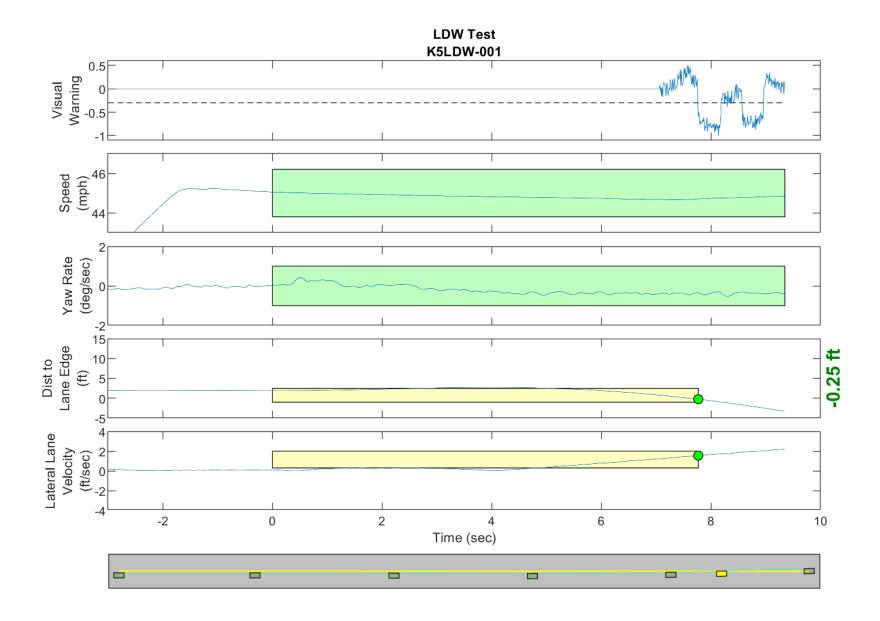
Figure D5. Time History for Run 01, Solid Line, Left Departure, Visual Warning

Run	Lane Marking Type	Departure Direction	Valid Run?	Distance at Auditory Alert (ft)	Distance at Visual Alert (ft)	Pass/Fail	Notes
1			Υ	-0.17	-0.25	Pass	
2			Ν				Yaw
3			Y	-0.14	-0.22	Pass	
4	Solid	olid Left	Y	-0.16	-0.24	Pass	
5	Solid		Y	-0.18	-0.28	Pass	
6			Υ	-0.23	-0.25	Pass	
7			Υ	-0.27	-0.38	Pass	
8			Y	-0.19	-0.31	Pass	
9		Solid Right	Y	0.48	0.40	Pass	
10			Y	0.53	0.44	Pass	
11			Y	0.46	0.40	Pass	
12	Solid		Υ	0.48	0.41	Pass	
13			Υ	0.47	0.38	Pass	
14			Υ	0.49	0.44	Pass	
15			Υ	0.46	0.37	Pass	
16	Doobood	Dight	Υ	0.47	0.35	Pass	
17	Dashed	Right	Y	0.47	0.39	Pass

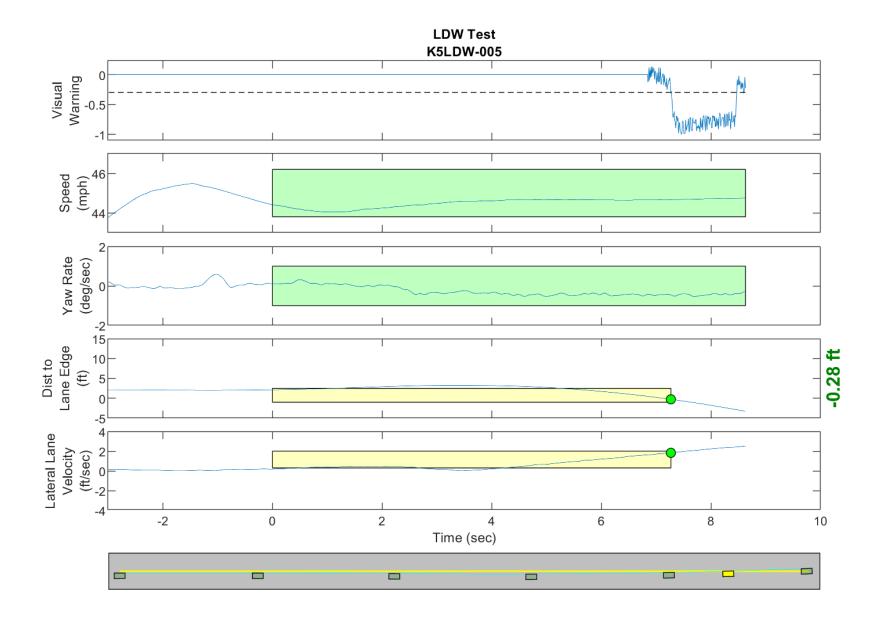
Figure D11. Time History for Run 05, Solid Line, Left Departure, Visual Warning

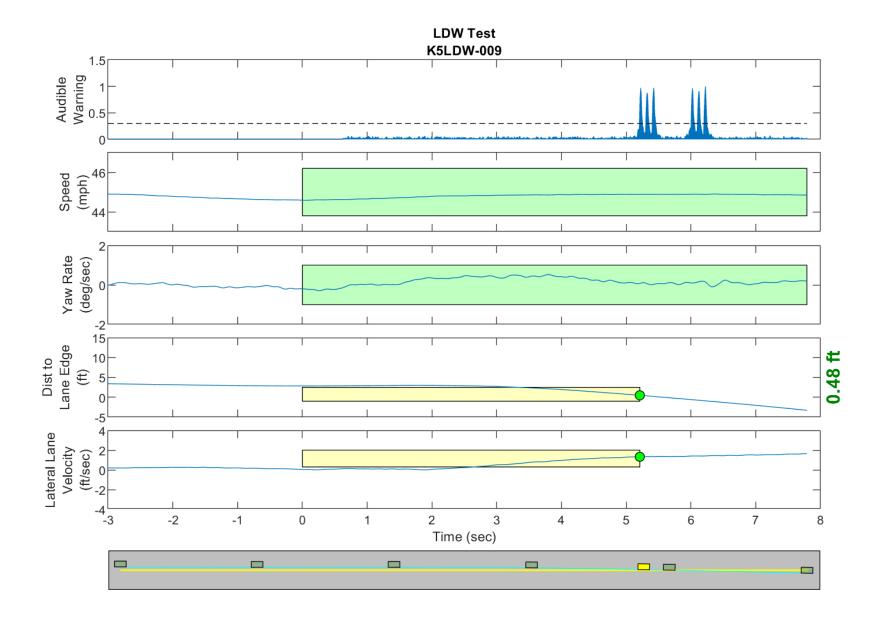
Figure D18. Time History for Run 09, Solid Line, Right Departure, Audible Warning

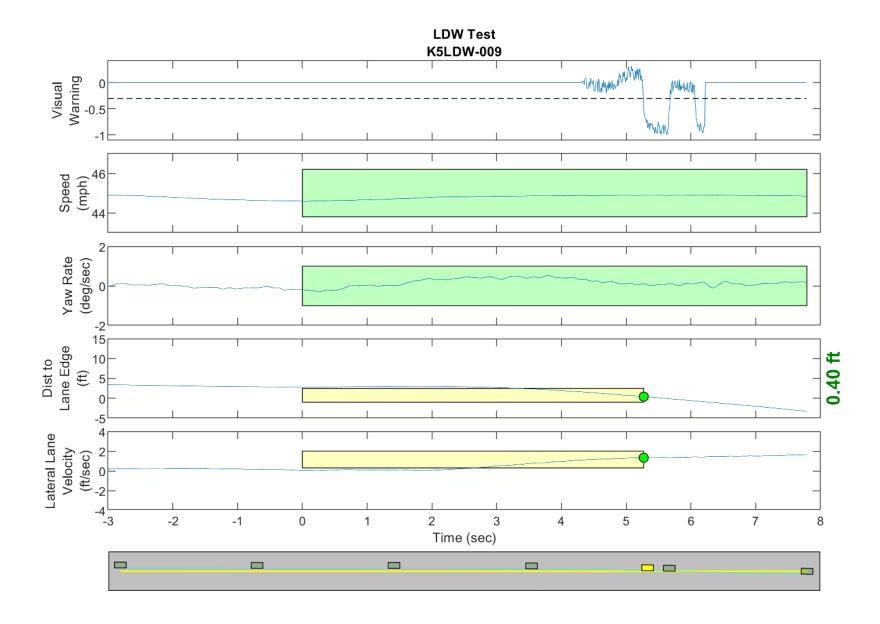
Figure D19. Time History for Run 09, Solid Line, Right Departure, Visual Warning

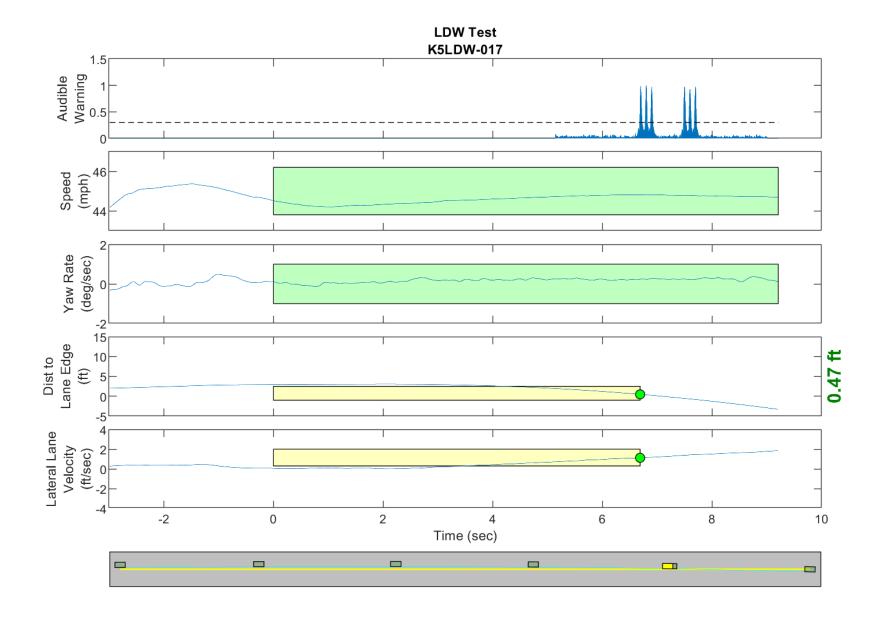
Figure D34. Time History for Run 17, Dashed Line, Right Departure, Audible Warning

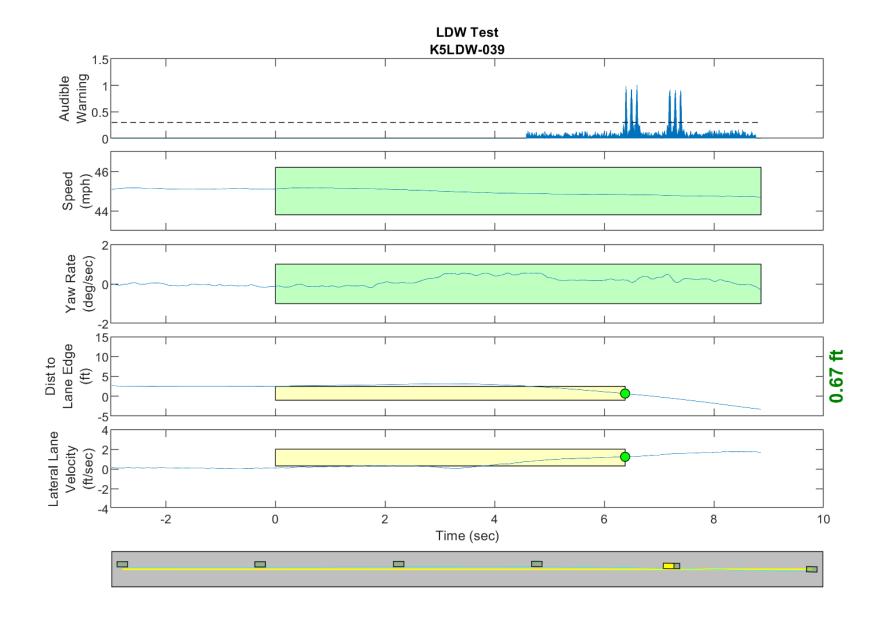
Figure D74. Time History for Run 39, Botts Dots, Right Departure, Audible Warning

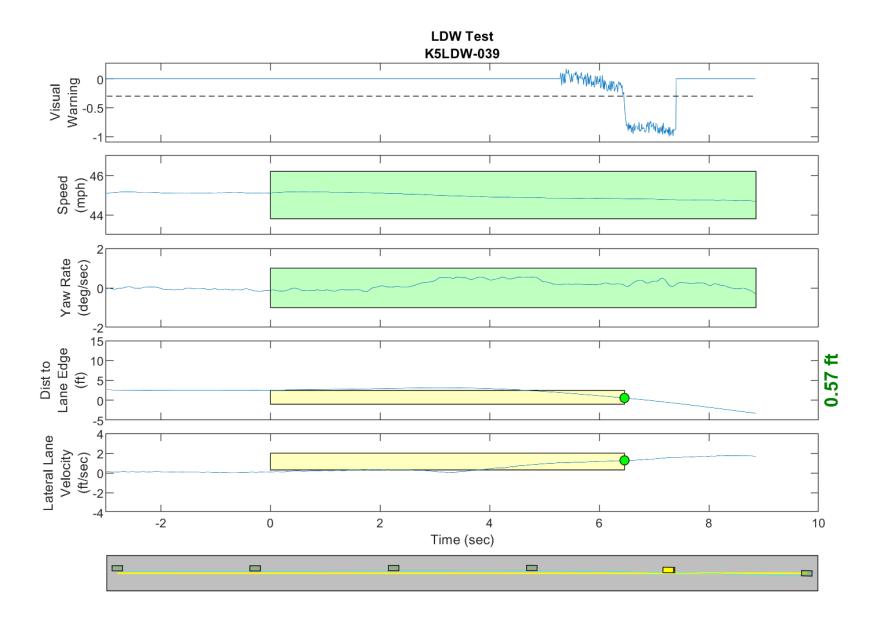
Figure D75. Time History for Run 39, Botts Dots, Right Departure, Visual Warning
