**NEW CAR ASSESSMENT PROGRAM
CRASH IMMINENT BRAKING SYSTEM CONFIRMATION TEST
NCAP-DRI-CIB-21-08**

2021 Hyundai Elantra SEL

DYNAMIC RESEARCH, INC.

Final Report

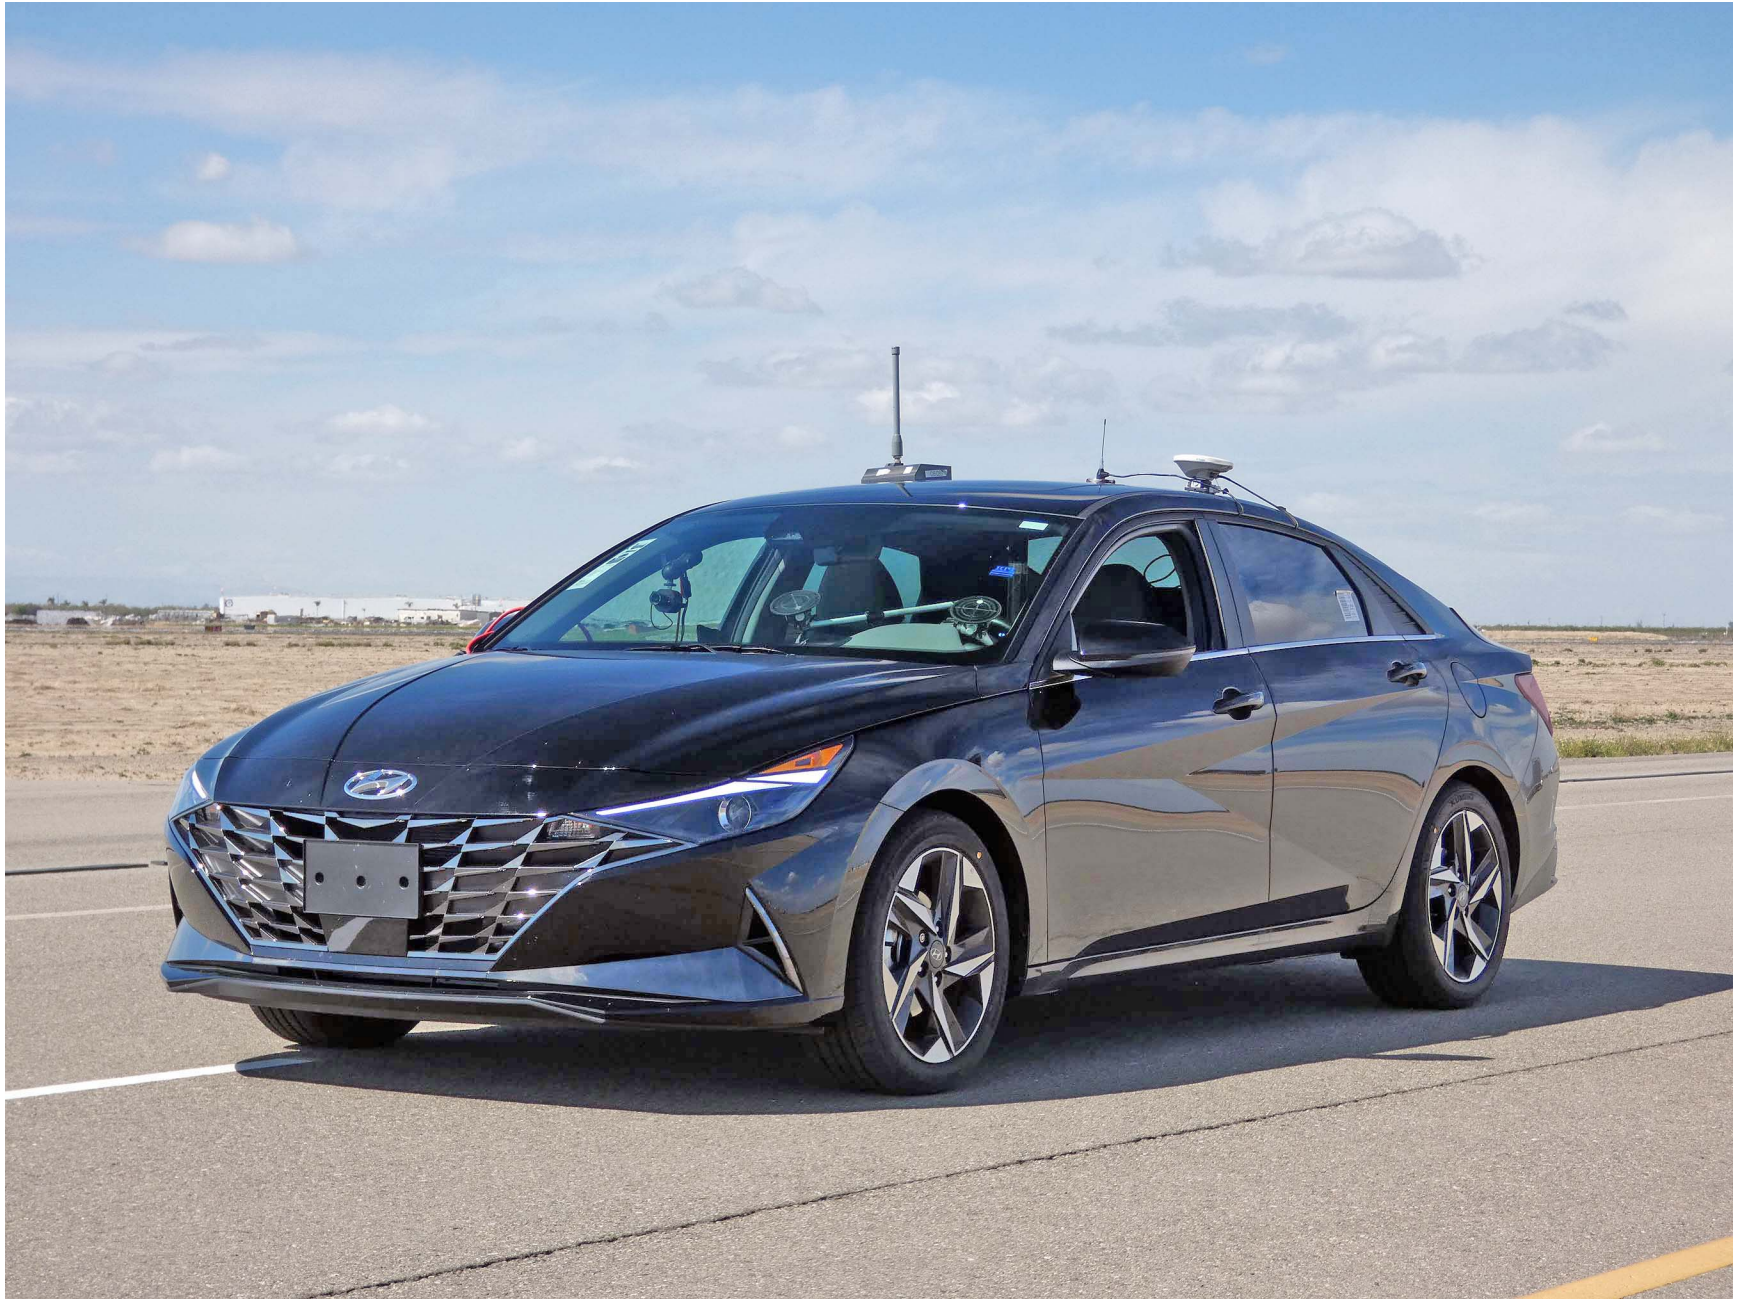
Figure A1. Front View of Subject Vehicle

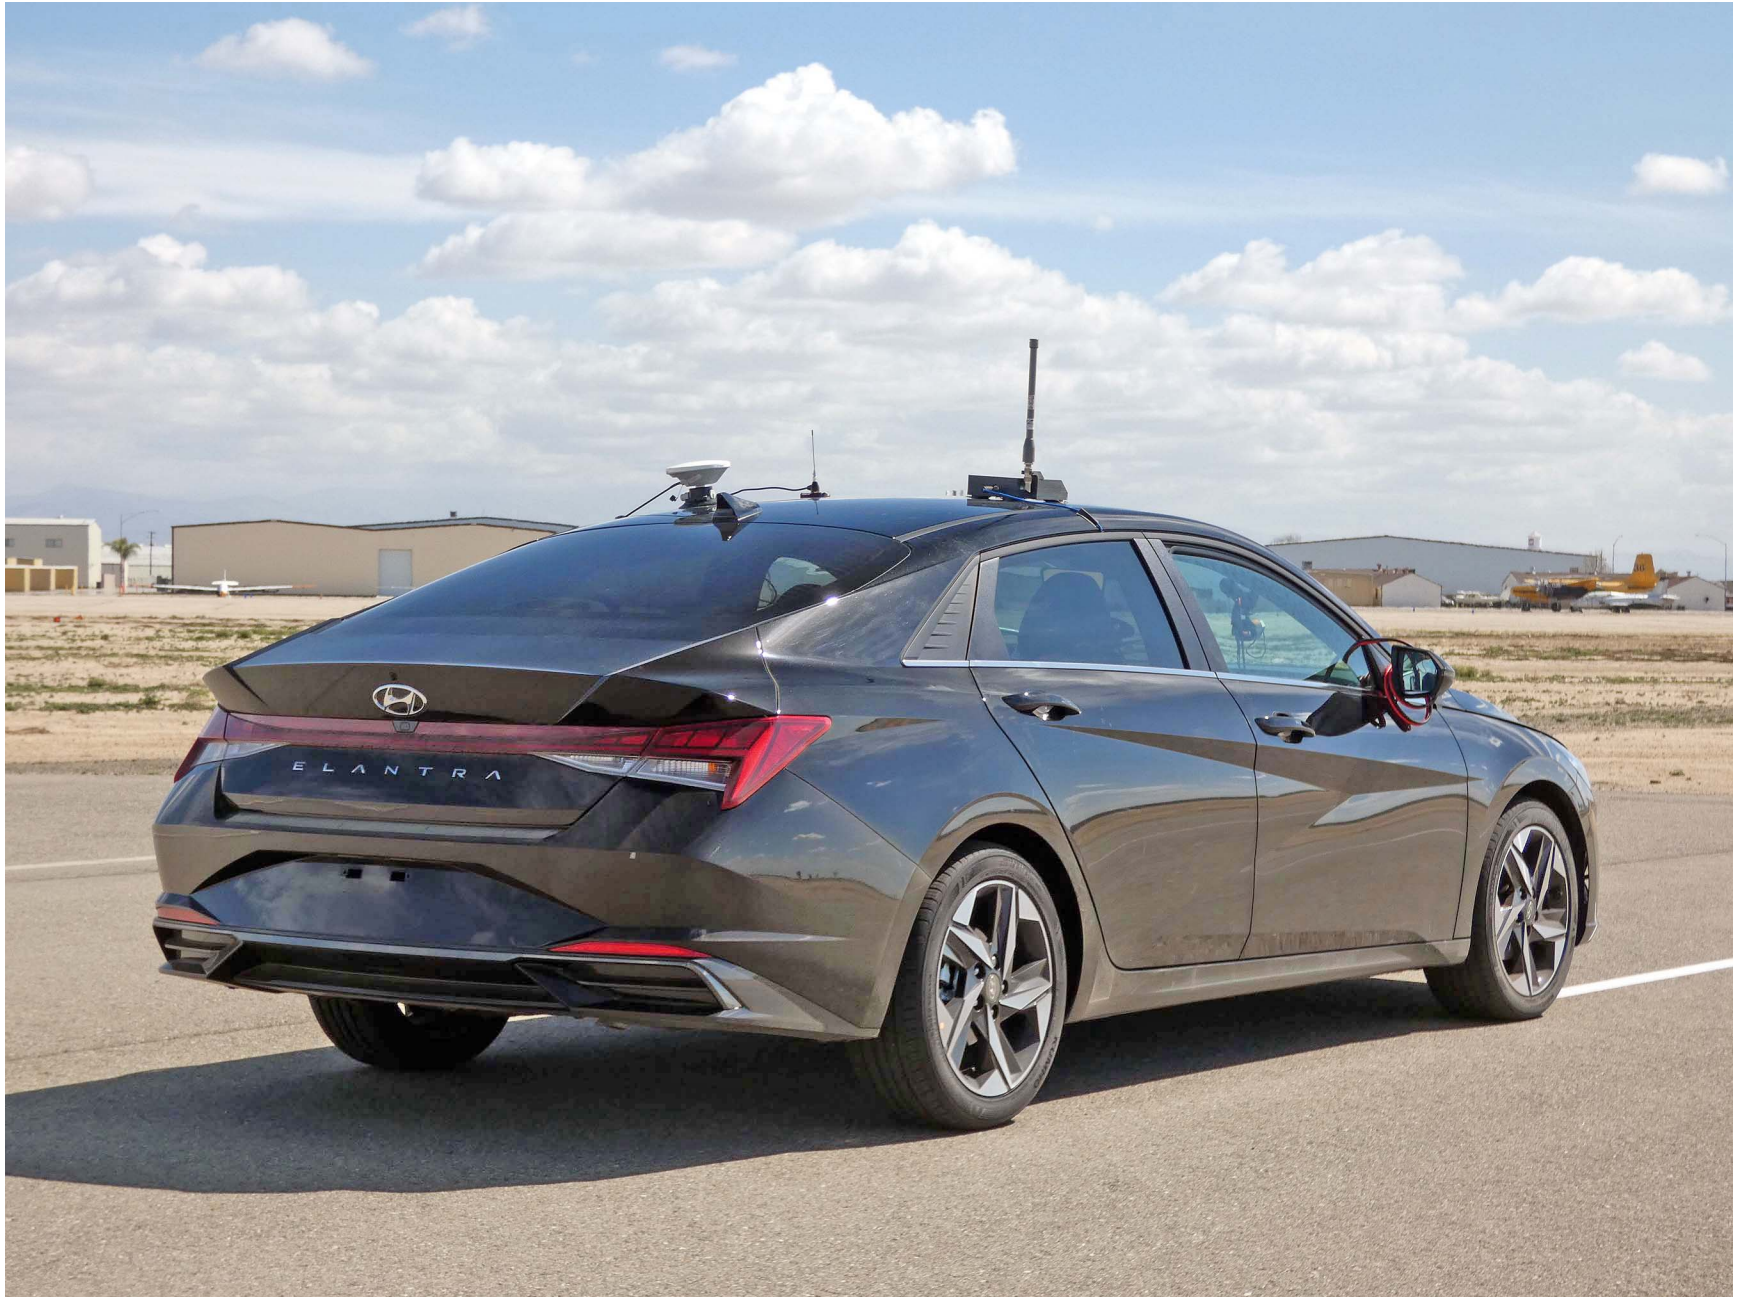
Figure A2. Rear View of Subject Vehicle

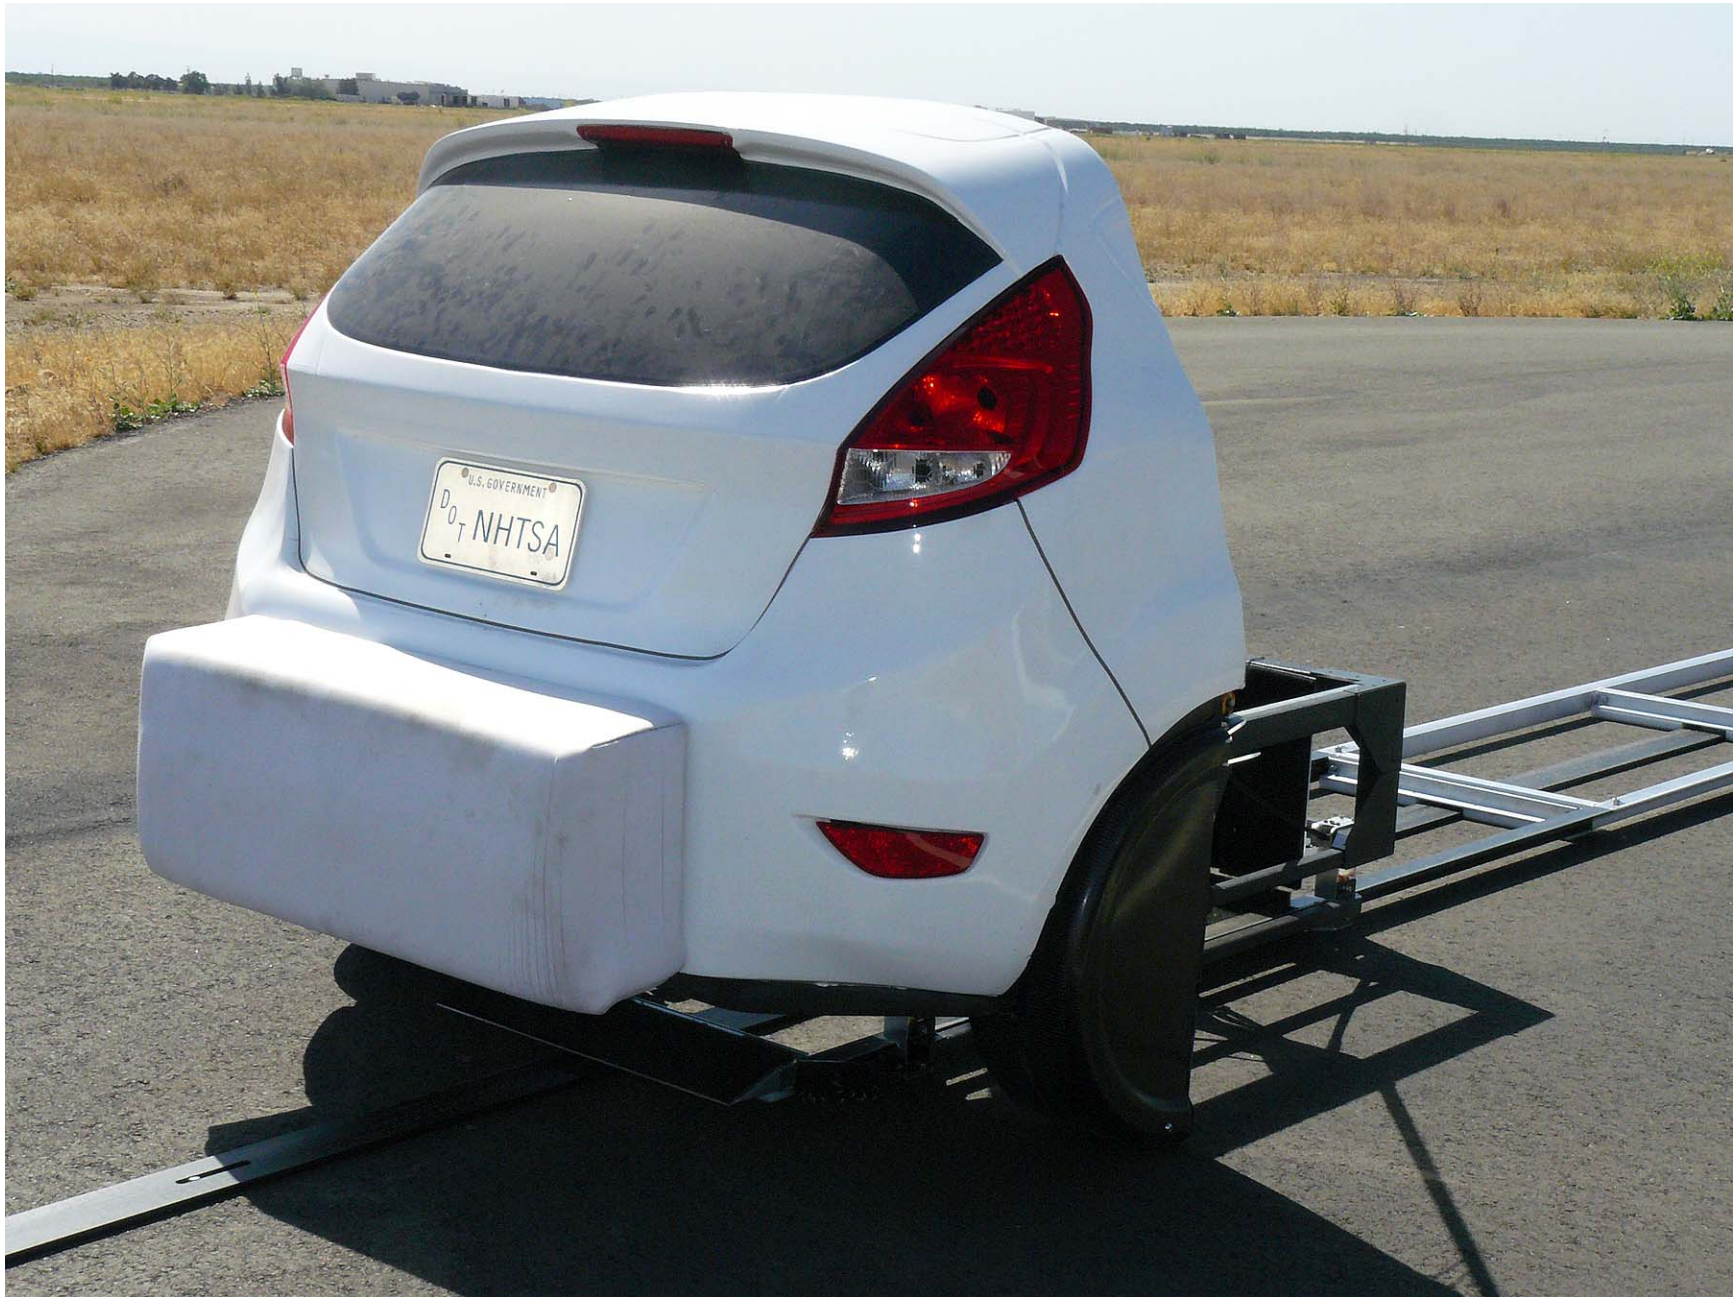
Figure A6. Rear View of Principal Other Vehicle (SSV)

CIB testing requires a POV that realistically represents typical vehicles, does not suffer damage or cause damage to a test vehicle in the event of collision, and can be accurately positioned and moved during the tests. The tests reported herein made use of the NHTSA developed Strikeable Surrogate Vehicle (SSV).

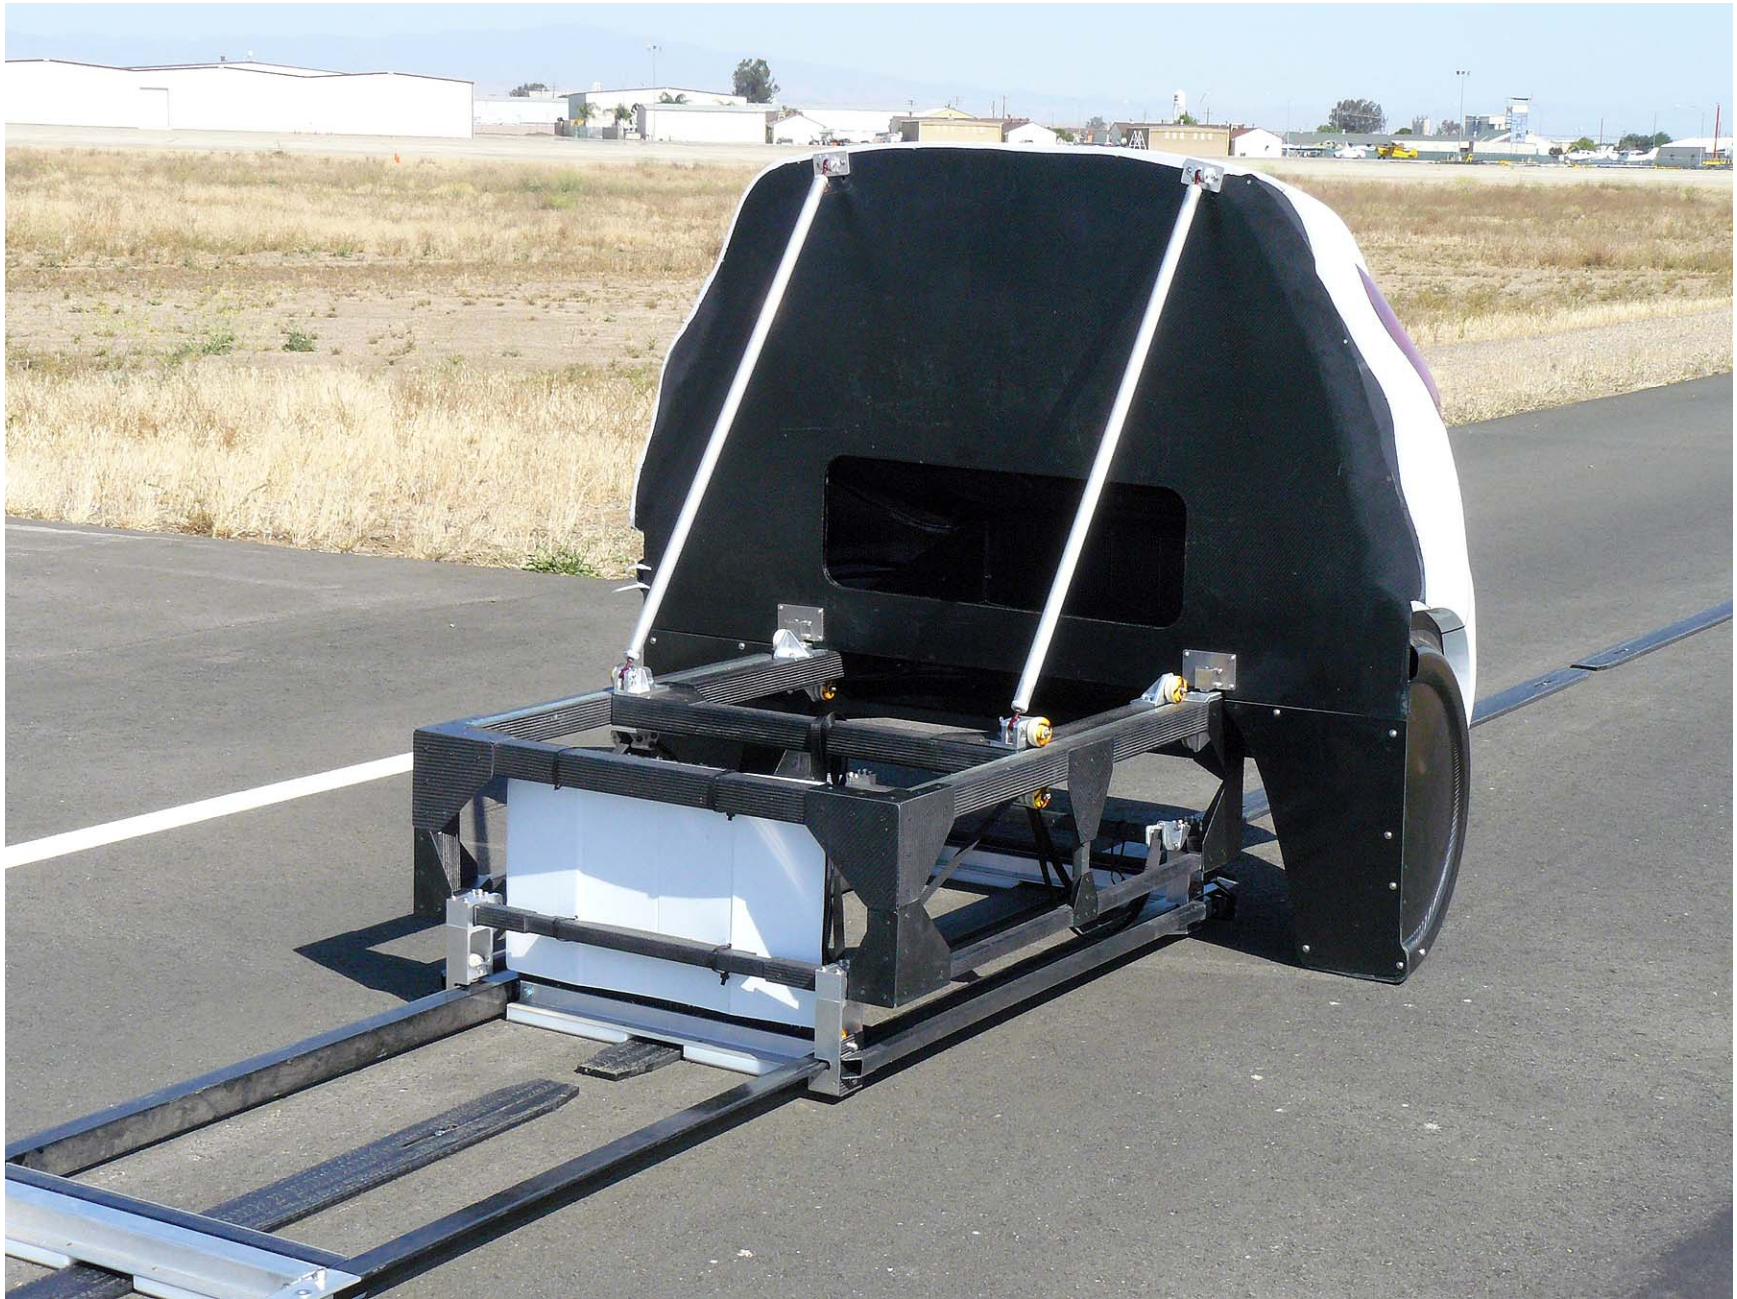
Figure A7. Load Frame/Slider of SSV

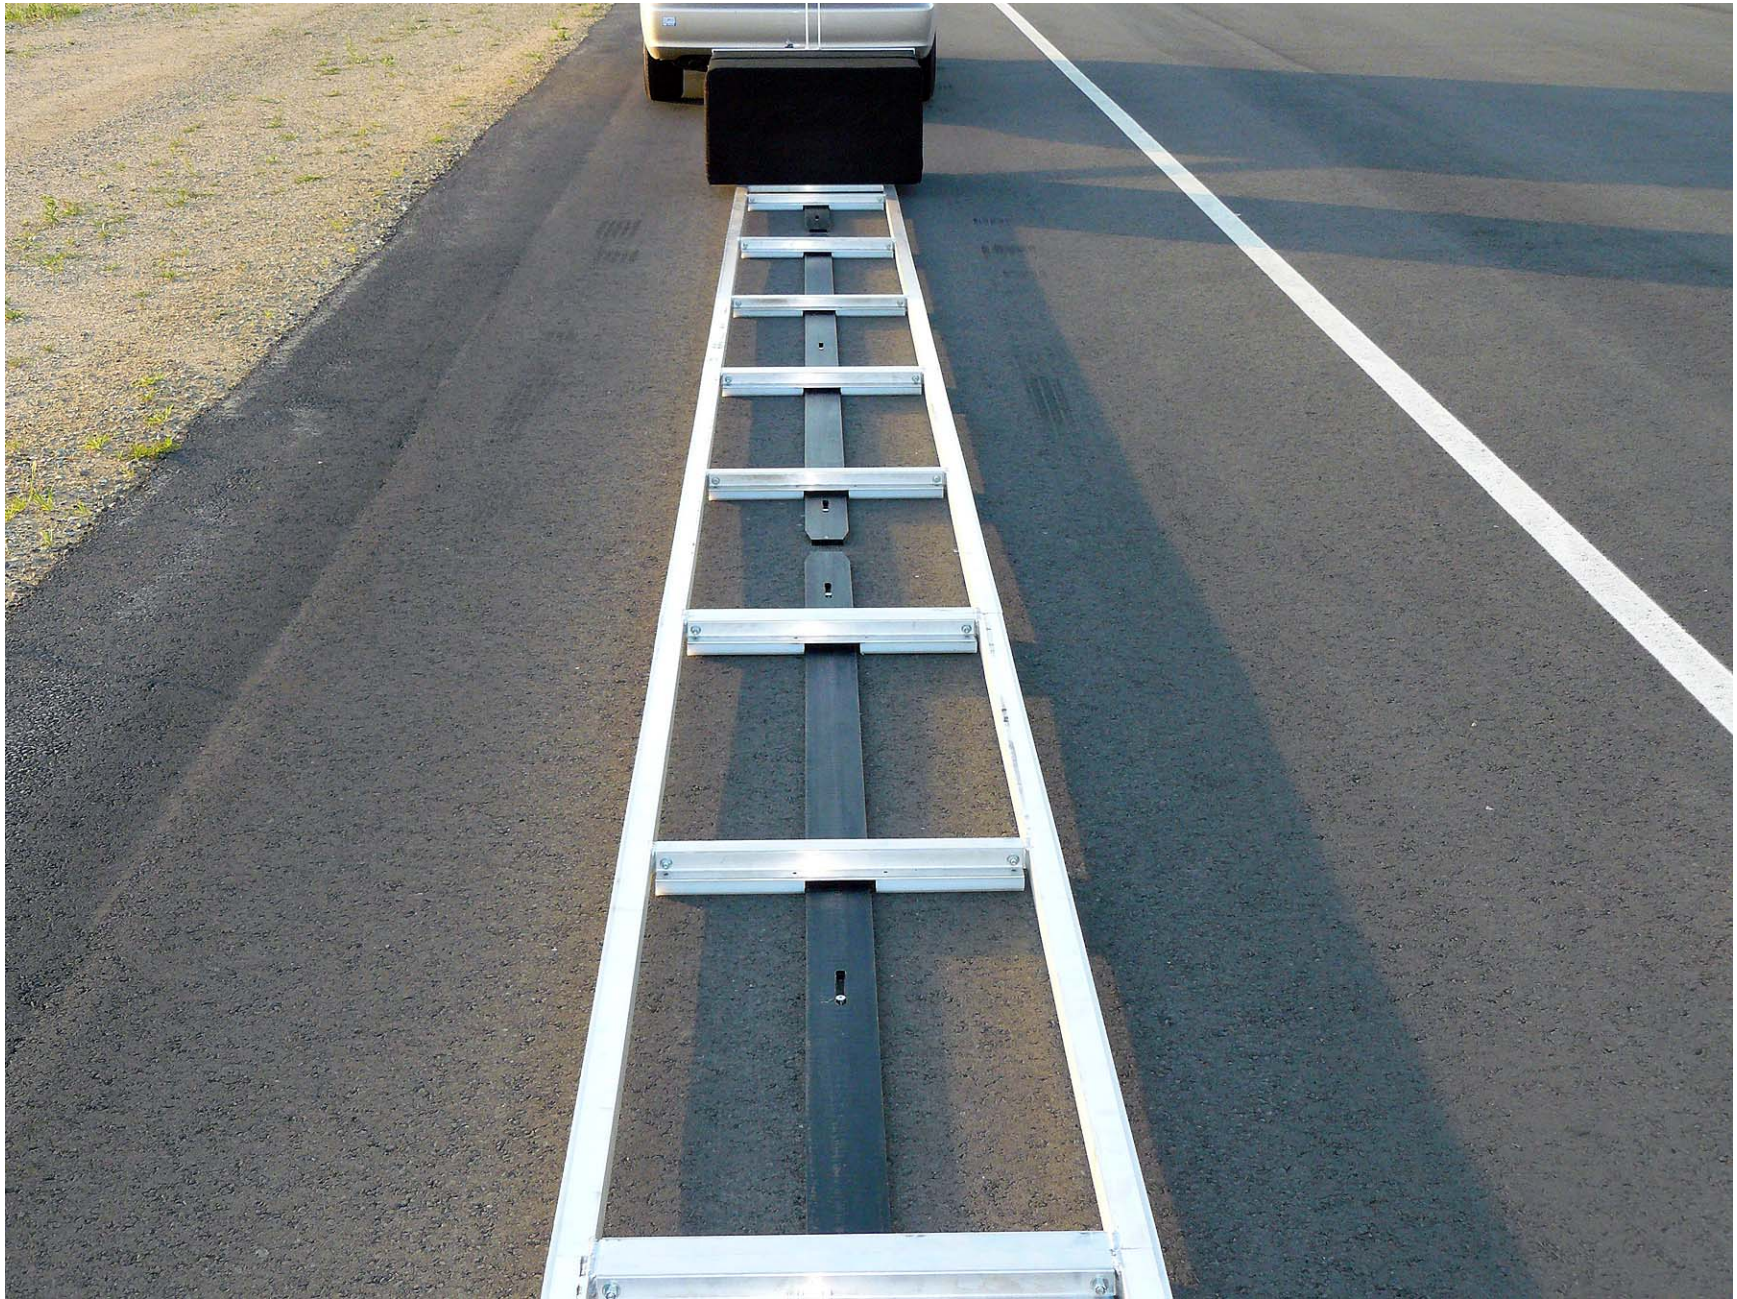
Figure A8. Two-Rail Track and Road-Based Lateral Restraint Track

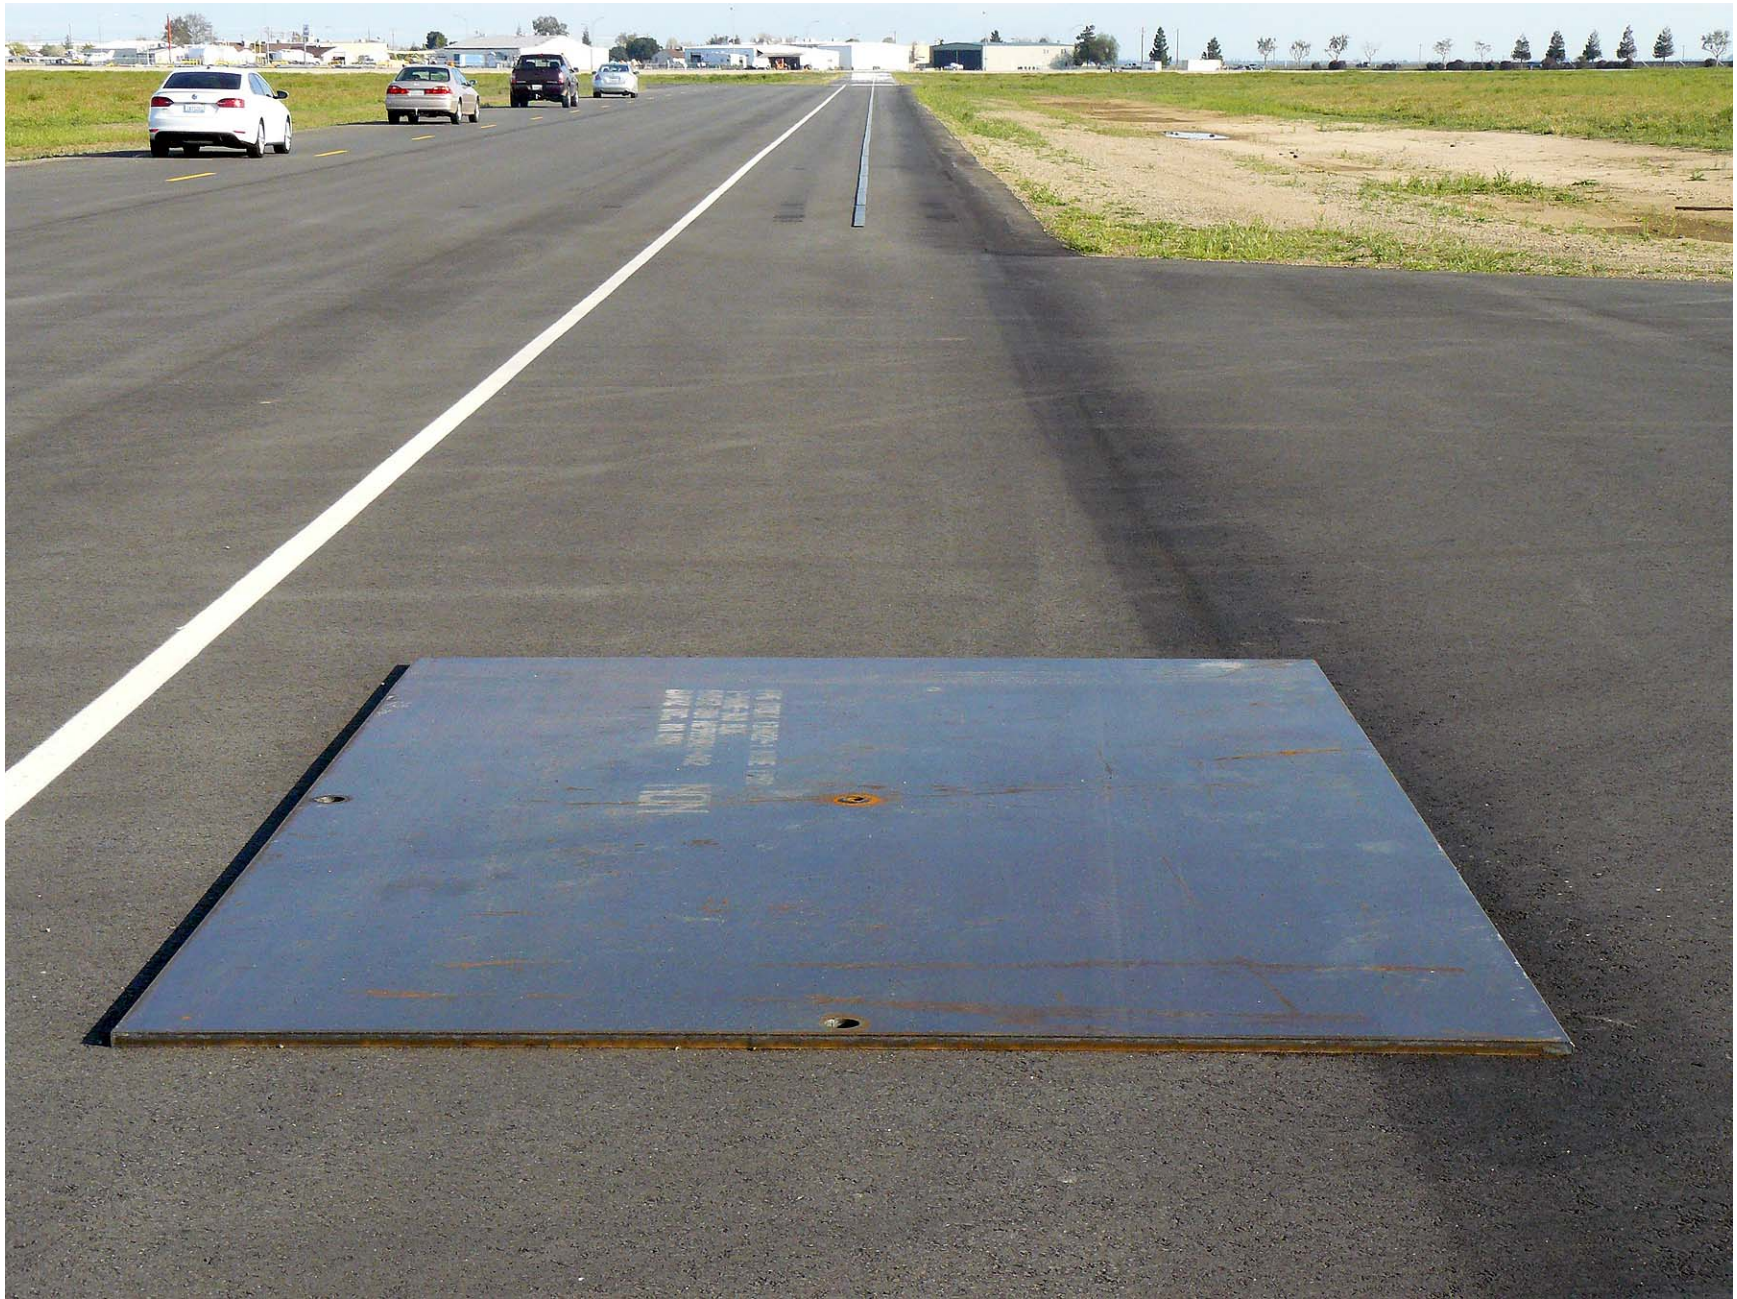
Figure A9. Steel Trench Plate

The false positive suppression test series evaluates the ability of a CIB system to differentiate a steel trench plate (STP) from an object presenting a genuine safety risk to the SV. Although the STP is large and metallic, it is designed to be driven over without risk of injury to the driver or damage to the SV. Therefore, in this scenario, the automatic braking available from CIB is not necessary and should be suppressed. The test condition is nearly equivalent to that previously defined for Test 1, the stopped POV condition, but with an STP in the SV forward path in lieu of a POV.

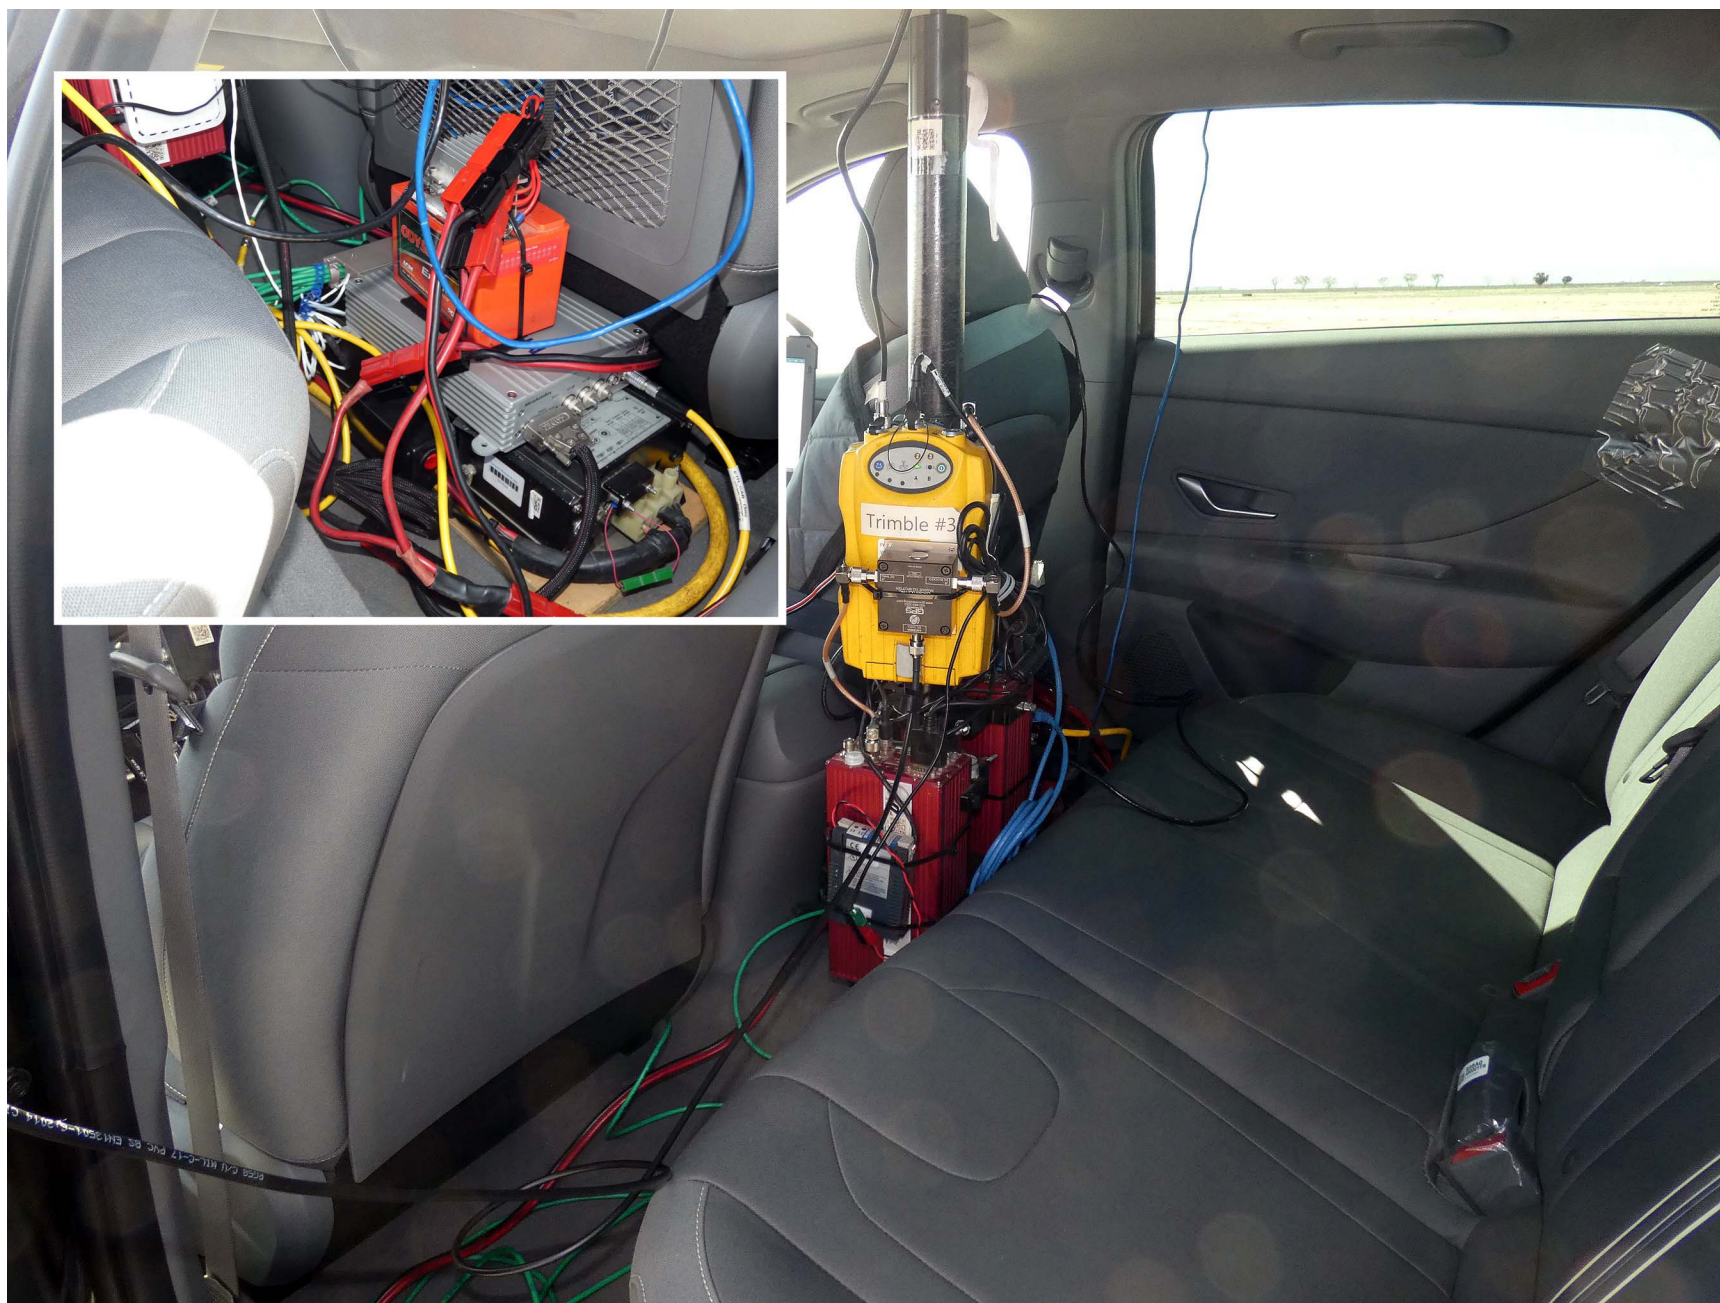
Figure A10. DGPS, Inertial Measurement Unit, and MicroAutoBox Installed in Subject Vehicle

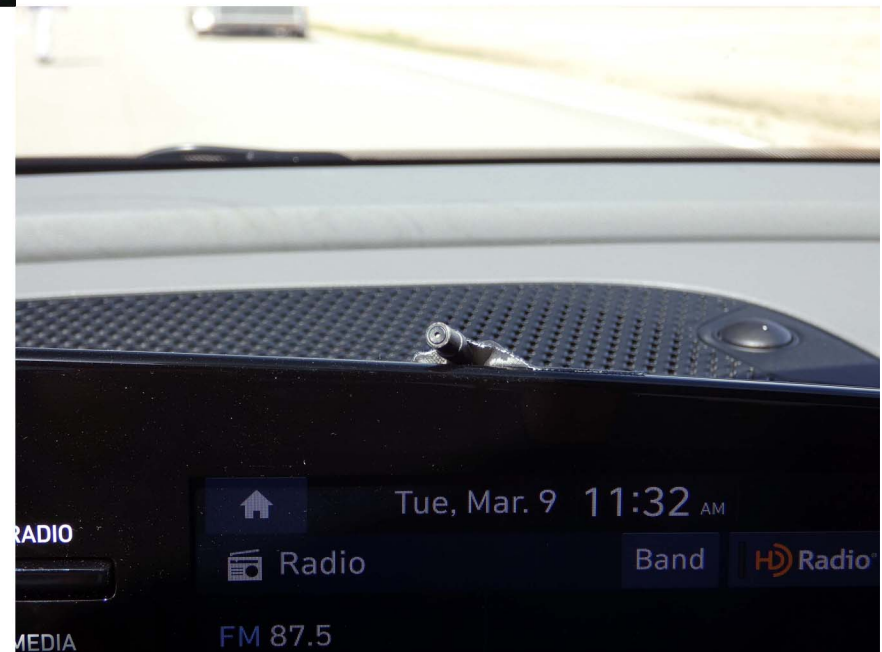
Figure A11. Sensors for Detecting Auditory and Visual Alerts

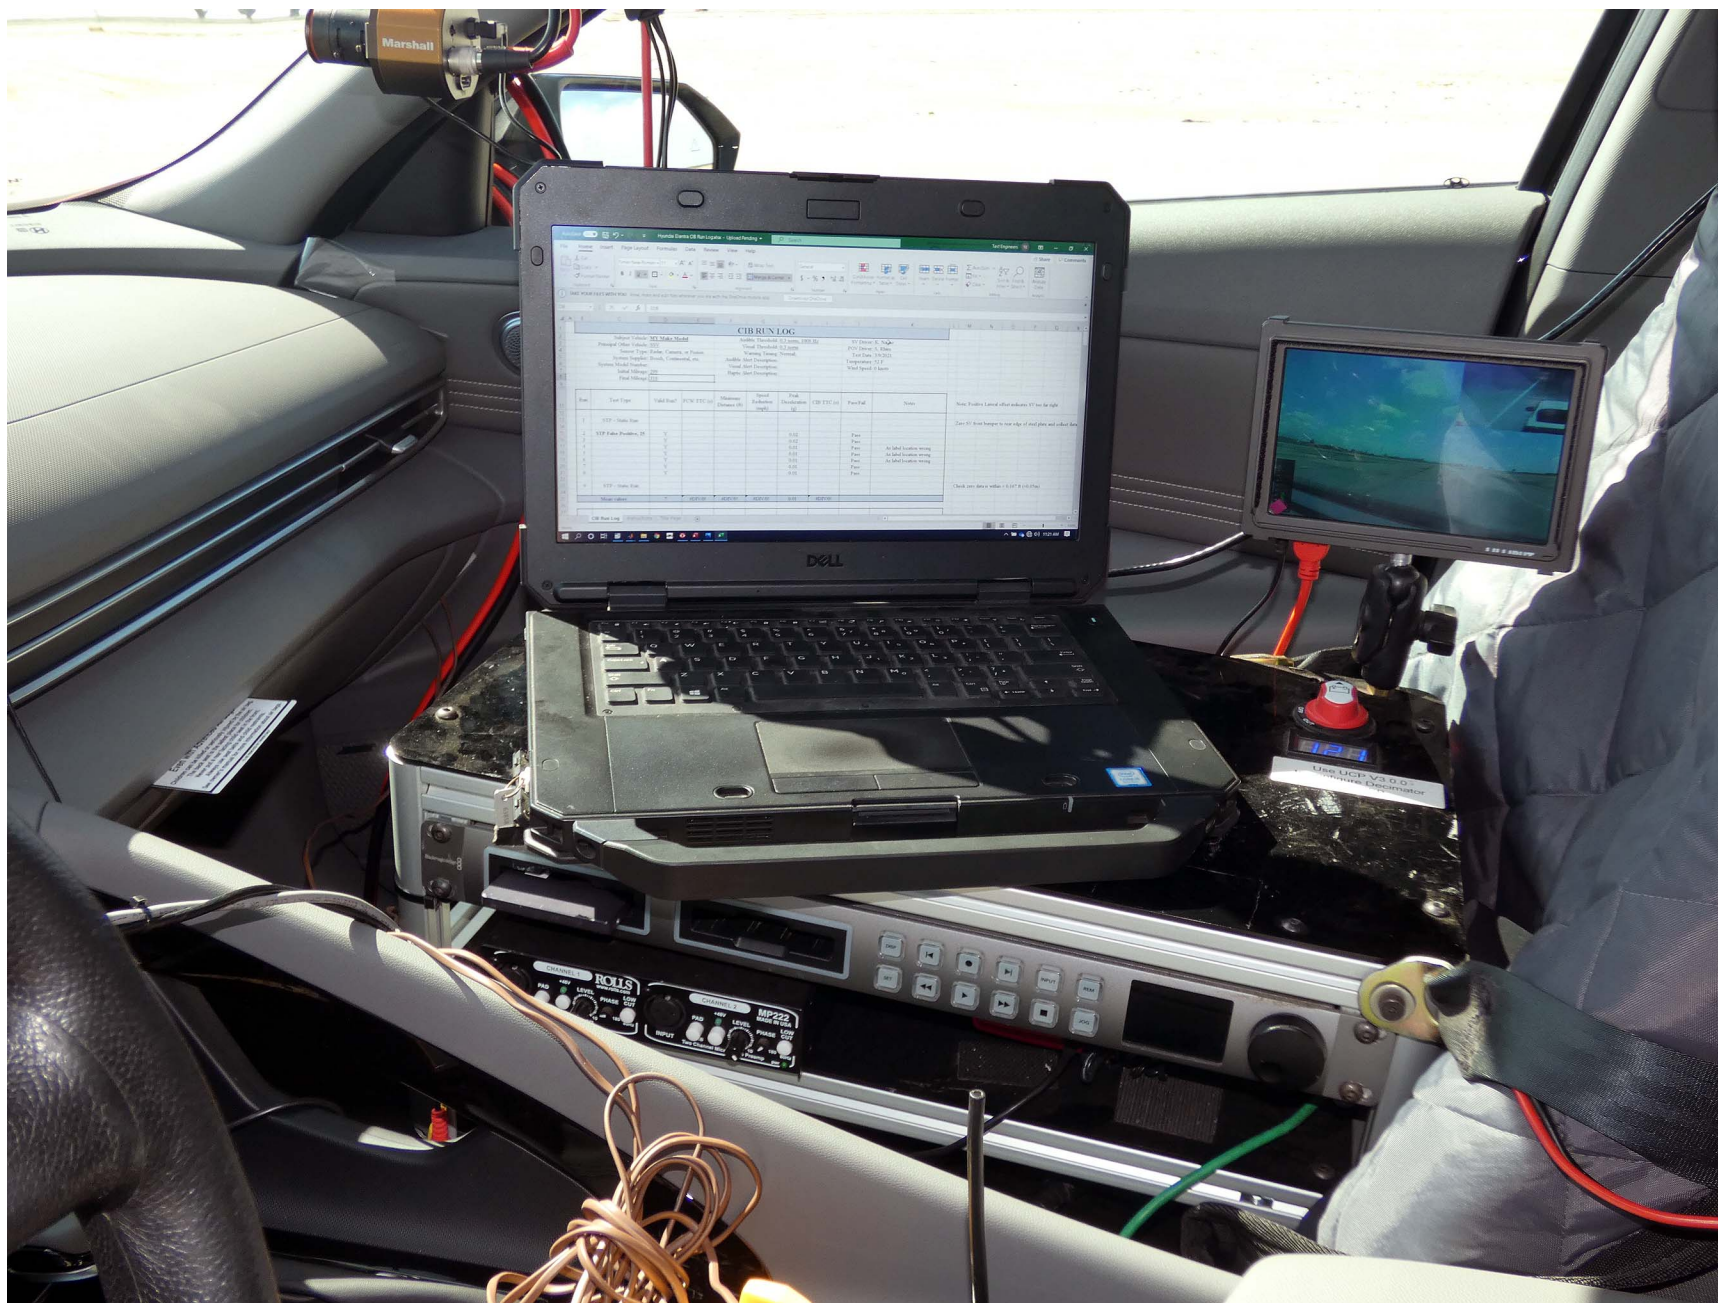
Figure A12. Computer Installed in Subject Vehicle

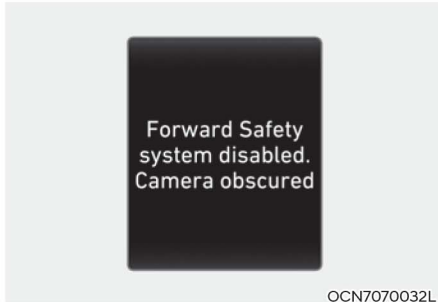
Function disabled

When the front windshield where the front view camera is located or the sensor is covered with foreign material, such as snow or rain, it can reduce the detecting performance and temporarily limit or disable Forward Collision-Avoidance Assist.

If this occurs the 'Forward Safety system disabled. Camera obscured' warning message, and the

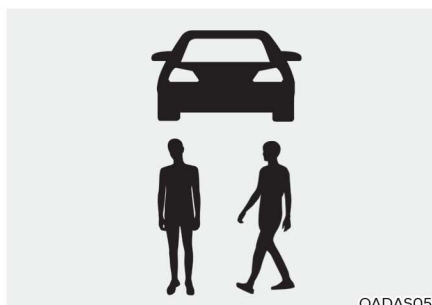
The illustration above shows the image the front view camera will detect as a vehicle and pedestrian.

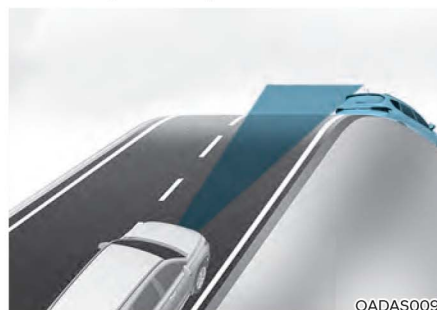
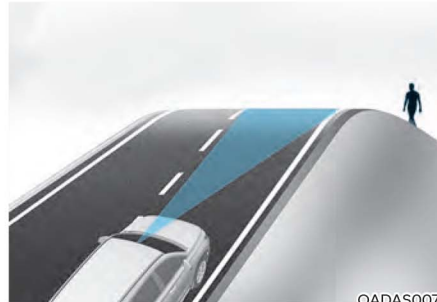
- **Driving on a slope**

Forward Collision-Avoidance Assist may not detect other vehicles or pedestrians in front of you while driving uphill or downhill adversely affecting the performance of the sensors.

This may result in unnecessary warning or braking assist, or no warning or braking assist when necessary.
