**National Highway
Traffic Safety
Administration**

DOT HS 812 092

Electric Vehicle GTR No. 20 Test Development, Validation, and Assessment

year 2019 Chevrolet Bolt electric vehicle using the draft test procedure. The vehicle manufacturer, NHTSA, and other subject matter experts were consulted to develop specific test methodologies related to the Chevrolet Bolt. The draft test procedure and validation test results are presented in this report, along with revisions that were made to the draft test procedure during the validation testing and recommendations based on the lessons learned during testing.

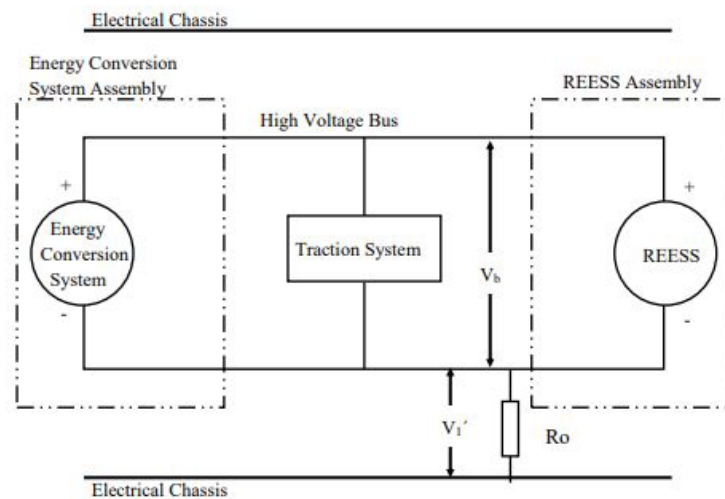
Figure 3
Measurement of V_1'

3. Measure and record the voltage (V_1) between the negative side of the high-voltage bus and the electrical chassis (see Figure 2).
4. Measure and record the voltage (V_2) between the positive side of the high-voltage bus and the electrical chassis (see Figure 2).
5. If V_1 is greater than or equal to V_2 , a standard known resistance (R_o) is inserted between the negative side of the high-voltage bus and the electrical chassis. With R_o installed, measure the voltage (V_1') between the negative side of the high-voltage bus and the electrical chassis (see Figure 3).

6. Calculate the electrical isolation (R_i) according to the following formula.

$$R_i = R_o \cdot (V_b/V_1' - V_b/V_1) \text{ or } R_i = R_o \cdot V_b \cdot (1/V_1' - 1/V_1)$$

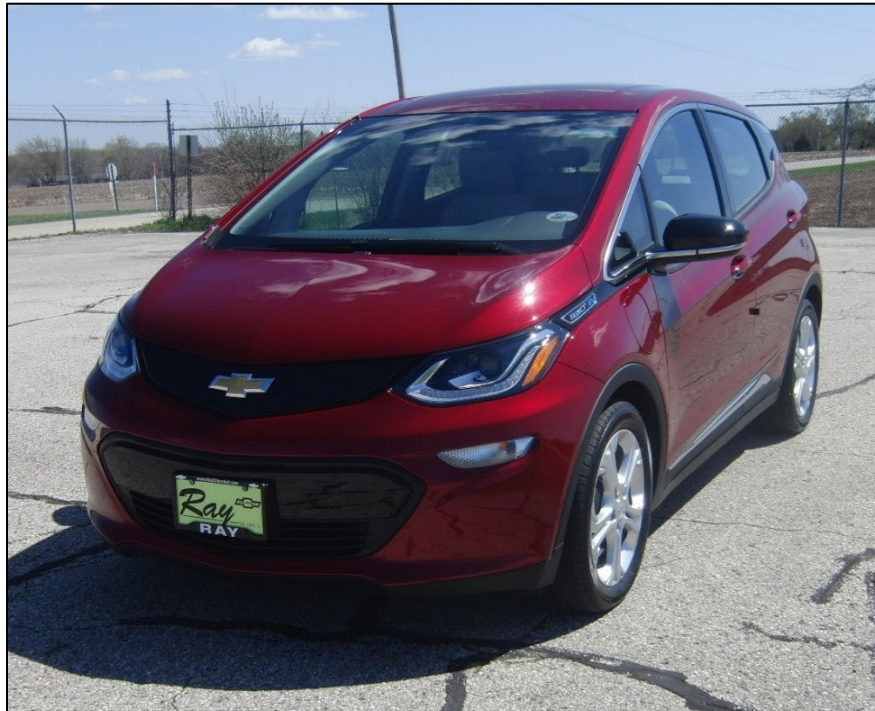
This test report presents the results of GTR testing and procedure validation for a model year 2019 Chevrolet Bolt with DC fast charge capability following the procedures outlined in this report. The subject vehicle is equipped with a 60kW lithium-ion battery pack. Additional details on the vehicle and battery pack were recorded based on information typically supplied by manufacturers to support FMVSS 305 requirements.

Figure 1: 2019 Chevrolet Bolt

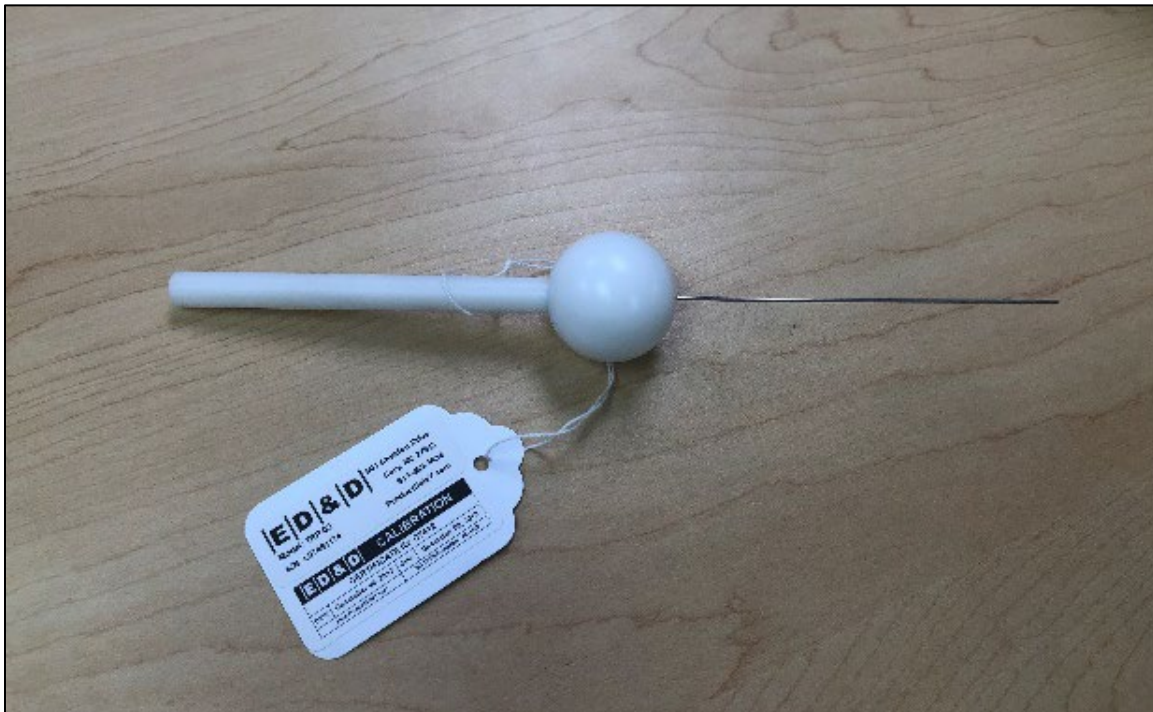
The IPXXD tool that was available for purchase by the test lab at the time of testing, shown in Figure 2 below, is not equipped with an electrical lead. The only method available for measuring voltage from the probe would be direct connection to the test surface, which would alter the specified dimensions of the probe. An updated probe, Model TRP-02D, is currently available from ED&D with a continuity check in the handle.

Figure 2: IPXXD Test Probe

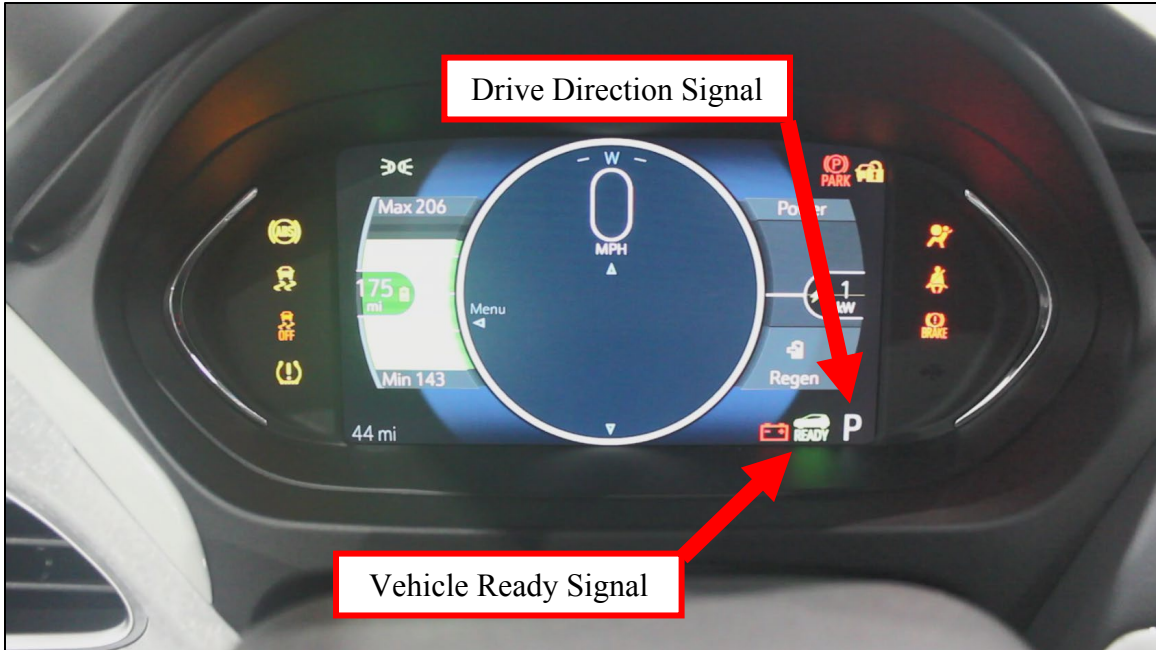
A real-time camera was placed inside the vehicle to record the instrument cluster while the vehicle was started and placed into all possible active driving modes. The visual and audio indications were recorded and noted for the test report. Figure 7 presents the vehicle instrument cluster during startup, while most of the tell-tale signals are illuminated. The “Vehicle Ready” signal is located toward the bottom right and is represented by the outline of a passenger vehicle with the word ‘READY’ below it, both colored green. A drive direction signal is located at the bottom right corner of the instrument panel in white, which identifies the active driving mode that the vehicle is currently in.

Figure 7: Vehicle Instrument Cluster

<u>Drive Mode Selection</u>	<u>Momentary Indication Description</u>
Startup	Vehicle Ready light illuminates upon startup.
Drive/Forward	Drive direction icon at the bottom right of the instrument cluster changes from “P” to “D.”
Reverse	Drive direction icon at the bottom right of the instrument cluster changes from “P” to “R.”

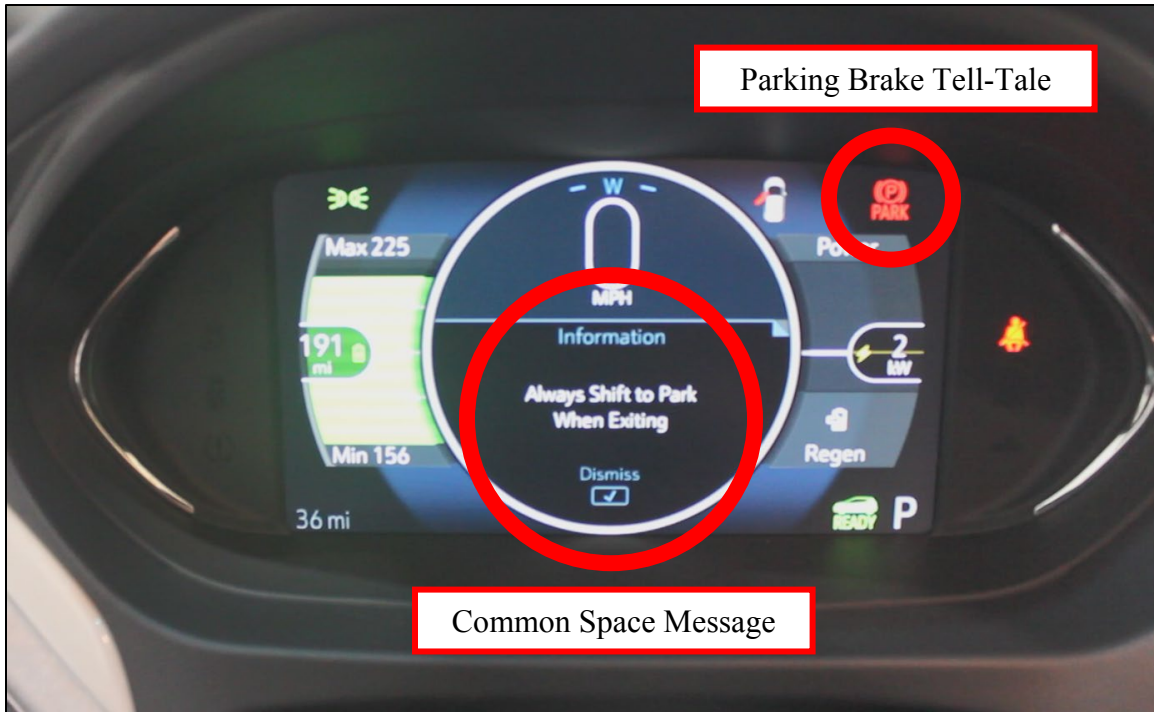
A real-time camera was placed inside the vehicle to record the instrument cluster while the driver attempted to leave the vehicle while still in active driving mode. While following the draft procedure the vehicle responded to any attempts with three actions:

1. The vehicle was removed from active driving mode and placed in Park.
2. A message on the instrument cluster common space informed the driver “Always Shift to Park When Exiting,” shown in Figure 8. This message needed to be dismissed by the driver by pressing the confirmation button (✓) on the steering wheel, and is shown in Figure 8.
3. The parking brake was engaged and a momentary message to the driver appeared on the instrument cluster common space stating that the parking brake was engaged, and then reverted back to the message outlined in item #2. The parking brake tell-tale signal, located at the upper right corner of the instrument cluster, illuminated.

Figure 8: GTR 5.1.2.2 Driver Signal

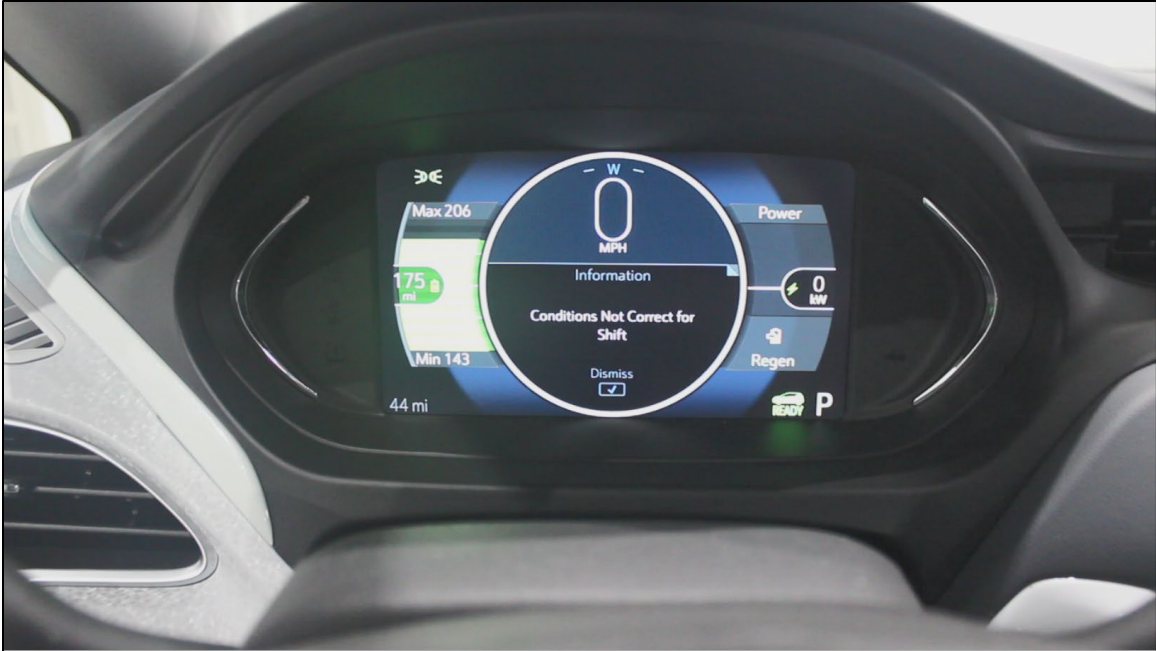
1. “Conditions Not Correct for Shift” was momentarily displayed on the instrument cluster common space, shown in Figure 11.

Figure 11: Momentary Signal to Driver When Selecting Active Drive Mode Possible While External Charging Is Active.

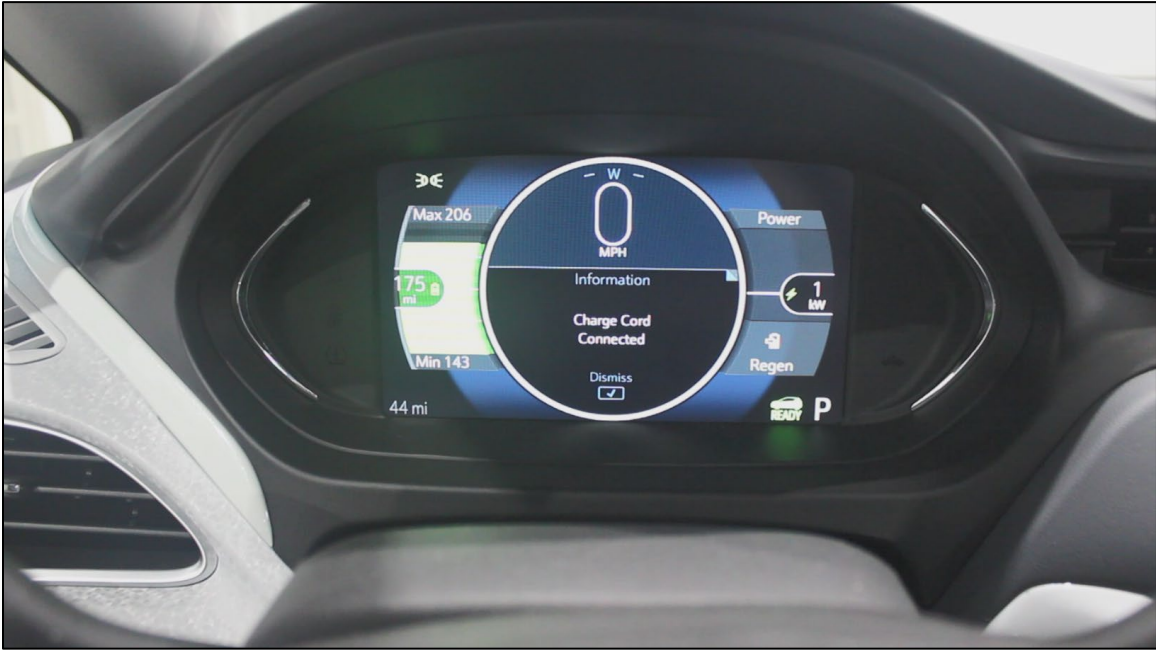
2. “Charge Cord Connected” was displayed on the instrument cluster common space, shown in Figure 12, and had to be dismissed by the driver by pressing the confirmation button (✓) on the steering wheel.

Figure 12: Signal to Driver When Selecting Active Drive Mode Possible While External Charging Is Active.

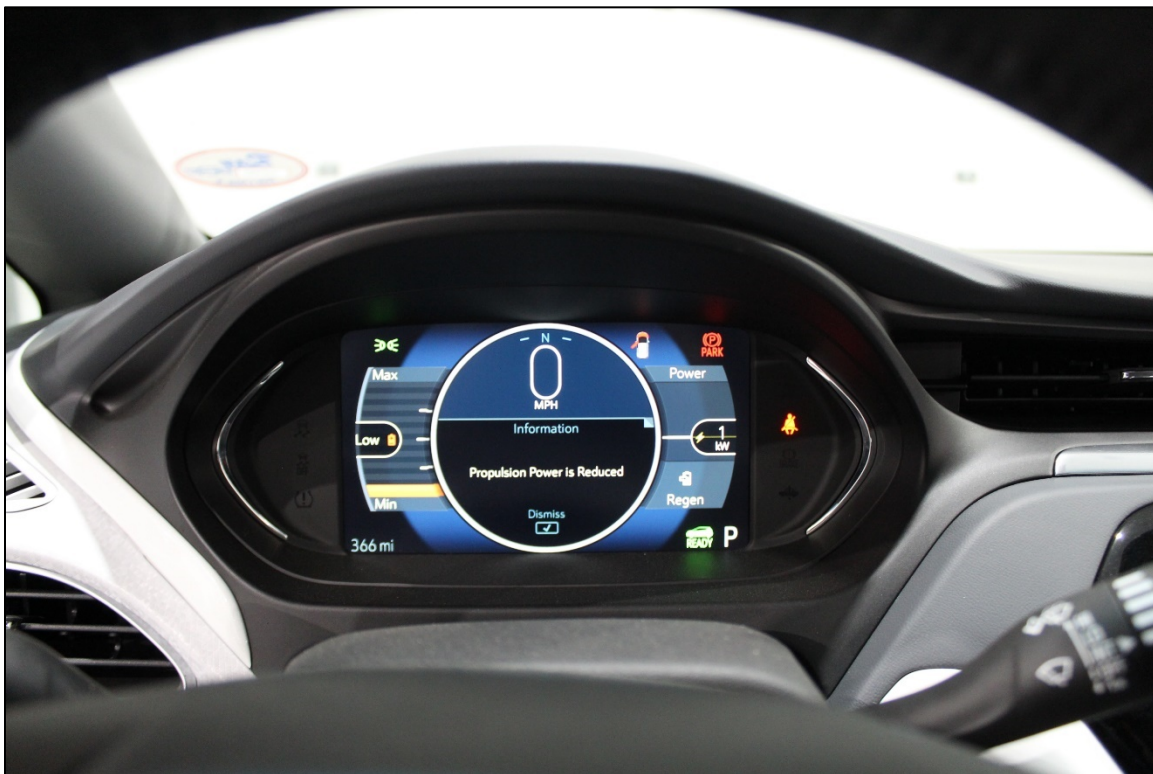
The vehicle warns the driver of low energy content at approximately 10 percent remaining state of charge. A visual message is displayed to the driver in the instrument cluster common space stating “Propulsion Power is Reduced,” the range gauge turns from green to yellow, and the numeric range is replaced with the text “Low.” Figure 13 displays the low energy driver alerts present on the instrument cluster. The infotainment screen also displays a message, providing the driver the option of entering low power mode to conserve energy, and is presented in Figure 14.

Figure 13: Low Energy Warning to the Driver

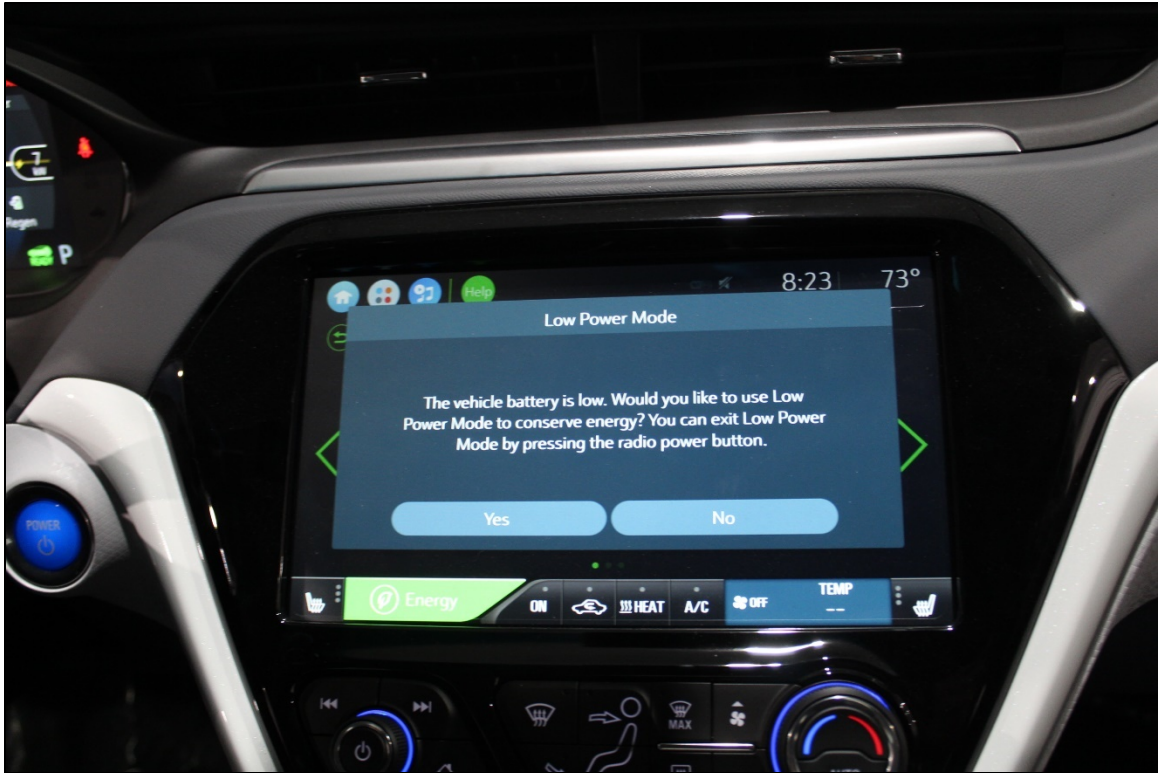
Figure 14: Low Energy Warning on Infotainment System

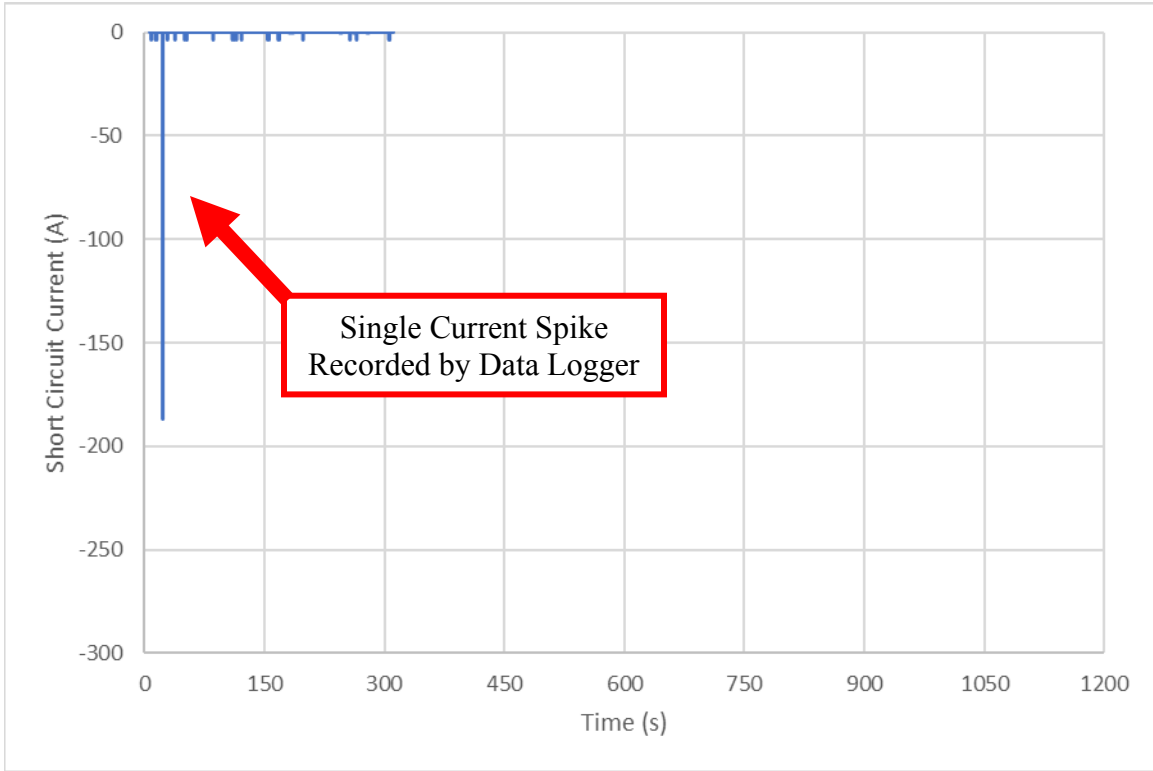
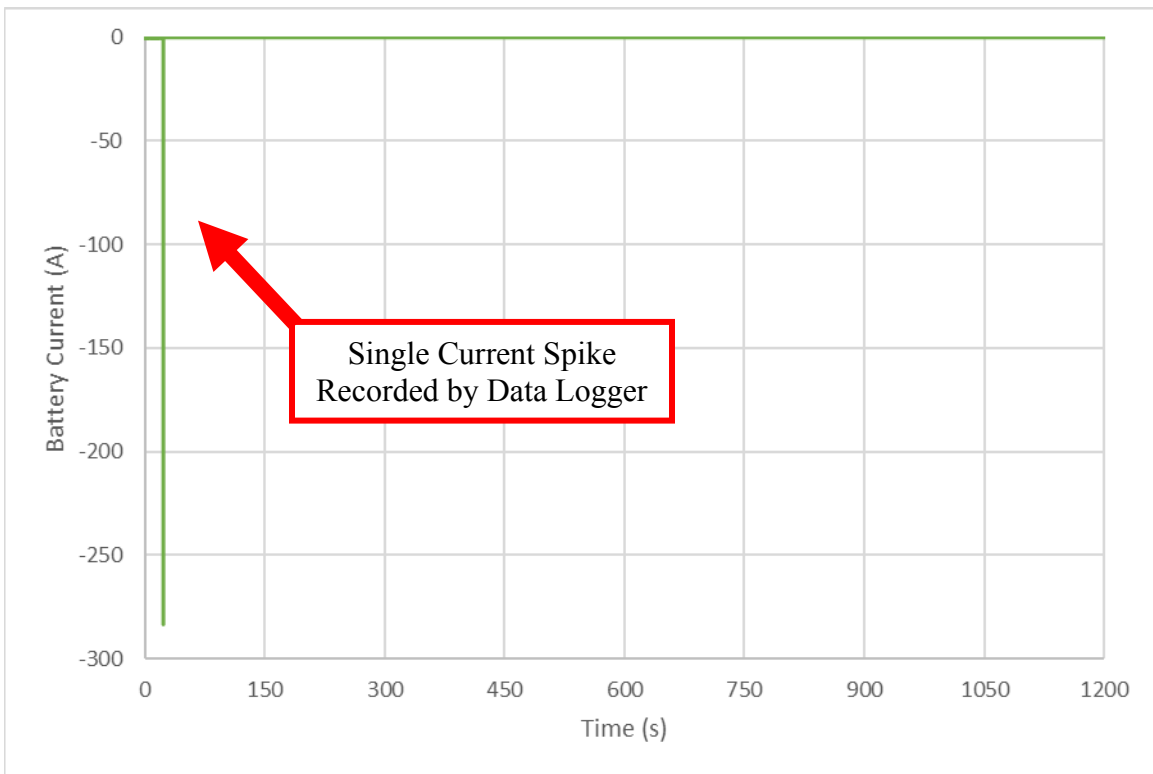
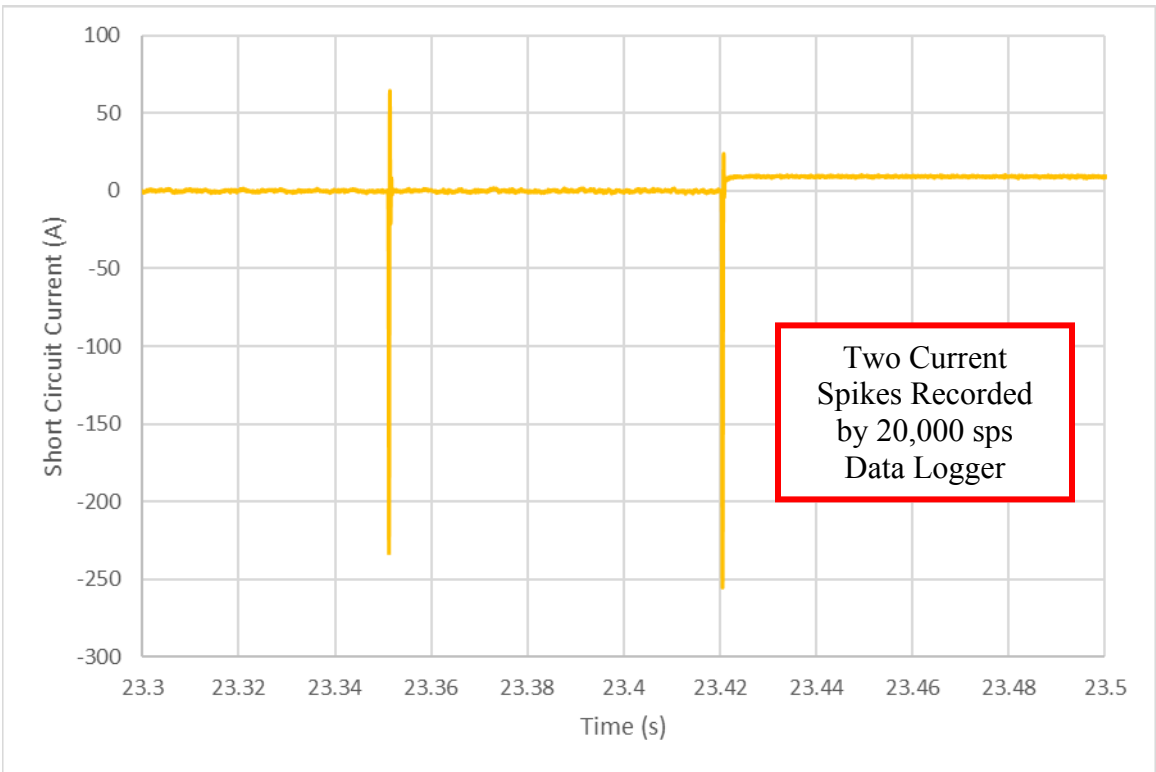
The short circuit contactor was closed approximately 23 seconds after the data recorders were started. Two current pulses in the range of 200 – 250 amps were recorded about 70 milliseconds apart in the high sample rate data set, shown in Figure 21. The CAN data and 1,000 hertz data logger each only recorded a single current pulse at the time of contact closure. No additional current was observed in any of the data after 70 milliseconds, and the battery voltage value recorded through the diagnostic port measured 0 V after the current pulse. The short circuit contactor was opened after observing no current across the shunt for 30 seconds. Data traces from the test are presented in Figures 18 – 21.

Figure 18: External Short Circuit Test Shunt Current at 1,000 sps

Figure 19: External Short Circuit Test Battery Current

Figure 20: External Short Circuit Test Battery Voltage

Figure 21: External Short Circuit Test Shunt Current at 20,000 sps

A standard cycle was not possible after the short circuit test, but the vehicle would power on. The instrument cluster stated "Service Vehicle Soon," the service vehicle soon tell-tale was illuminated, and the Vehicle Ready light would not illuminate. No evidence of electrolyte leakage, rupture, venting, fire, or explosion was observed. The vehicle was towed to a dealership for repair, and required replacement of the lever disconnect fuse (MFG Part # 24294004) and relay contactor assembly (MFG Part # 24291633).

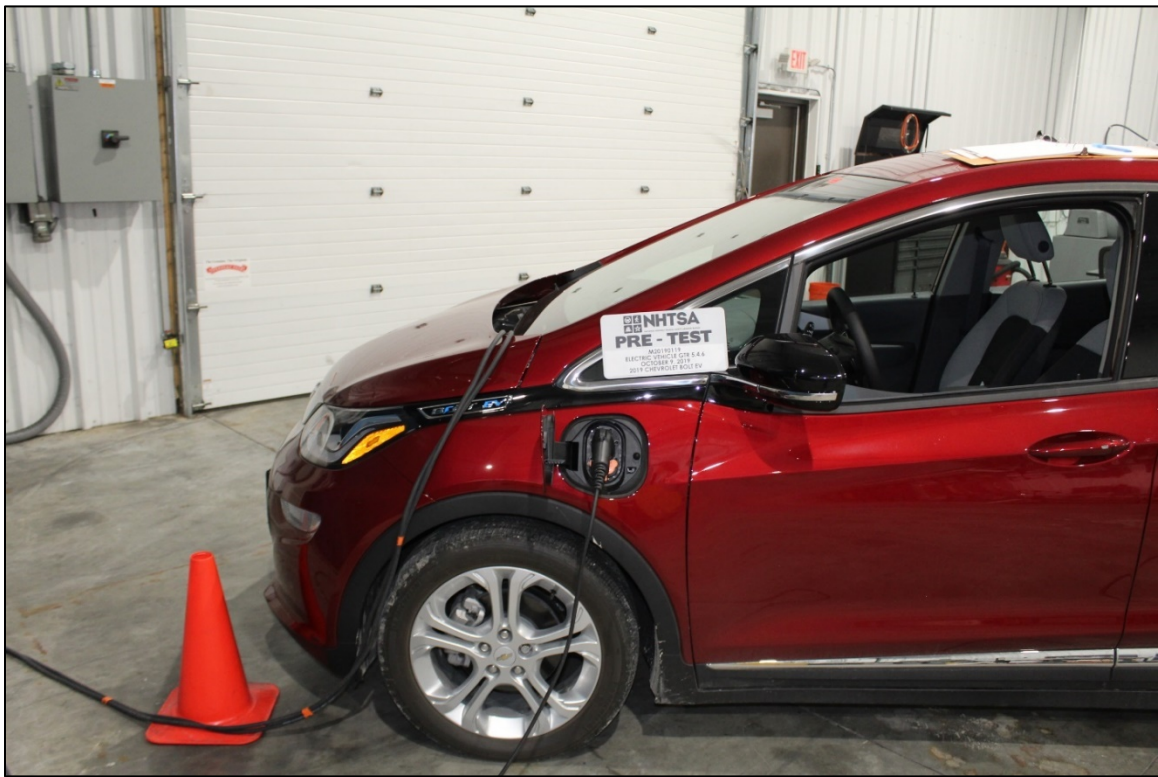
The manufacturer's breakout harness was connected between the high power distribution module and onboard charging module. The manufacturer's test method used the supplied Level 1 AC charger in conjunction with the NHR Battery Test System to produce the over-charge. The Level 1 AC charger supplied AC current to the onboard charging module. The onboard charging module converted the AC current to DC current and then passed it through the breakout harness to the high power distribution module. The NHR Battery Test System produced an additional DC current that was supplied through the breakout harness to the high power distribution module. The manufacturer specified that the NHR Battery Test System should supply an additional 1kW of charging power for the test. The maximum normal operating temperature of the battery pack was specified as 50 °C.

Figure 22: Over-Charge Breakout Harness

Figure 23: Over-Charge Test Setup

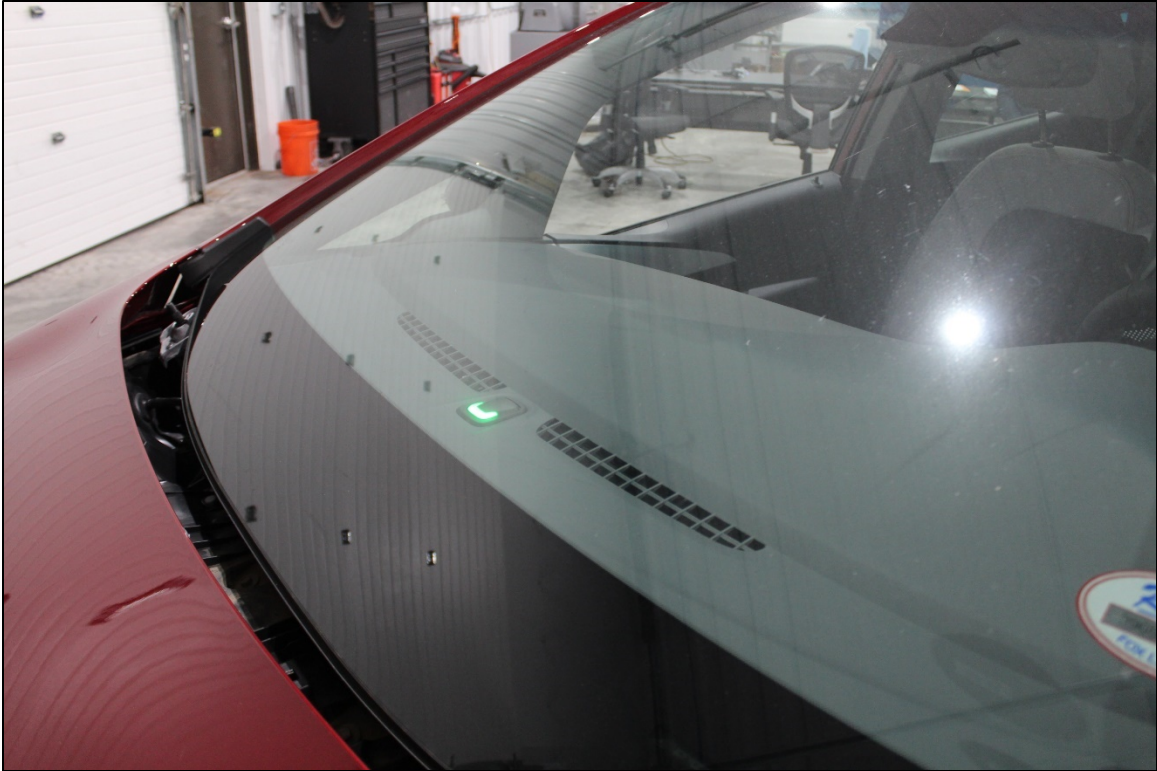
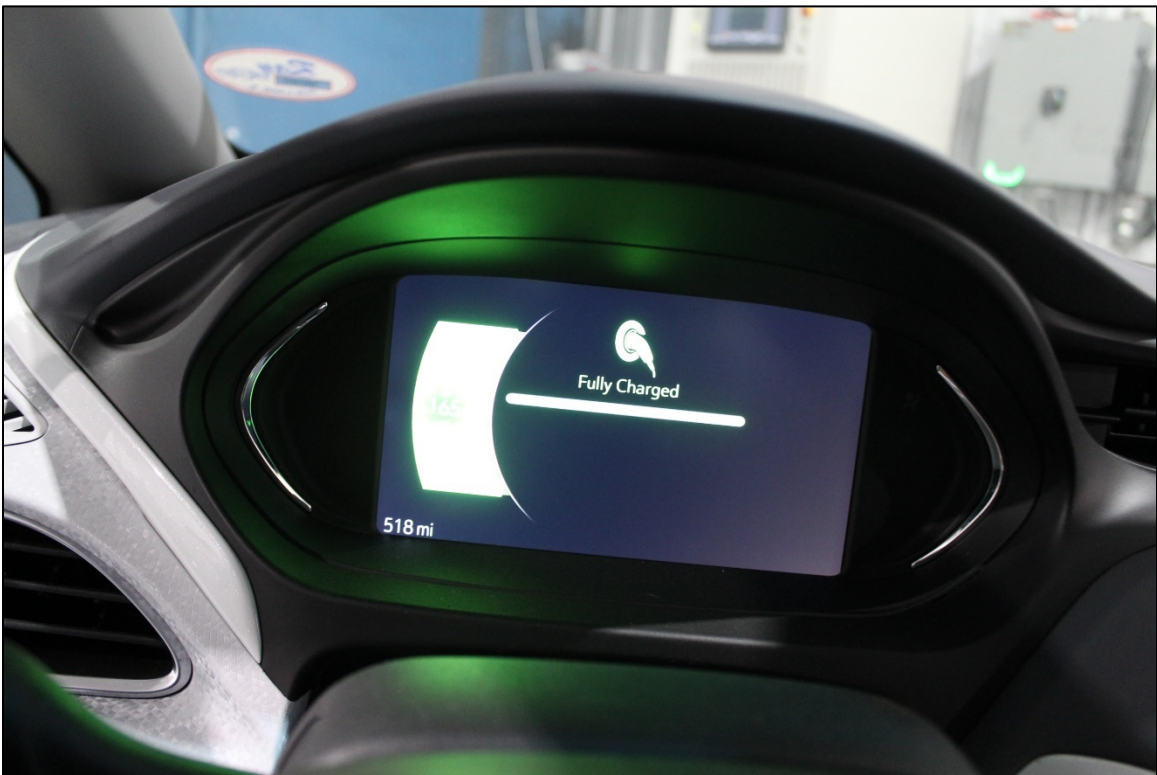
The vehicle was charged to 95 percent state of charge prior to the test, resulting in an initial voltage of 393 V. The starting temperature of the battery pack was 20 °C according to the battery management system. The Level 1 charger was secured to the vehicle and charging was confirmed by observing the indicator light on the dash. The vehicle instrument cluster stated that full charge would be reached in 4 hours. The NHR Battery Test System was started and continued to supply its over-charge for 1 hour and 57 minutes, at which point the battery management system terminated charging at 400 V. The indicator light on the dash turned solid green, indicating fully charged. The instrument cluster also stated "Fully Charged." Battery pack temperature was 20 °C as measured by the battery management system. A standard cycle was performed on the vehicle with discharge conducted via vehicle operation and charging completed with the Level 1 charger. No evidence of electrolyte leakage, rupture, venting, fire, or explosion was observed.

Figure 24: Over-Charge Dash Indicator Light

Figure 25: Over-Charge Instrument Cluster Message

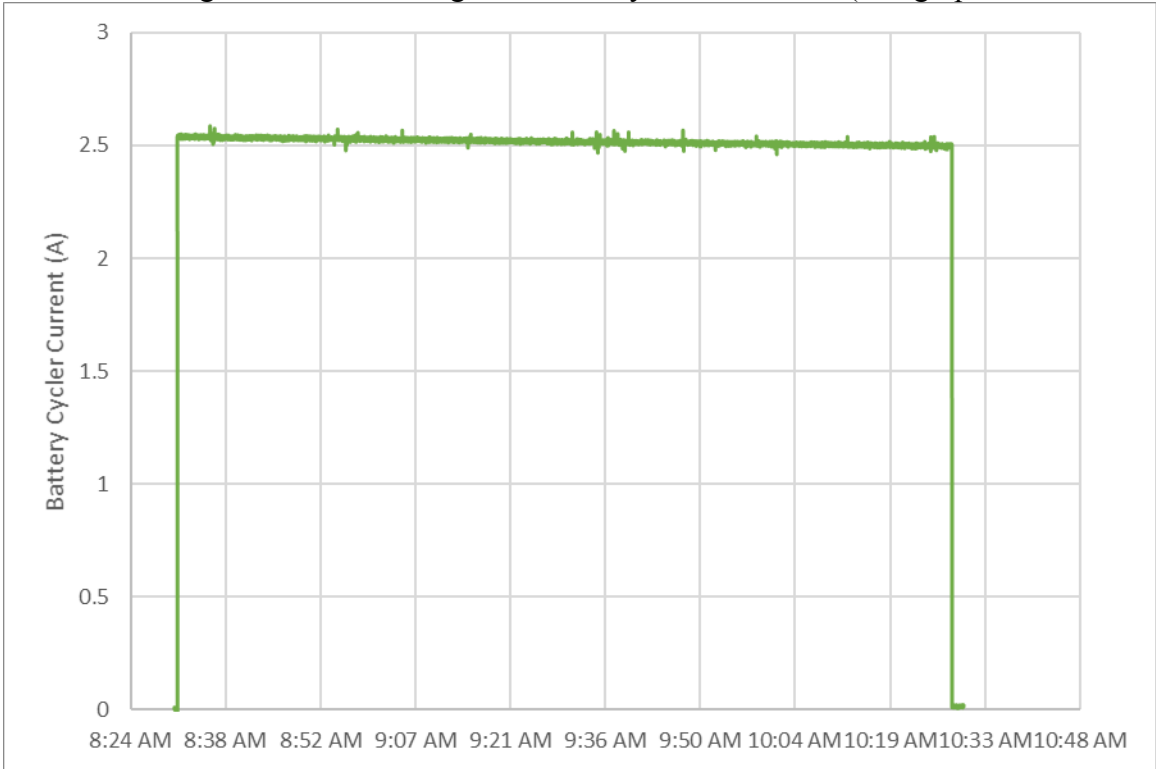
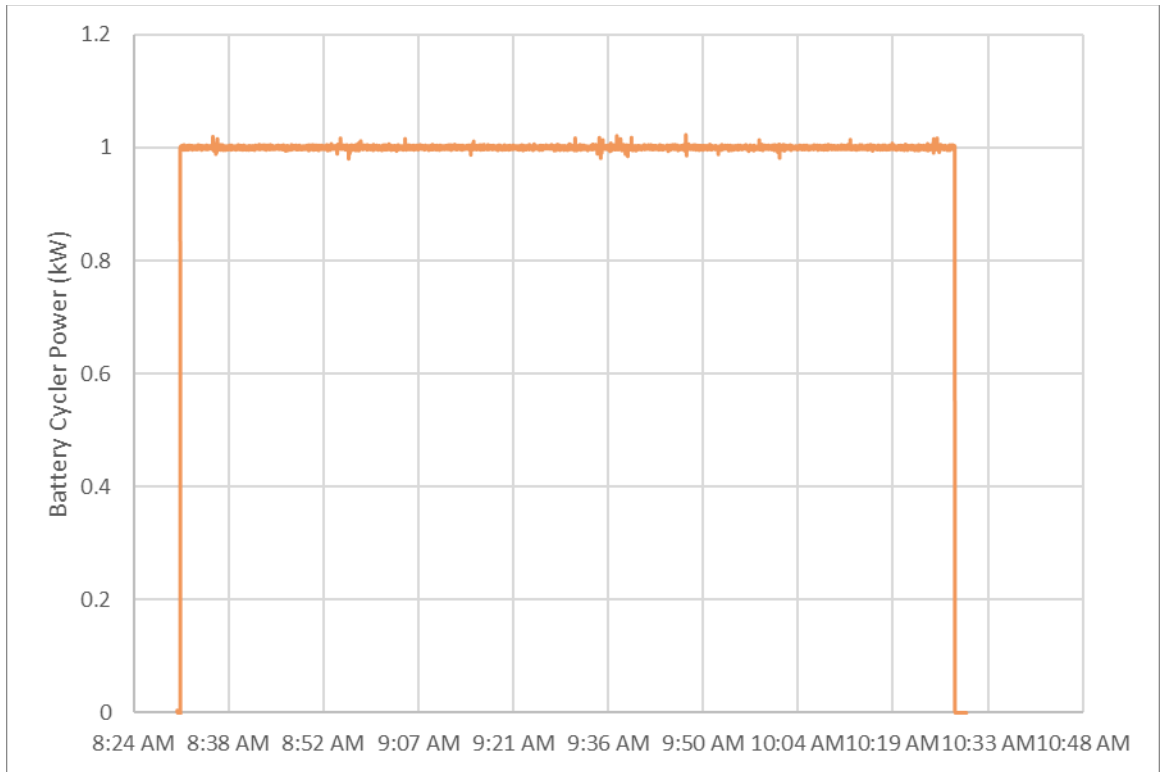
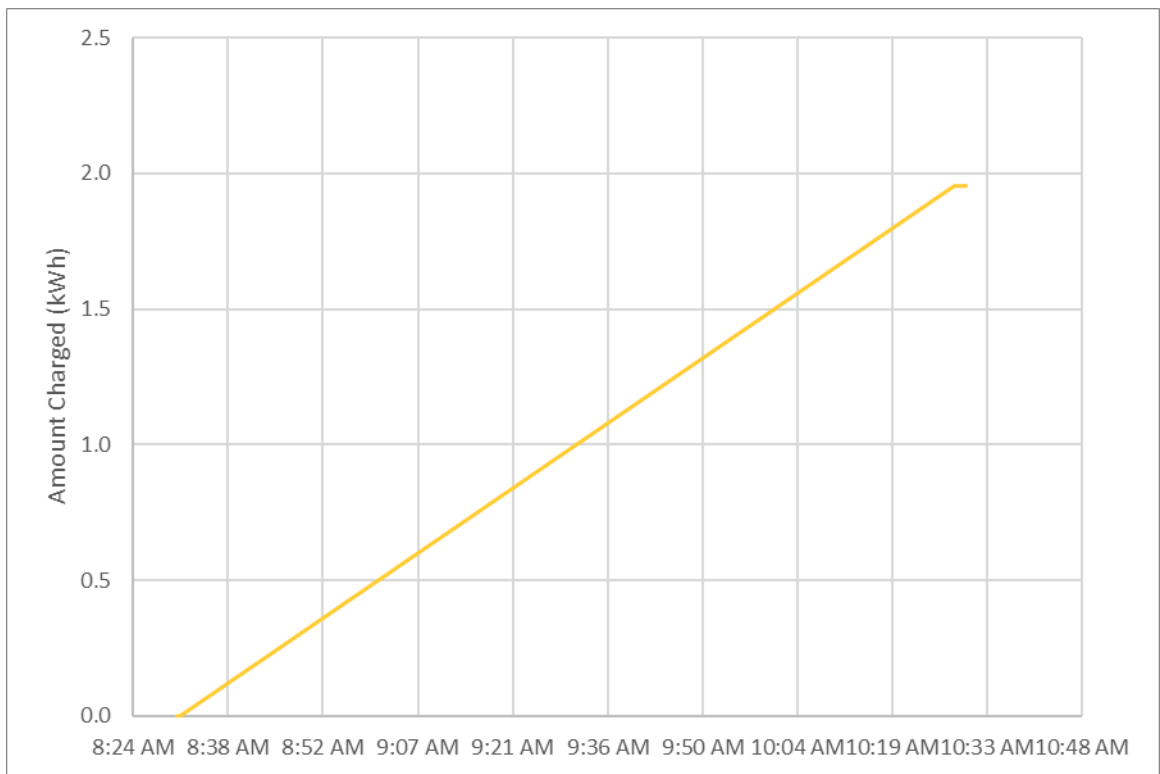
Figure 26: Over-Charge Test Battery Tester Voltage

Figure 27: Over-Charge Test Battery Tester Current

Figure 28: Over-Charge Test Battery Tester Power

Figure 29: Over-Charge Test Battery Tester Amount Charged

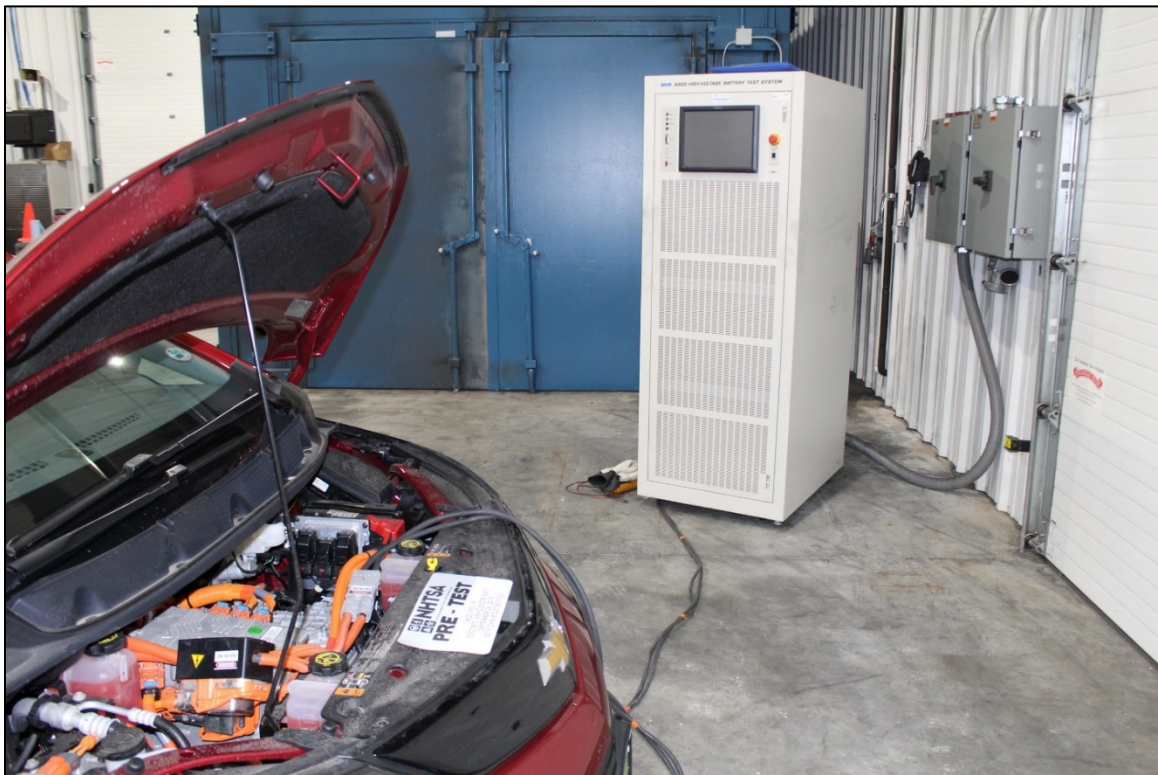
The starting temperature of the battery pack was 23 °C according to the battery management system. The NHR Battery Test System was enabled and the vehicle began discharging at a rate of 1 kW, corresponding to approximately 3 amps. Discharging continued for 107 minutes, until the vehicle manufacturer's onsite representative requested to pause the test to perform diagnostics. The REESS voltage was 326 V when the test was paused. Vehicle power was cycled on and off several times for diagnostics, which is visible in the battery voltage graph in Figure 34. Testing was paused for a total of 20 minutes. At the manufacturer's direction, the discharge rate was increased to 20 amps constant current when testing resumed.

Figure 30: Over-Discharge Breakout Harness

Figure 31: Over-Discharge Test Setup

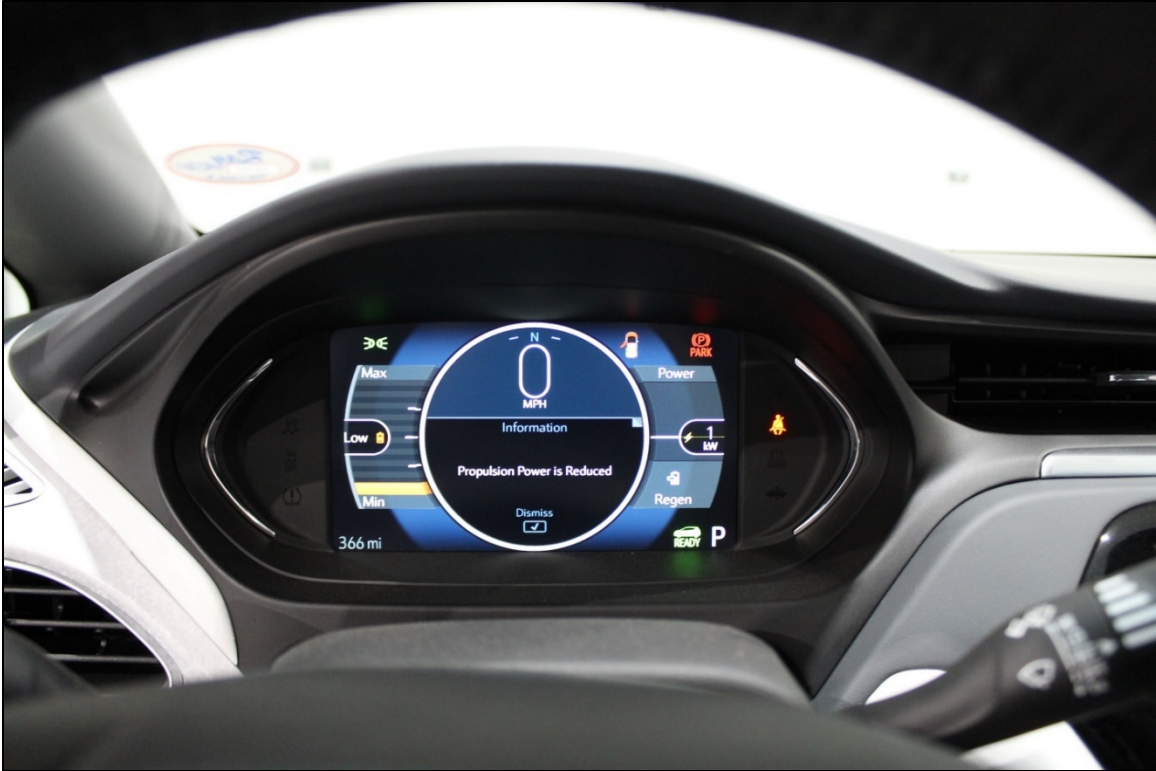
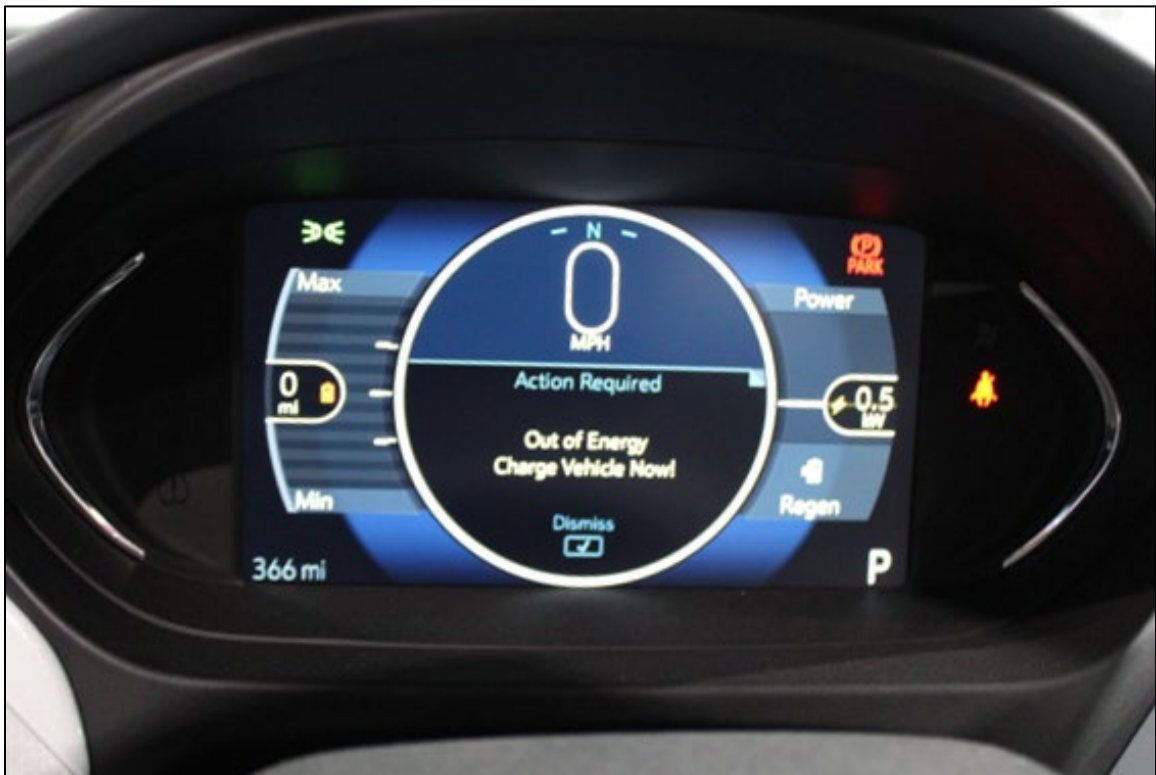
When the battery voltage reached 288 volts the REESS terminated the discharge current. A message displayed on the instrument cluster common space stating "Out of Energy, Charge Vehicle Now!" A standard cycle was performed on the vehicle with the discharge cycle conducted via vehicle operation and the charging cycle using the Level 1 charger. No evidence of electrolyte leakage, rupture, venting, fire, or explosion was observed.

Figure 32: Over-Discharge Pre-Test Instrument Cluster Message

Figure 33: Over-Discharge Post-Test Instrument Cluster Message

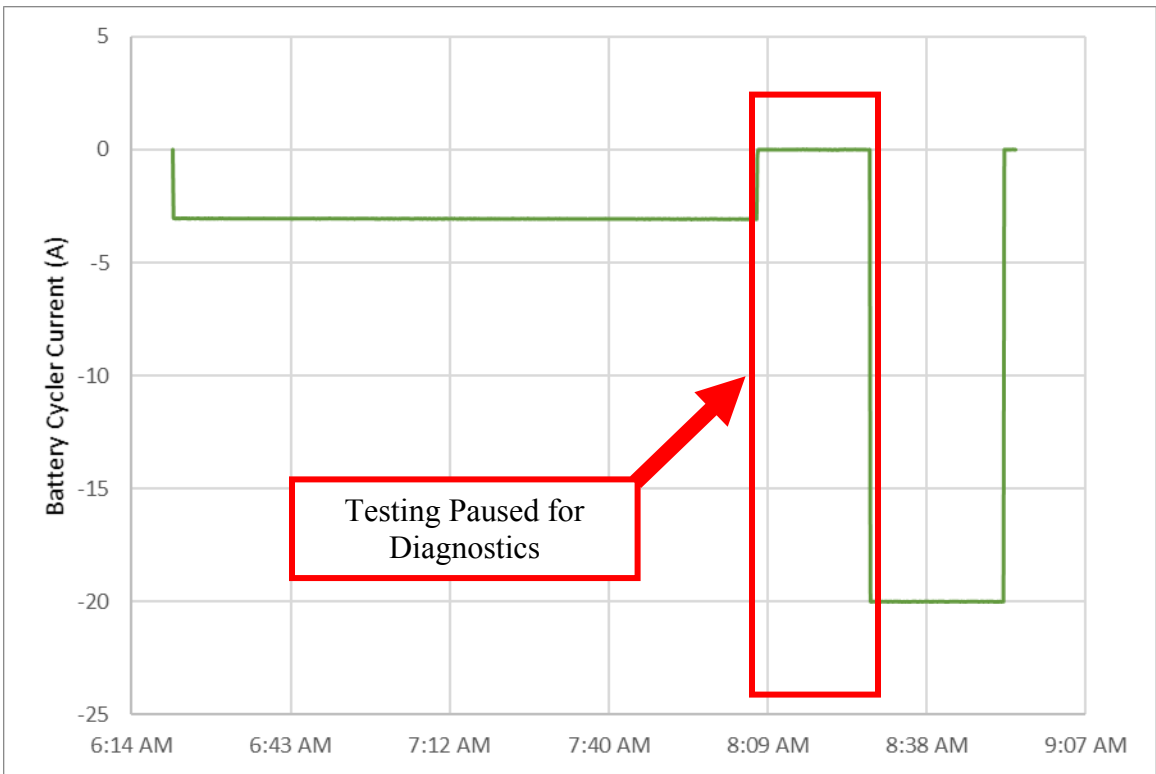
Figure 34: Over-Discharge Test Battery Tester Voltage

Figure 35: Over-Discharge Test Battery Tester Current

Figure 36: Over-Discharge Test Battery Tester Power

Figure 37: Over-Discharge Test Battery Tester Amount Discharged
