**National Highway
Traffic Safety
Administration**

DOT HS 812 092

Electric Vehicle GTR No. 20 Test Development, Validation, and Assessment

year 2019 Chevrolet Bolt electric vehicle using the draft test procedure. The vehicle manufacturer, NHTSA, and other subject matter experts were consulted to develop specific test methodologies related to the Chevrolet Bolt. The draft test procedure and validation test results are presented in this report, along with revisions that were made to the draft test procedure during the validation testing and recommendations based on the lessons learned during testing.

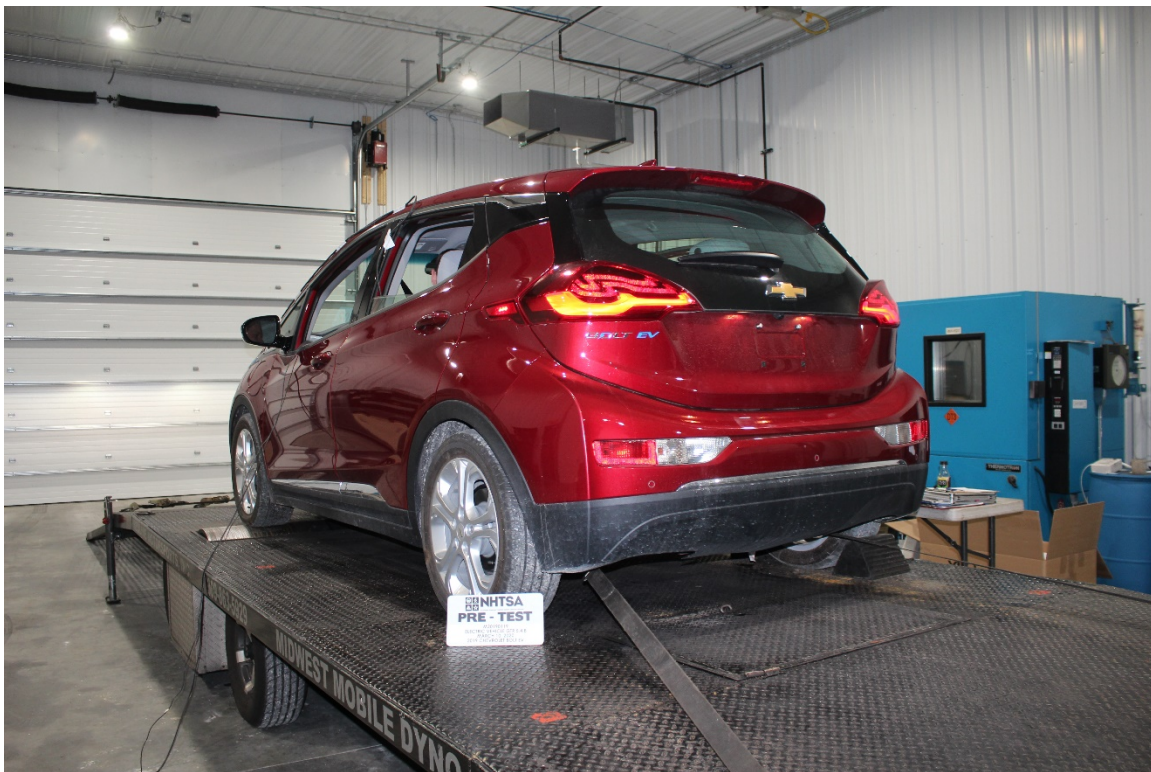
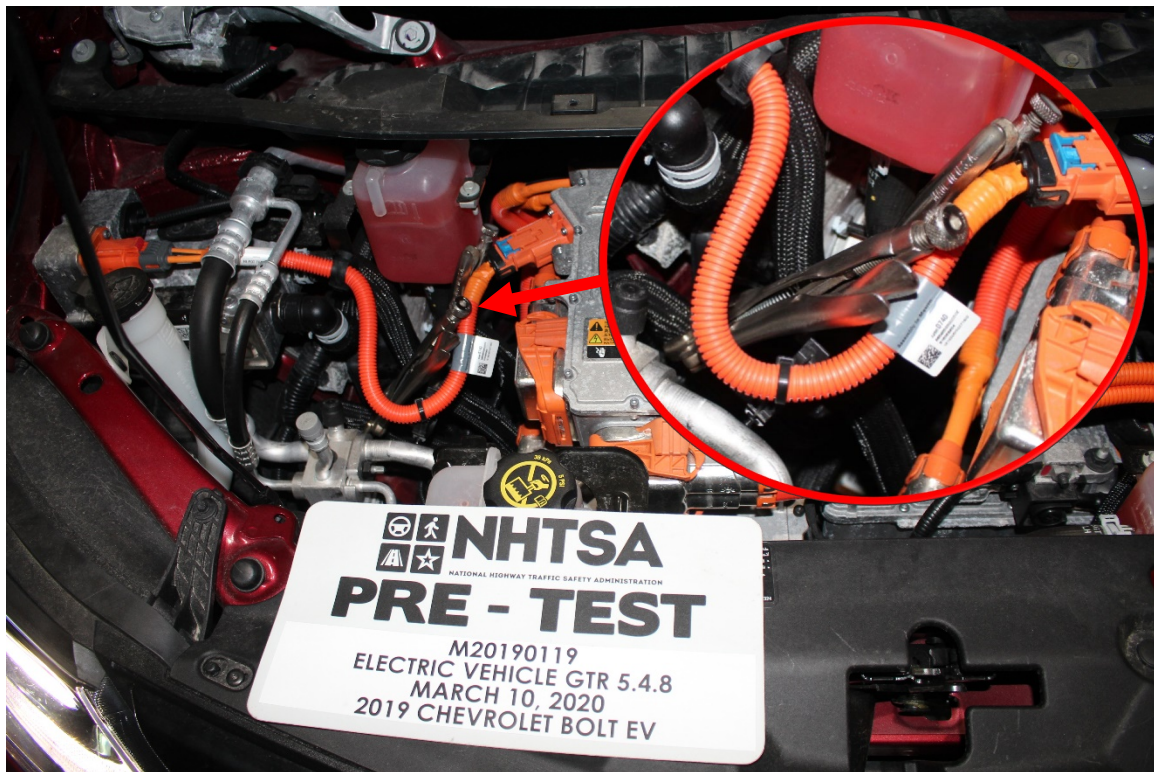
system, or the impact that the coolant temperature decrease had on the overall battery temperature. Additional steps may be necessary in future tested to ensure that the cooling system has no, or very minimal, impact during the over-temperature evaluation. Several methods were discussed prior to testing, including disabling the cooling system pump and removing the coolant from the system. There was some concern that these actions would reduce the vehicle's performance from the onset of the driving profile, which is contrary to the intention of the GTR procedure.

Figure 38: Vehicle Installed on Mobile Dynamometer

Figure 40: Over-Temperature Coolant Hose Crimps

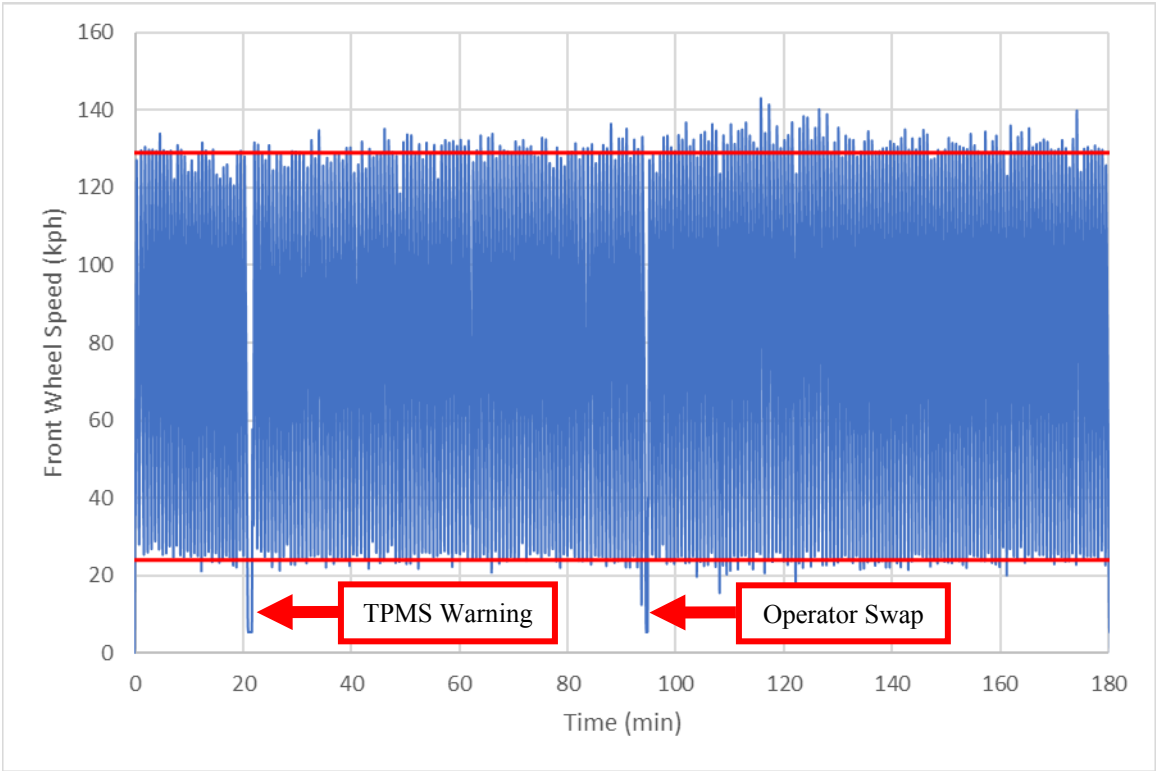
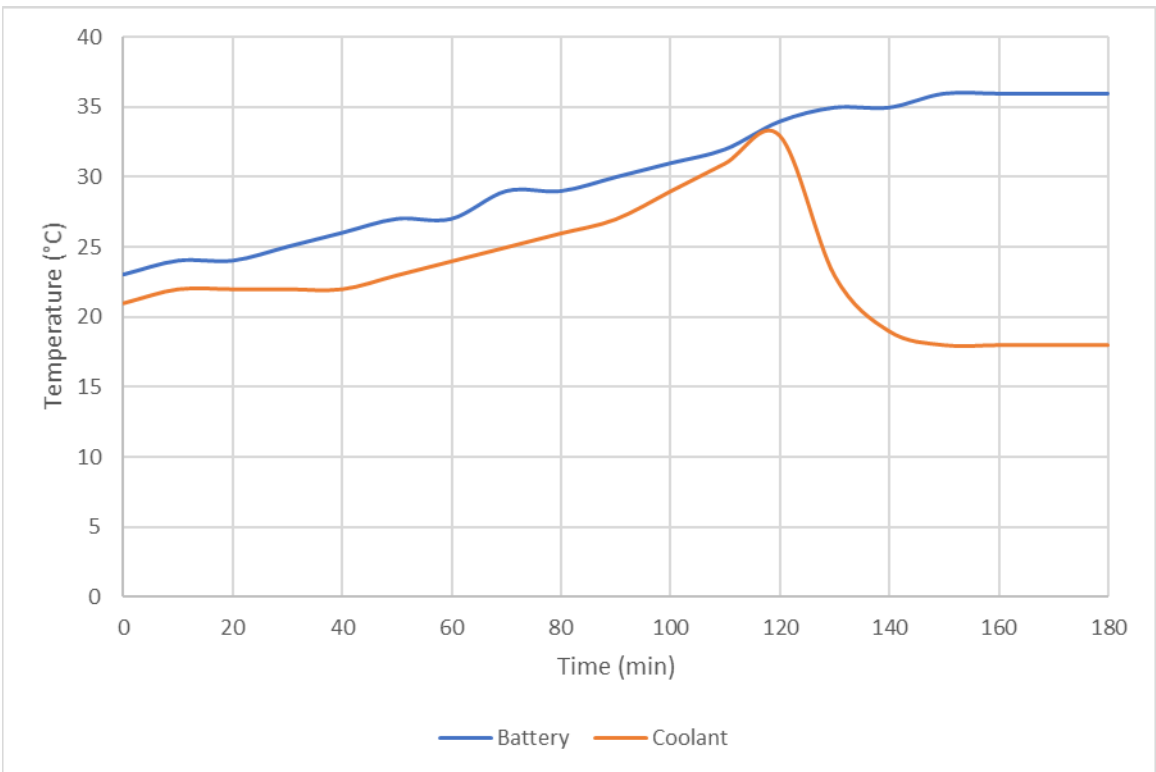
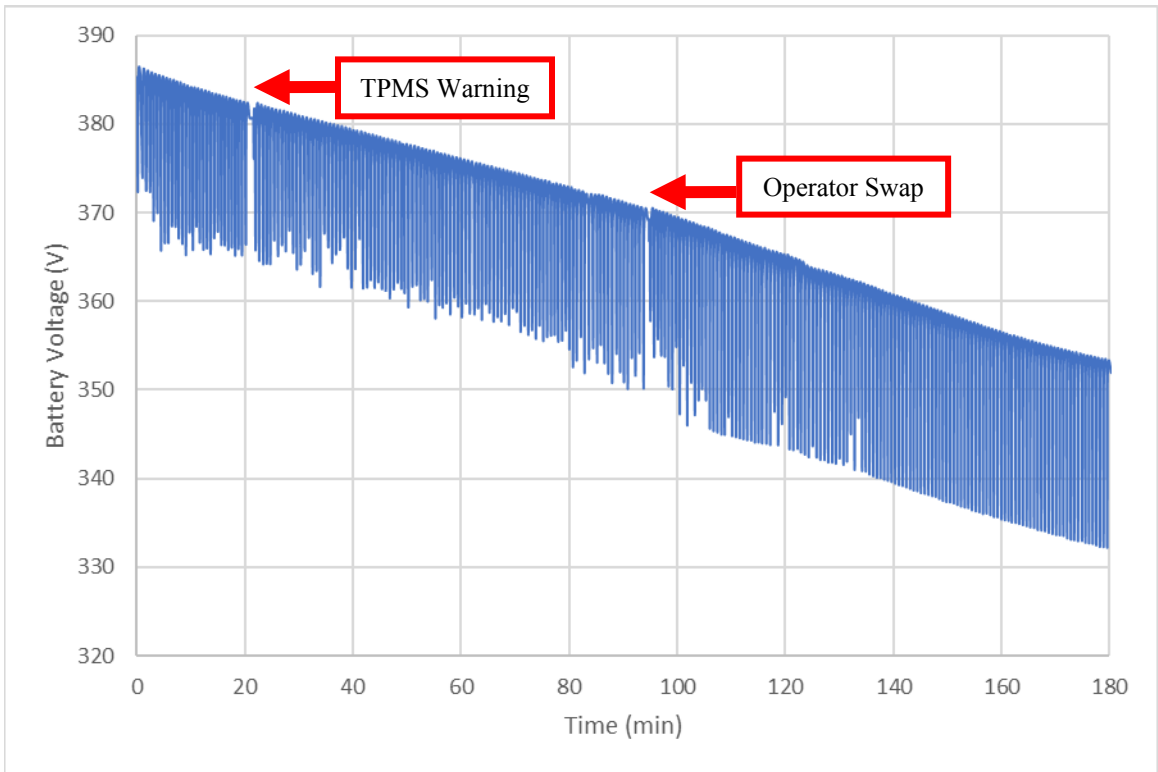
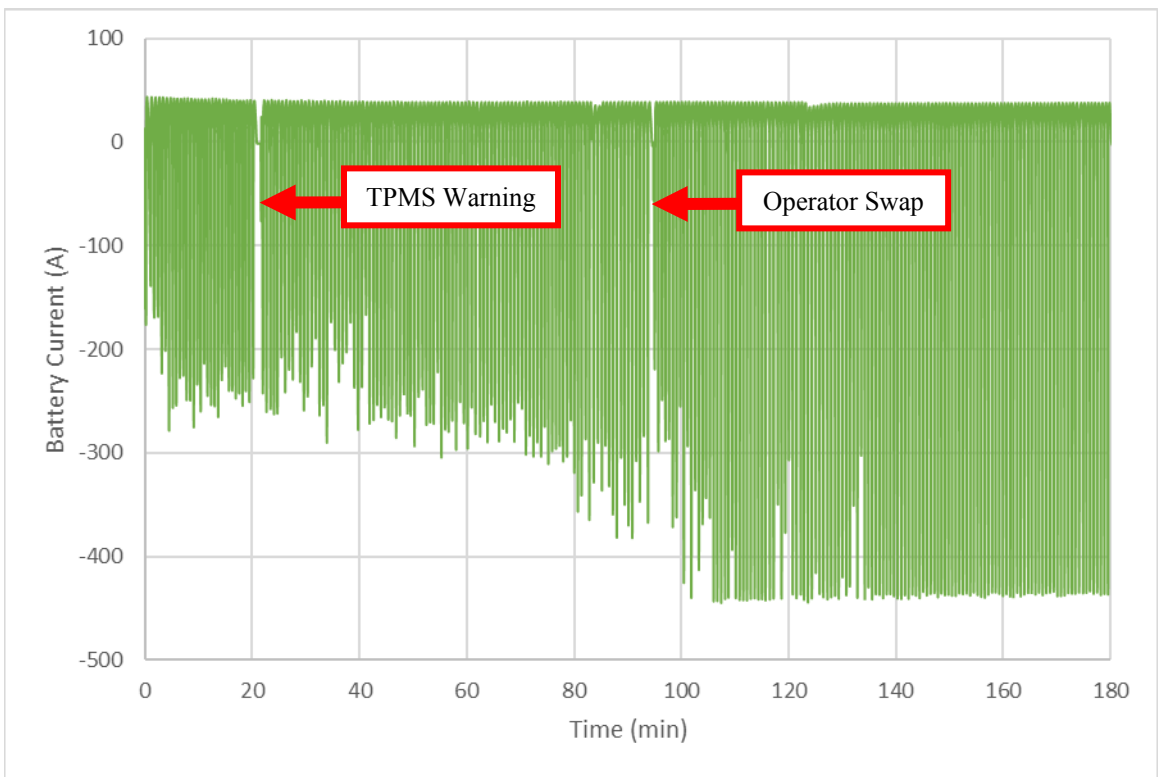
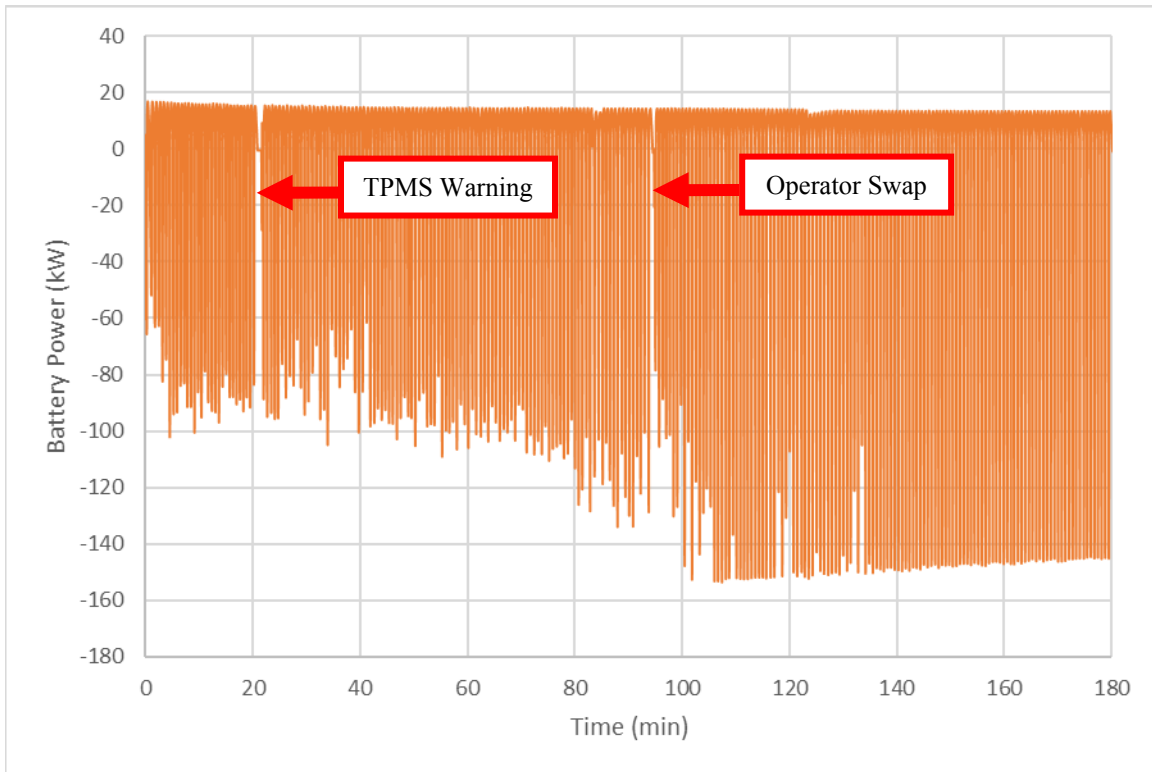
The test continued until 3 hours had elapsed from the start of the driving profile discharge/charge cycling. No evidence of electrolyte leakage, rupture, venting, fire, or explosion was observed at the conclusion of the test.

Figure 42: Over-Temperature Test Vehicle Drive Profile – Single Cycle

Figure 43: Over-Temperature Test Vehicle Drive Profile

Figure 44: Over-Temperature Test Battery Temperature

Figure 45: Over-Temperature Test Battery Voltage

Figure 46: Over-Temperature Test Battery Current

Figure 47: Over-Temperature Test Battery Power

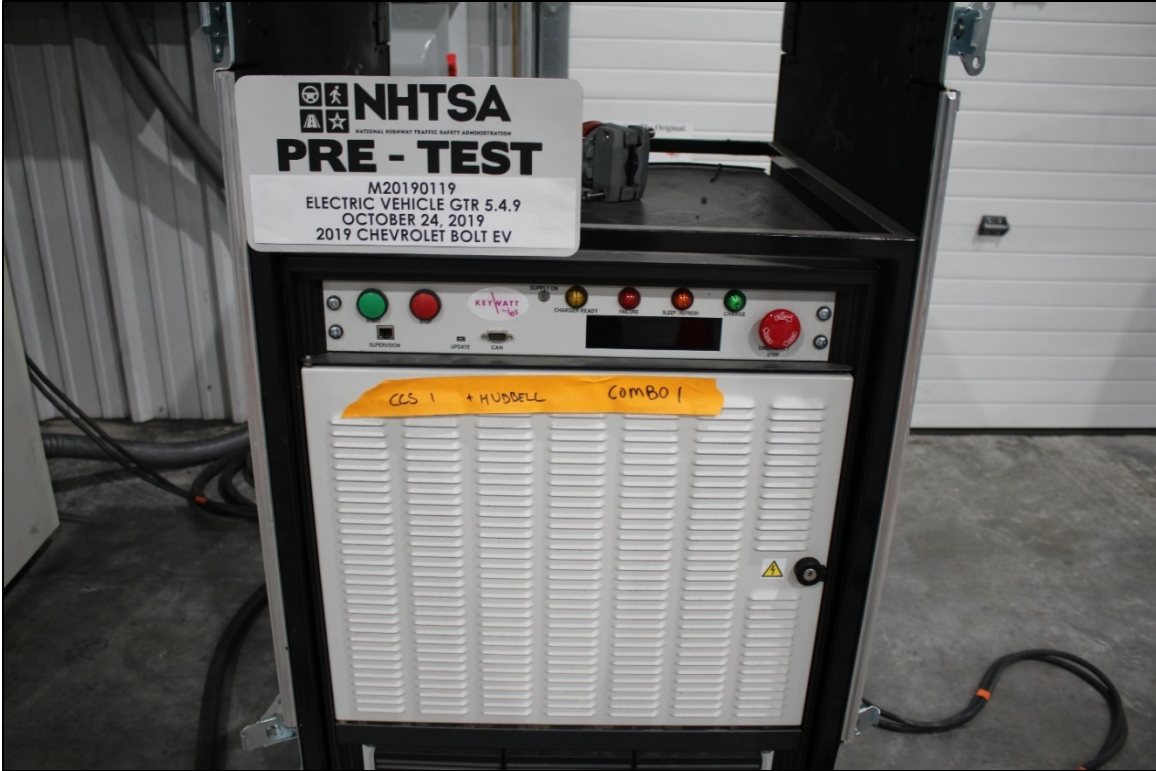
of charge was adjusted to approximately 70 percent during these attempts, and the REESS voltage was 378 V. The DC fast charger supplied 60 amps to the vehicle at this state of charge.

Figure 48: Over-Current Breakout Harness

Figure 49: DC Fast Charger

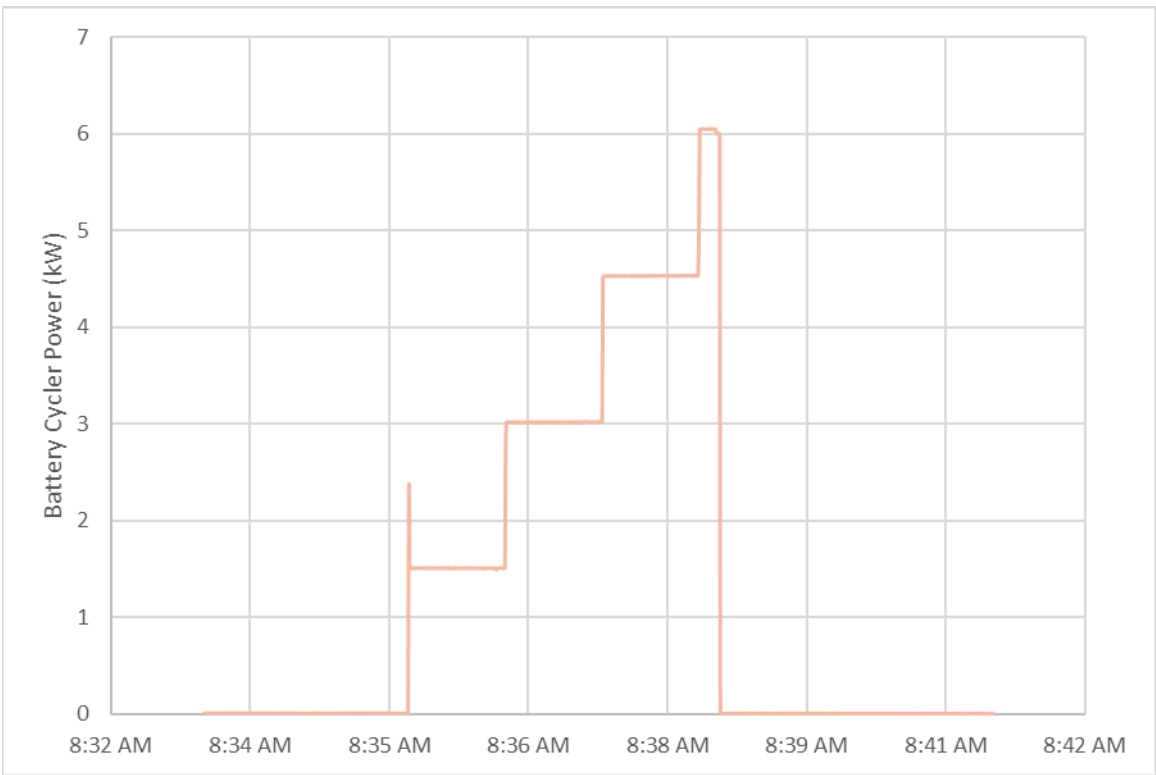
For the second attempt, the battery test system was enabled after the DC fast charger had initiated charging. The battery test system began increasing current output by 4 amps every minute. At each step the DC fast charger reduced its current output in a manner that kept the total current input to the vehicle at approximately 60 amps. This continued until the battery test system output reached 16 amps. The vehicle terminated charging 12 seconds after the battery test system switched from 12 amps to 16 amps. The DC fast charger terminated charging, illuminated the failure indicator light, and displayed a message stating “Error Vehicle Battery Malfunction.” A message displayed on the vehicle’s instrument cluster stated “Unable to Charge.” The DC fast charger was disconnected from the breakout harness and vehicle was power cycled once. The vehicle powered on normally and accepted charging from the Level 1 charger. A standard cycle was performed on the vehicle with discharge conducted via vehicle operation and charging completed with the Level 1 charger. No evidence of electrolyte leakage, rupture, venting, fire, or explosion was observed.

Figure 52: Over-Current Test Battery Tester Voltage

Figure 53: Over-Current Test Battery Tester Current

Figure 54: Over-Current Test Battery Tester Power

Figure 55: Over-Current Test Battery Tester Amount Charged
