NHTSA Campaign Number: 23V-562 Potential Number of Units Affected: 28,765

NHTSA Campaign Number: 23V-563 Potential Number of Units Affected: 403

Petition for Exemption due to Inconsequential Noncompliance

The noncompliance relates to 49 CFR 571.217 Paragraph S5.5.3(b), Bus Emergency Exits and Window Retention and Release.

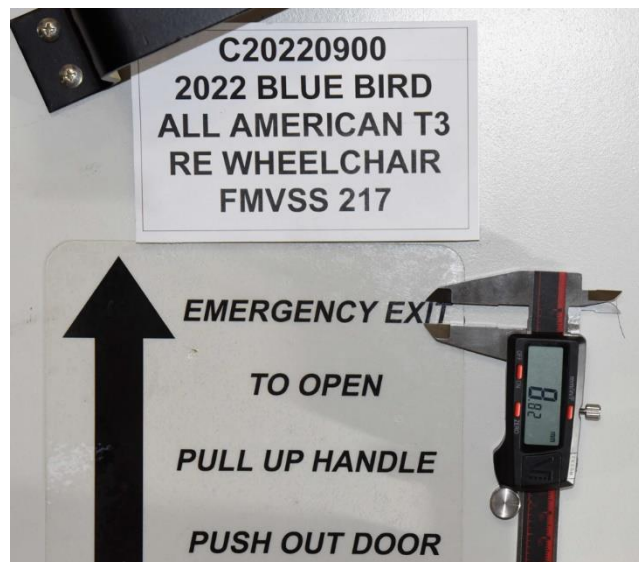
On August 2nd 2023, NHTSA informed Blue Bird that it discovered a non-compliance pertaining to labeling of the emergency exit during testing a 2022 Blue Bird All American School Bus (NHTSA # C20220900, VIN: 1BABJBSA5NF381107) at Applus IDIADA Karco Engineering. When testing to the requirements of 49 CFR 571.217, the vehicle appeared to be non-compliant with the Emergency Exit Label requirements for the operating instructions' letter height. As per the regulation, concise operating instructions describing the motions to unlatch and open the emergency exit doors shall be in letters at least 1 centimeter high and of a color that contrasts with its background. During testing the lettering in the bus was measured to 0.882 centimeters.

Additionally, we believe the jaws of a Vernier caliper when used for the official measurement of letter height can be inaccurate and inconsistent when used to differentiate such small variation from the standard. Manual error in repeatability of the measurement device and user could result in differences that exceed the difference the Blue Bird text size is from the requirement. Indeed, the actual photo provided of the measurement in this case demonstrates the potential for human error in distinguishing such a small variation. As shown in Figure 1, the caliper is not positioned flat against the decal, and only one location on the decal was measured. A difference of .118 cm could easily be accounted for by a slight angle of the calipers or measurements taken in multiple locations on the signage.

Figure 1: Letter Height Measurement

Blue Bird is requesting a declaration of an inconsequential non-compliance by NHTSA for this matter because the difference between 1 centimeter and 0.882 centimeters is difficult to differentiate without the use of very precise measuring equipment. A 0.118 cm difference is less than 3/64ths of an inch or

0.047 inches and will be unrecognizable. We believe this variation is not significant enough to make the instructions unclear to passengers or compromise their ability to open the door in an emergency.

NHTSA has not provided any claim or reasoning that that .118 cm variation from the 1 cm lettering height requirement compromises a passenger's ability to safely view or understand the lettering, and by its own prior decisions notes that a 1 mm variation from the standard is a substantial difference from a 2 mm variation (its basis for denial of a prior petition for inconsequential noncompliance). In addition, Blue Bird has demonstrated that manual use of Vernier calipers can create discrepancies and variations when distinguishing variations as small as .118 cm.
