**REPORT NUMBER: SideNCAPPole-KAR-21-014**  
**NEW CAR ASSESSMENT PROGRAM (NCAP)**  
**SIDE IMPACT POLE TEST**

**VOLKSWAGEN GROUP OF AMERICA**  
**2021 VOLKSWAGEN ID.4 5-DOOR SUV**

**NHTSA No: M20215801**

**FINAL REPORT**

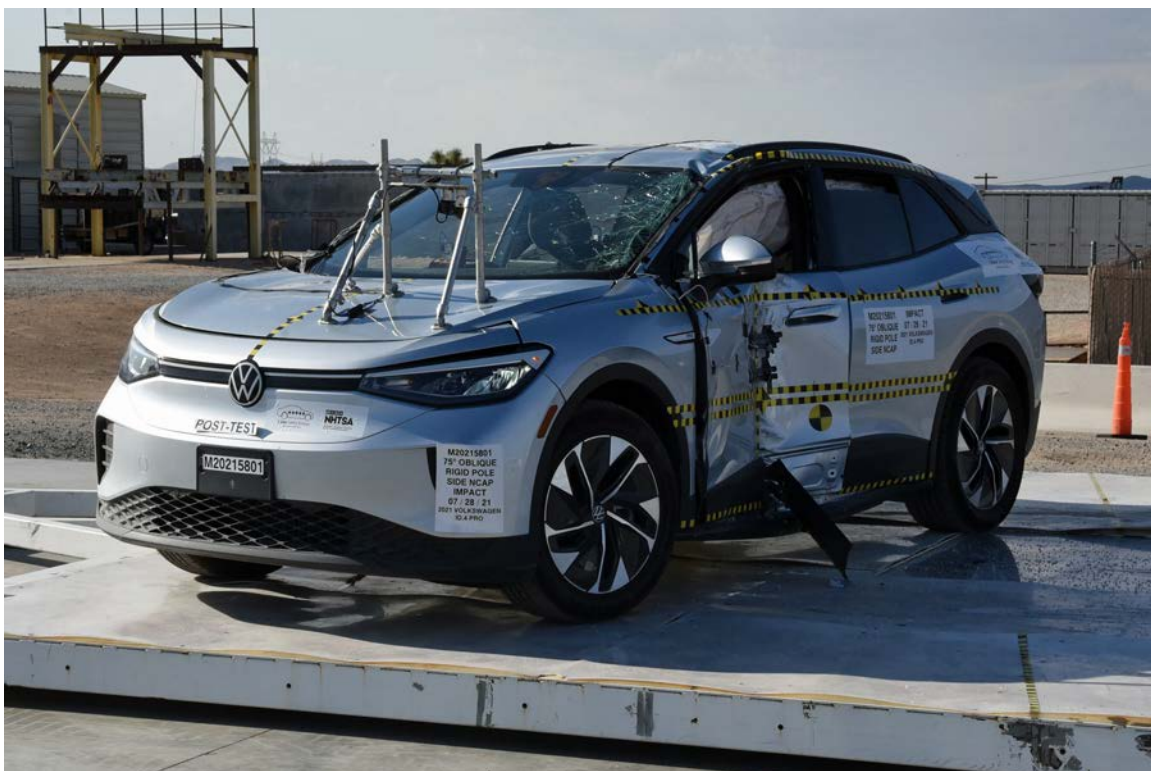
FIGURE 6. Post-Test Left Front  $\frac{3}{4}$  View of Test Vehicle

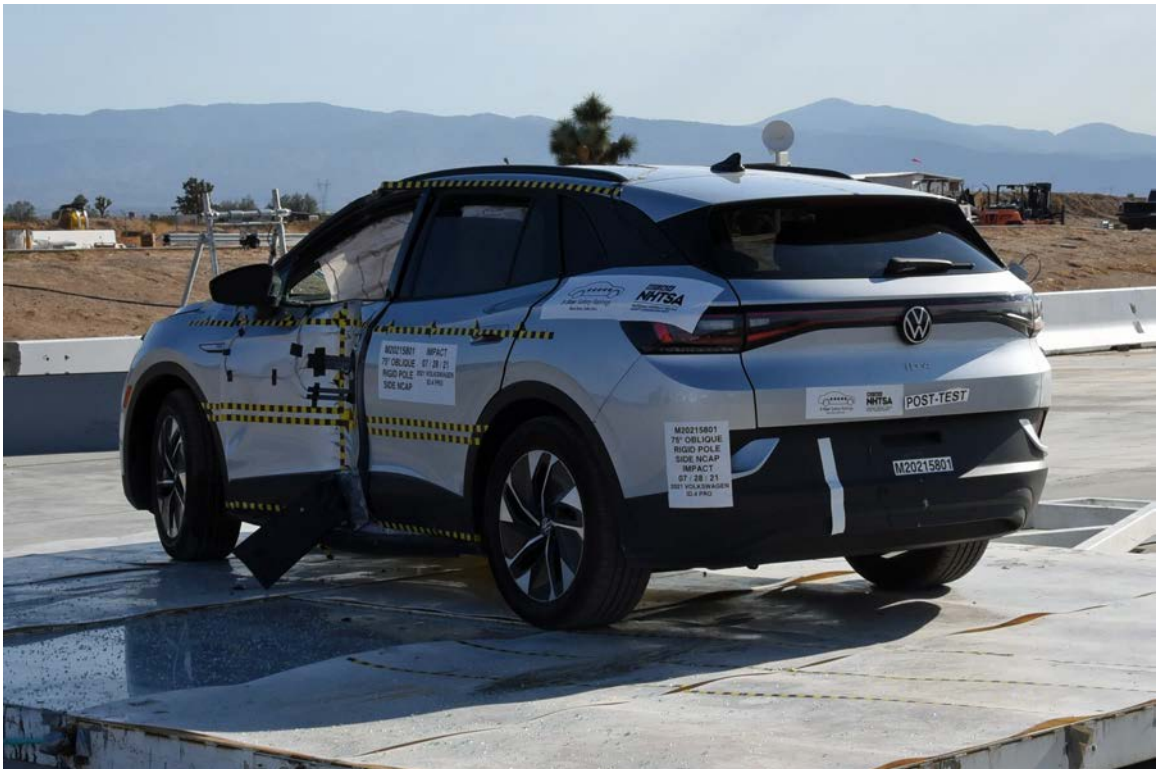
FIGURE 10. Post-Test Left Rear  $\frac{3}{4}$  View of Test Vehicle

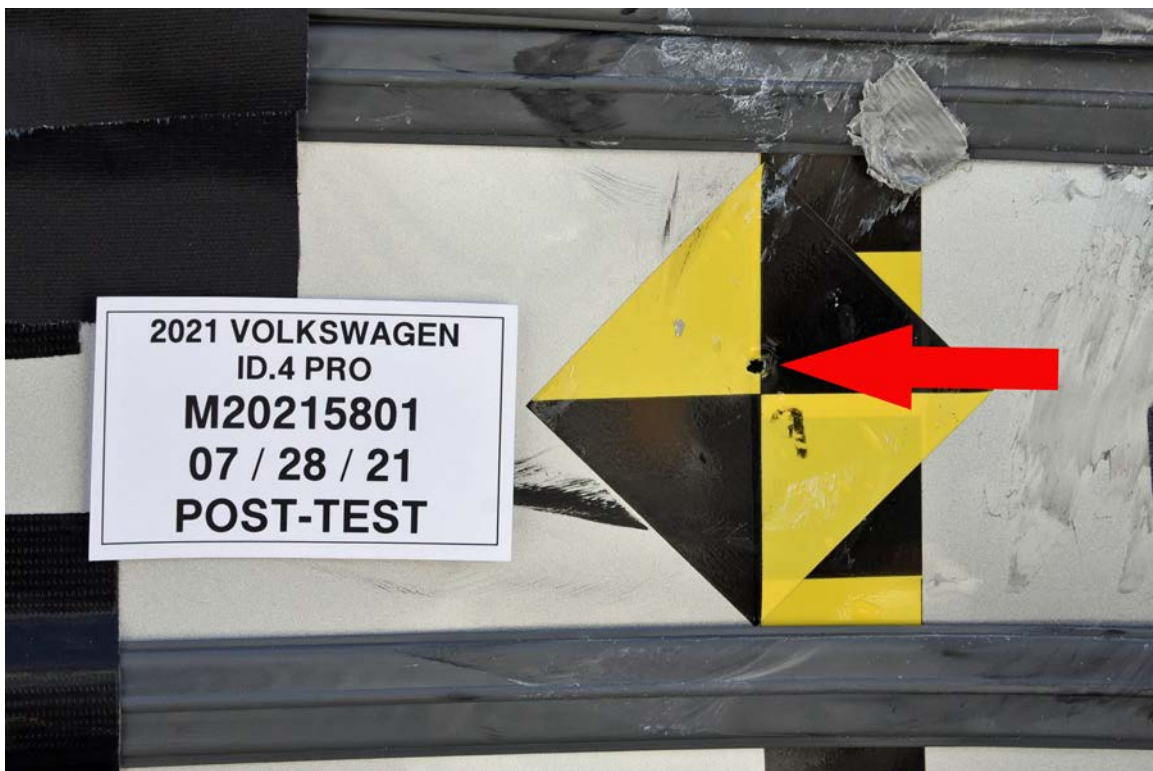
FIGURE 20. Post-Test Close-Up View of Impact Point Target Showing Impact Location

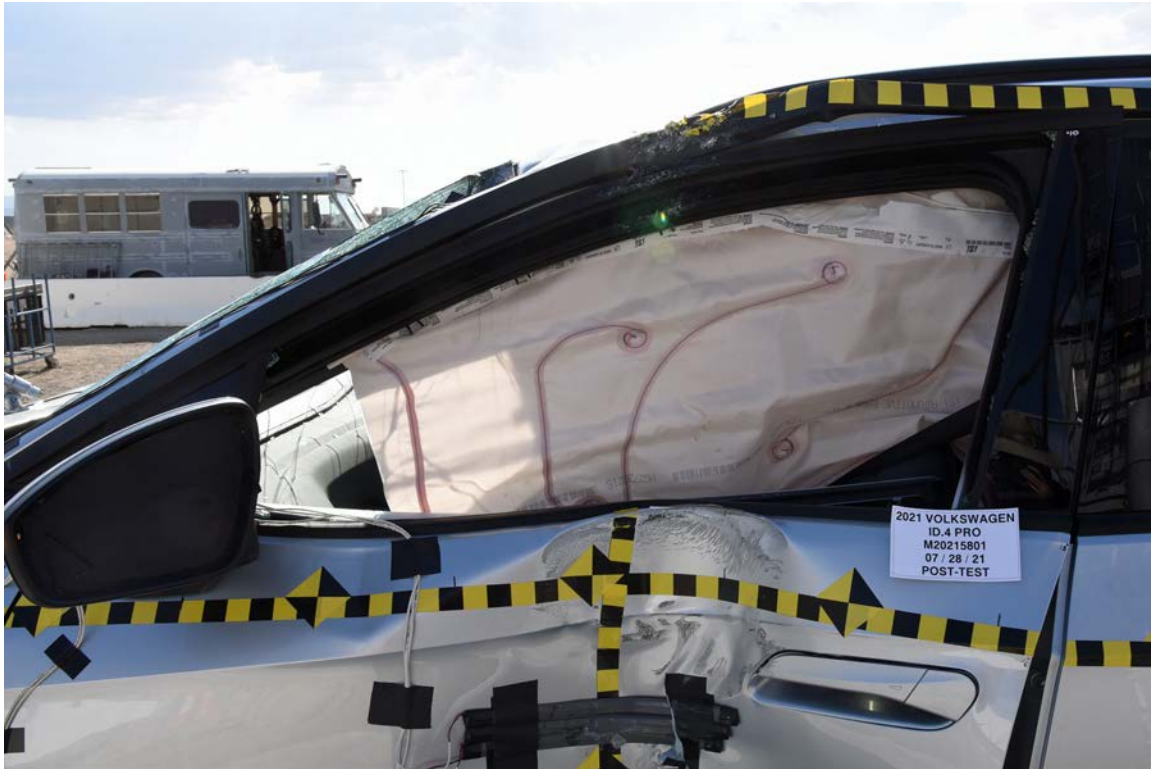
FIGURE 25. Post-Test Left Side View of Dummy Shoulder and Door Top View

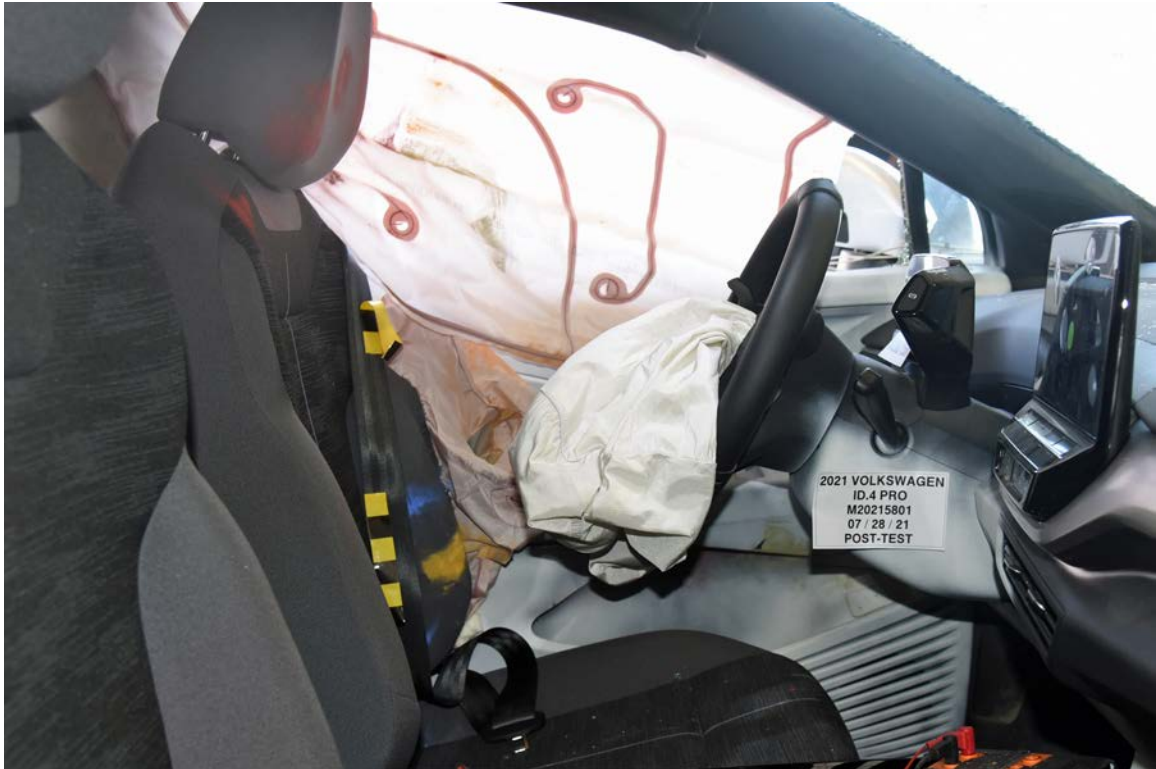
FIGURE 45. Post-Test Inner Door Panel View Showing Dummy Contact Locations

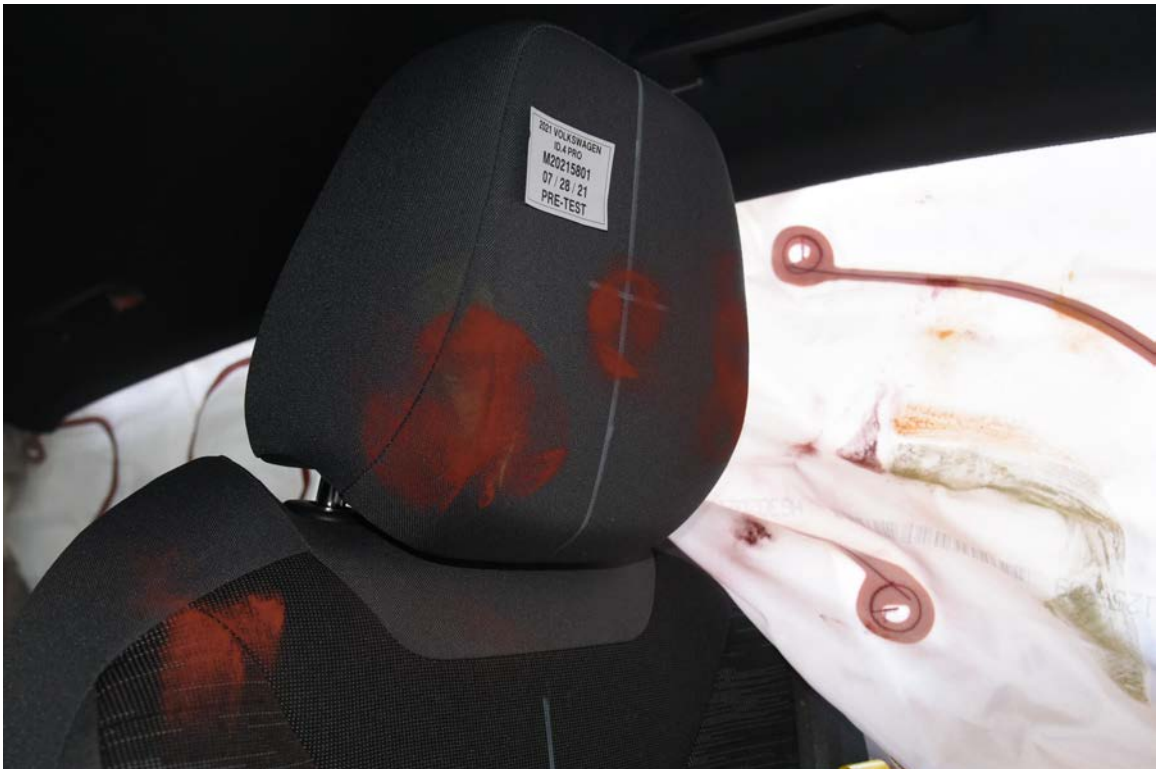
FIGURE 46. Post-Test Dummy Close-Up Head Contact with Vehicle Interior View

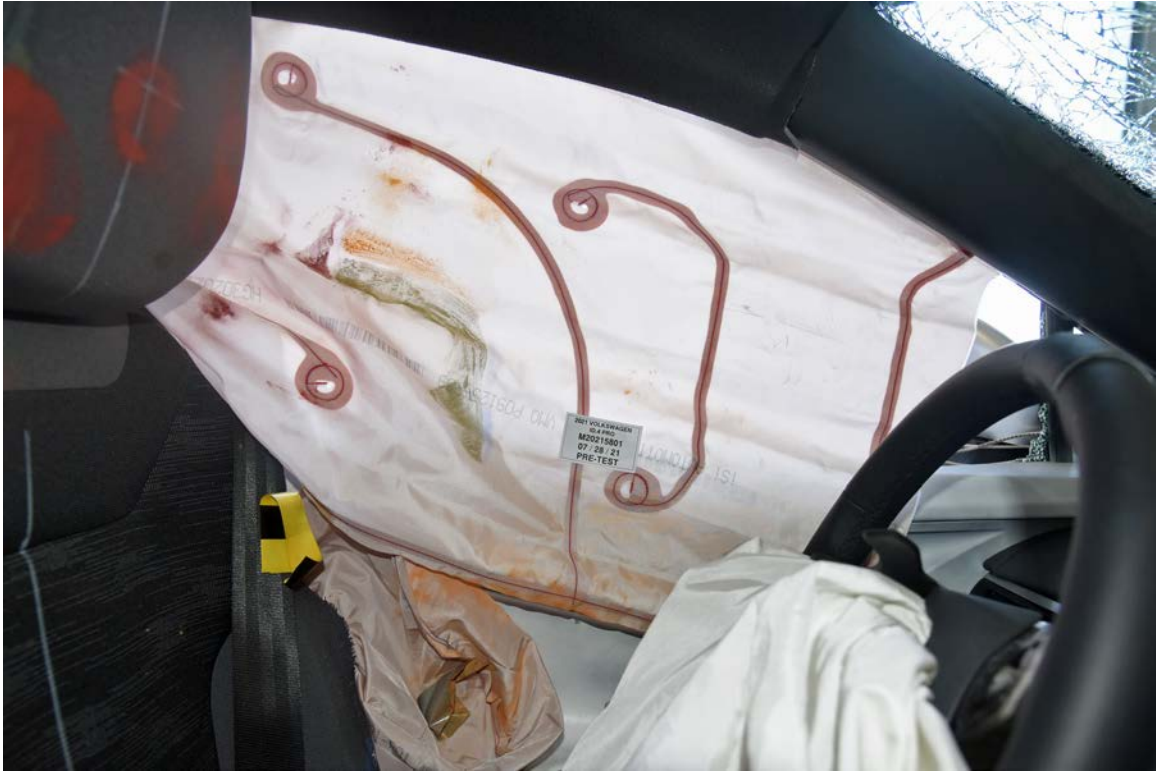
FIGURE 47. Post-Test Dummy Close-Up Head Contact With Side Airbag View

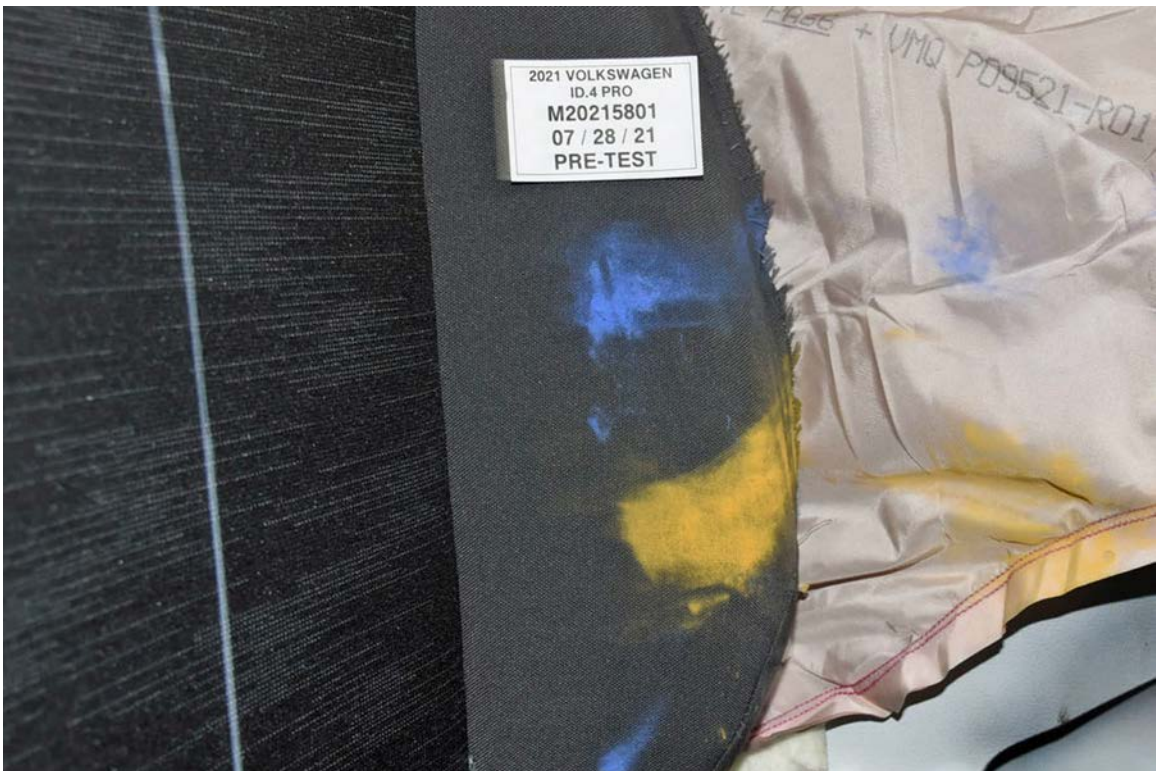
FIGURE 48. Post-Test Dummy Close-Up Torso Contact With Vehicle Interior View

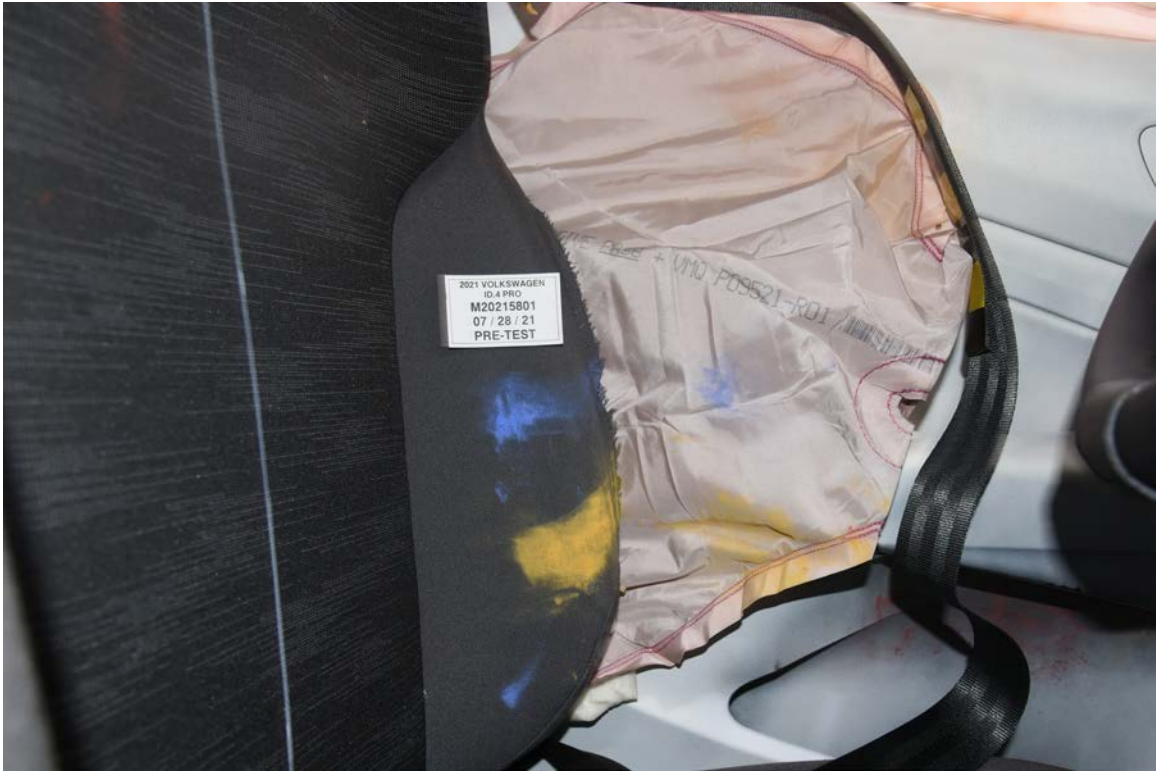
FIGURE 49. Post-Test Dummy Close-Up Torso Contact With Side Airbag View
