REPORT NUMBER: SideNCAPPole-MGA-22-012

**NEW CAR ASSESSMENT PROGRAM (NCAP)
Side Impact Pole Test**

**MAZDA MOTOR CORPORATION
2022 Mazda MX-30 5-Door Hatchback
NHTSA No.: O20225401**

**MGA RESEARCH CORPORATION
5000 Warren Road
Burlington, WI 53105**

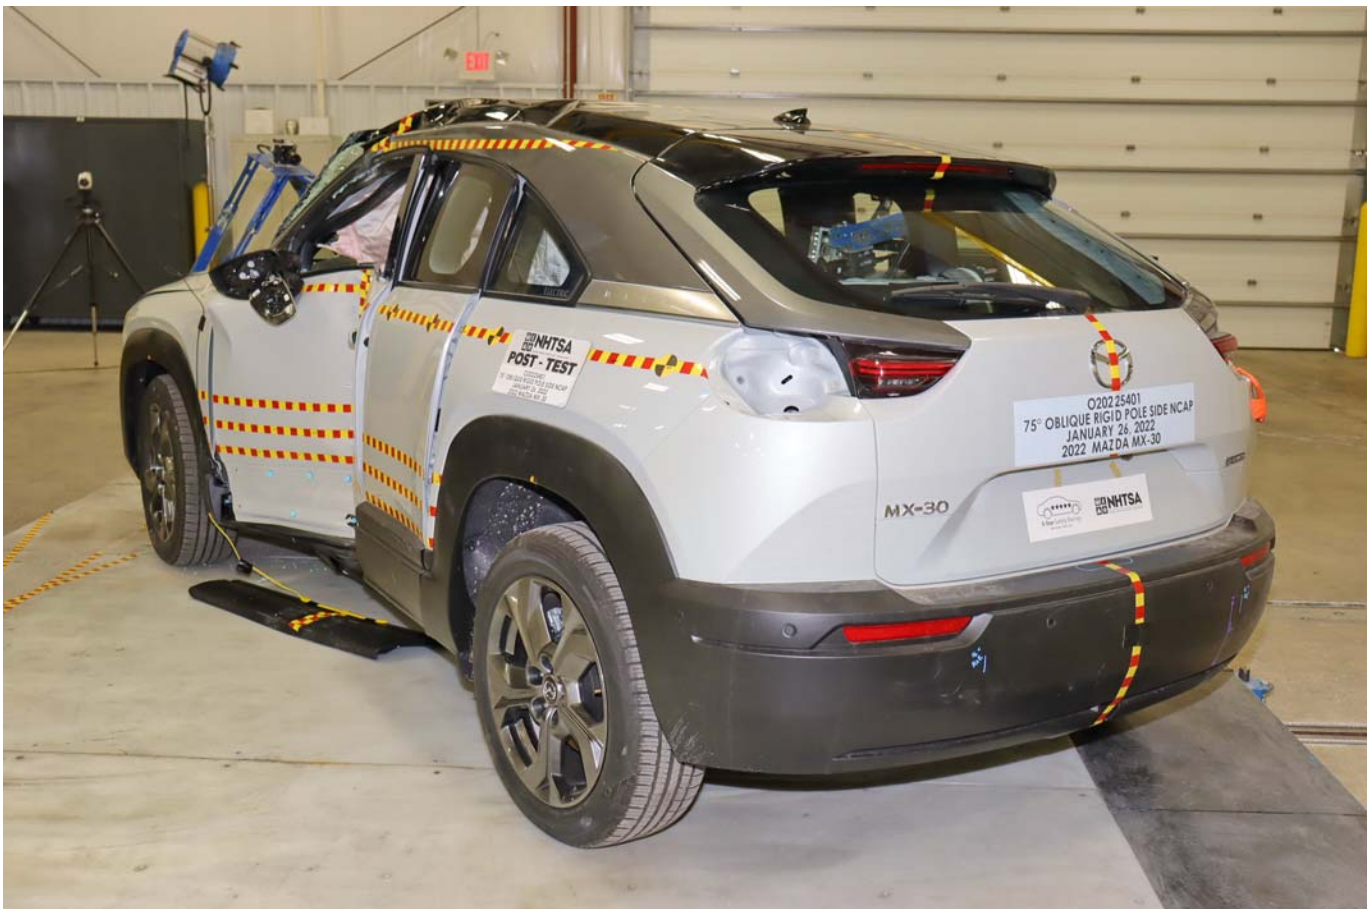
Photo No. 010 - Post-Test Left Rear Three-Quarter View of Test Vehicle

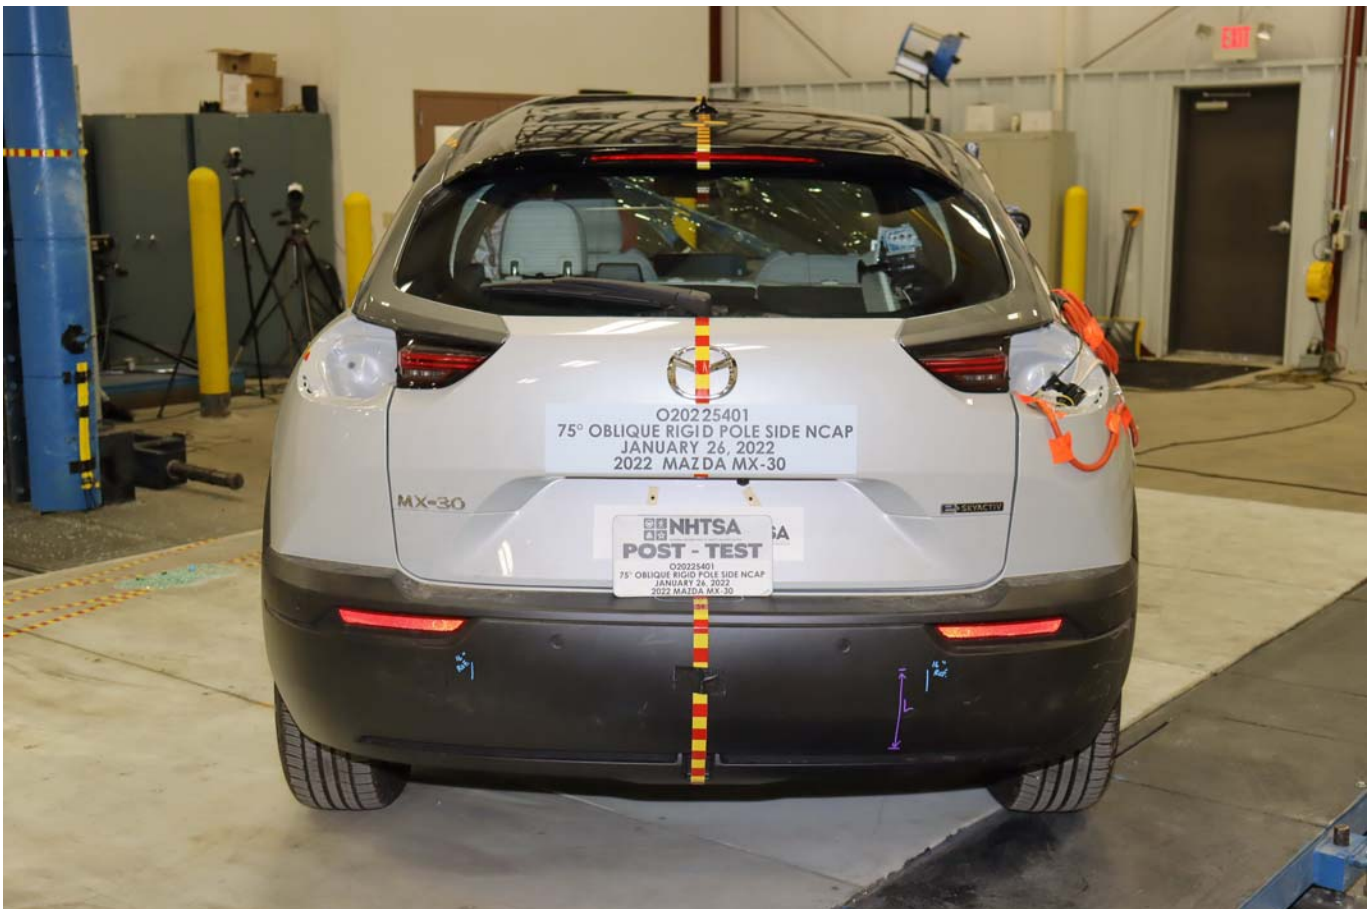
Photo No. 012 - Post-Test Rear View of Test Vehicle

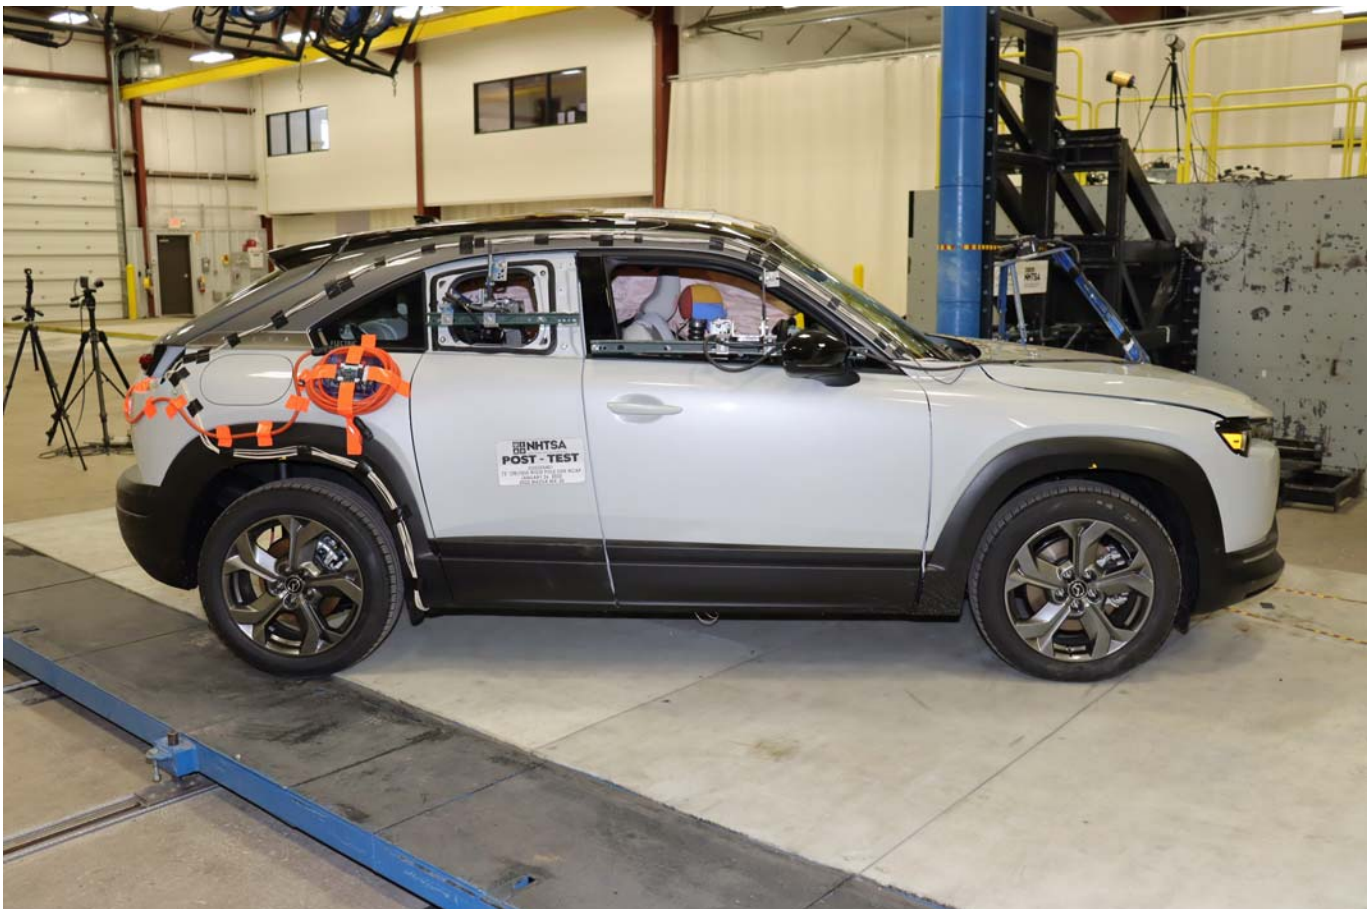
Photo No. 014 - Post-Test Right Side View of Test Vehicle

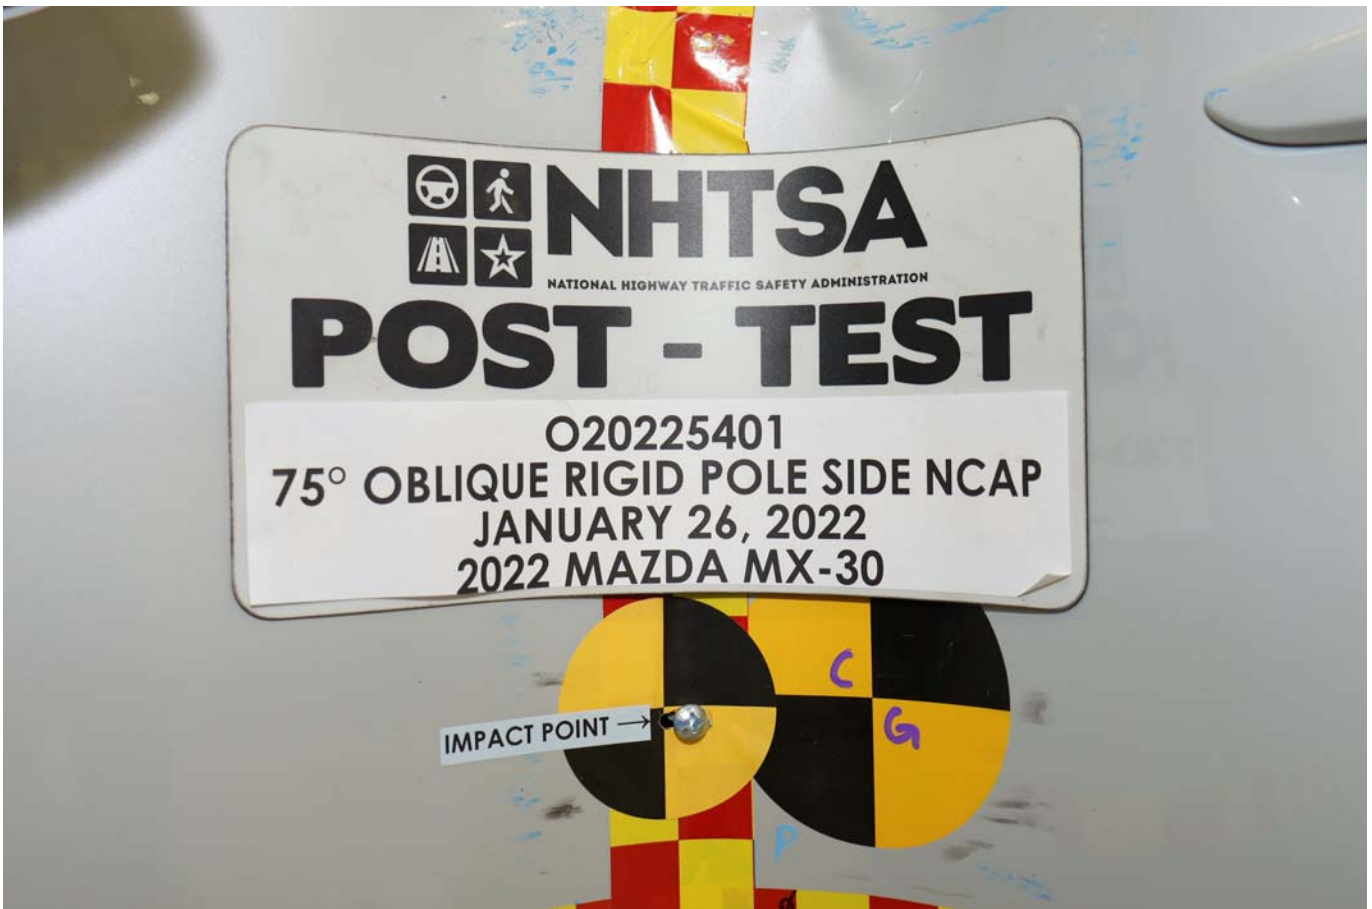
Photo No. 020 - Post-Test Close-Up View of Impact Point Target Showing Impact Location

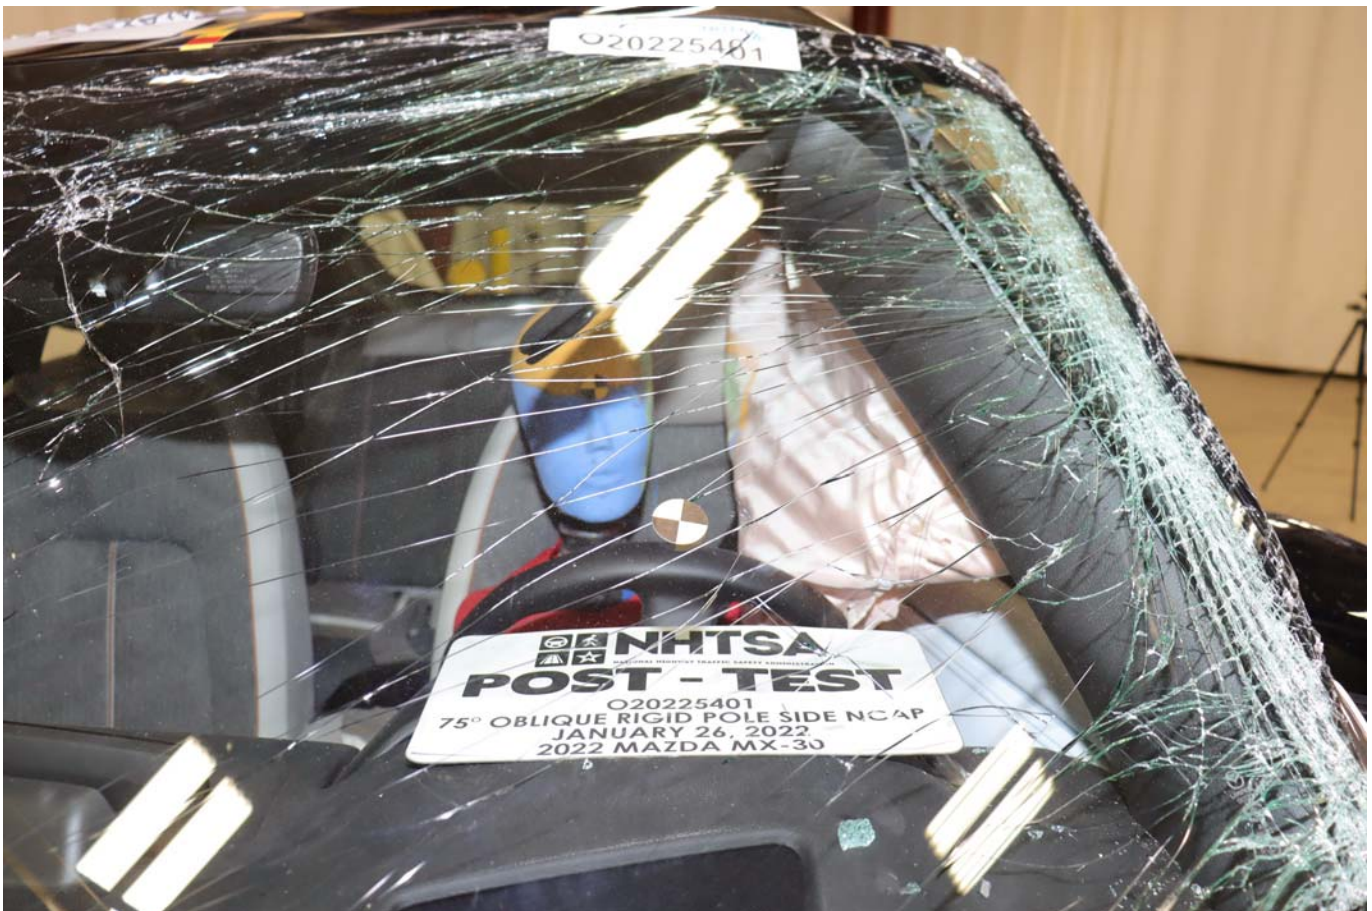
Photo No. 022 - Post-Test Front Close-Up View of Dummy

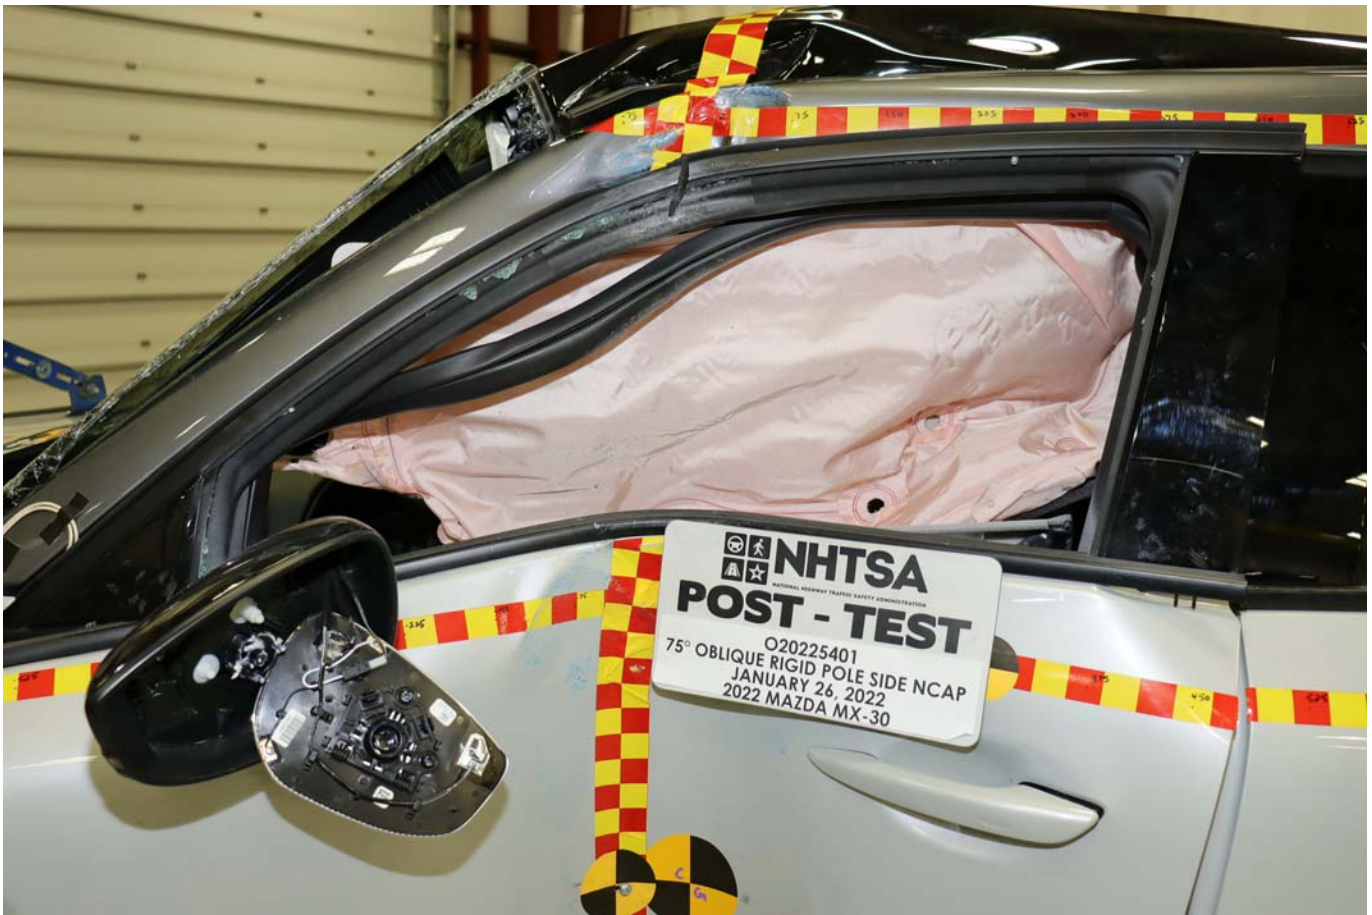
Photo No. 025 - Post-Test Left Side View of Dummy Shoulder and Door Top View

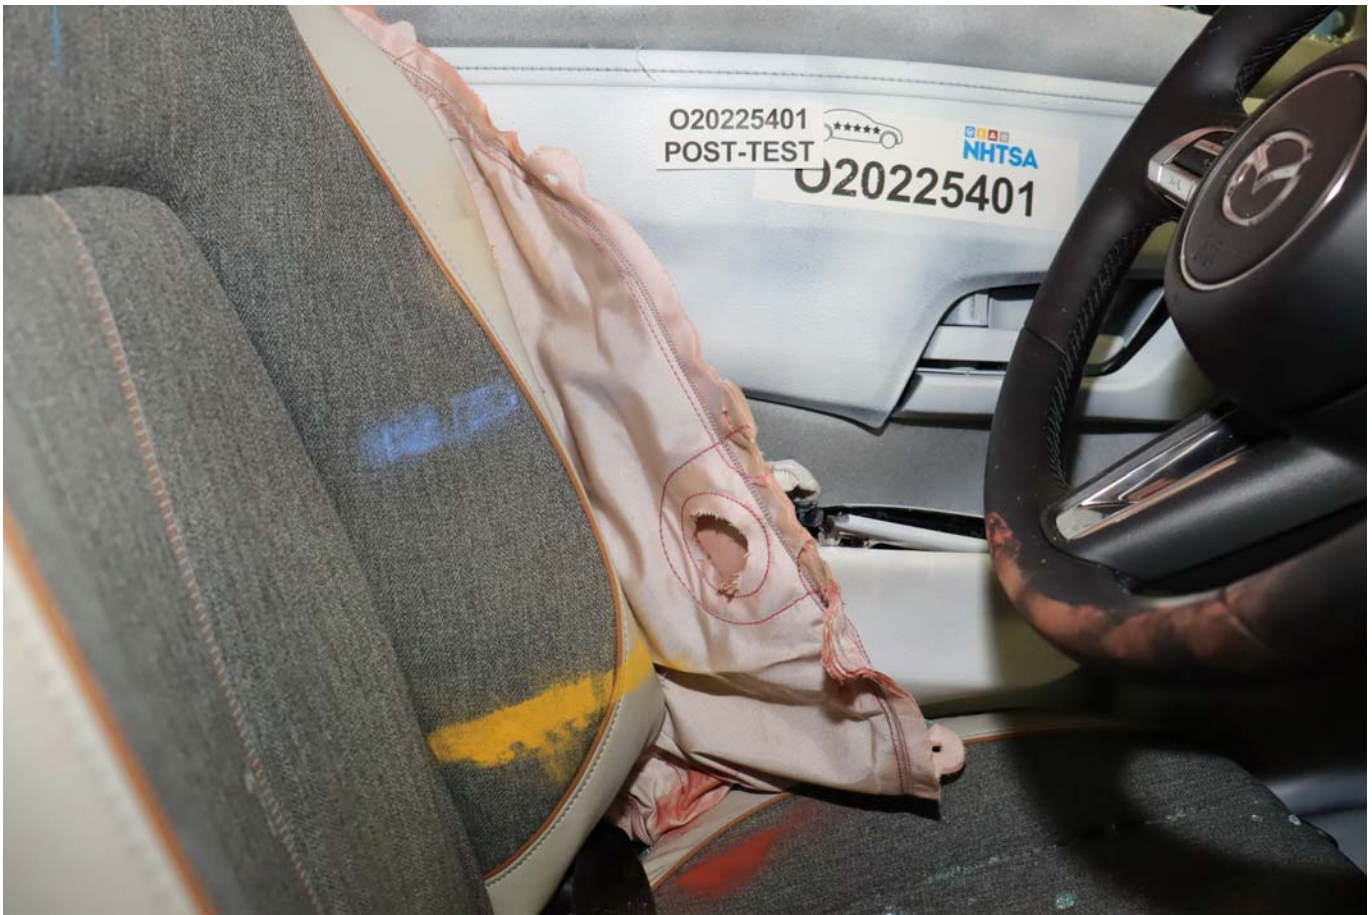
Photo No. 048 - Post-Test Dummy Close-Up Torso Contact with Vehicle Interior View

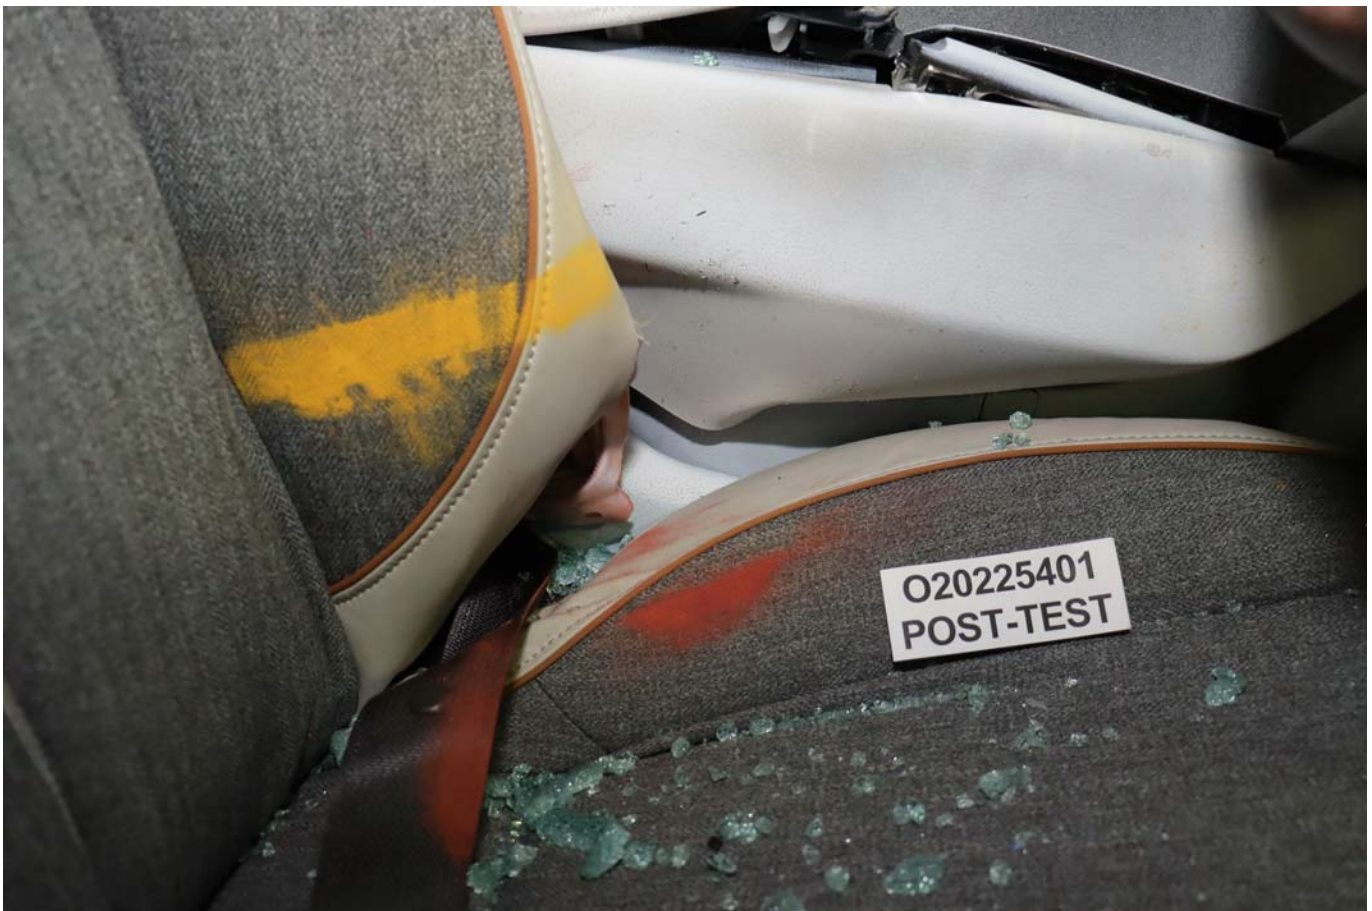
Photo No. 049 - Post-Test Dummy Close-Up Torso Contact with Side Air Bag View

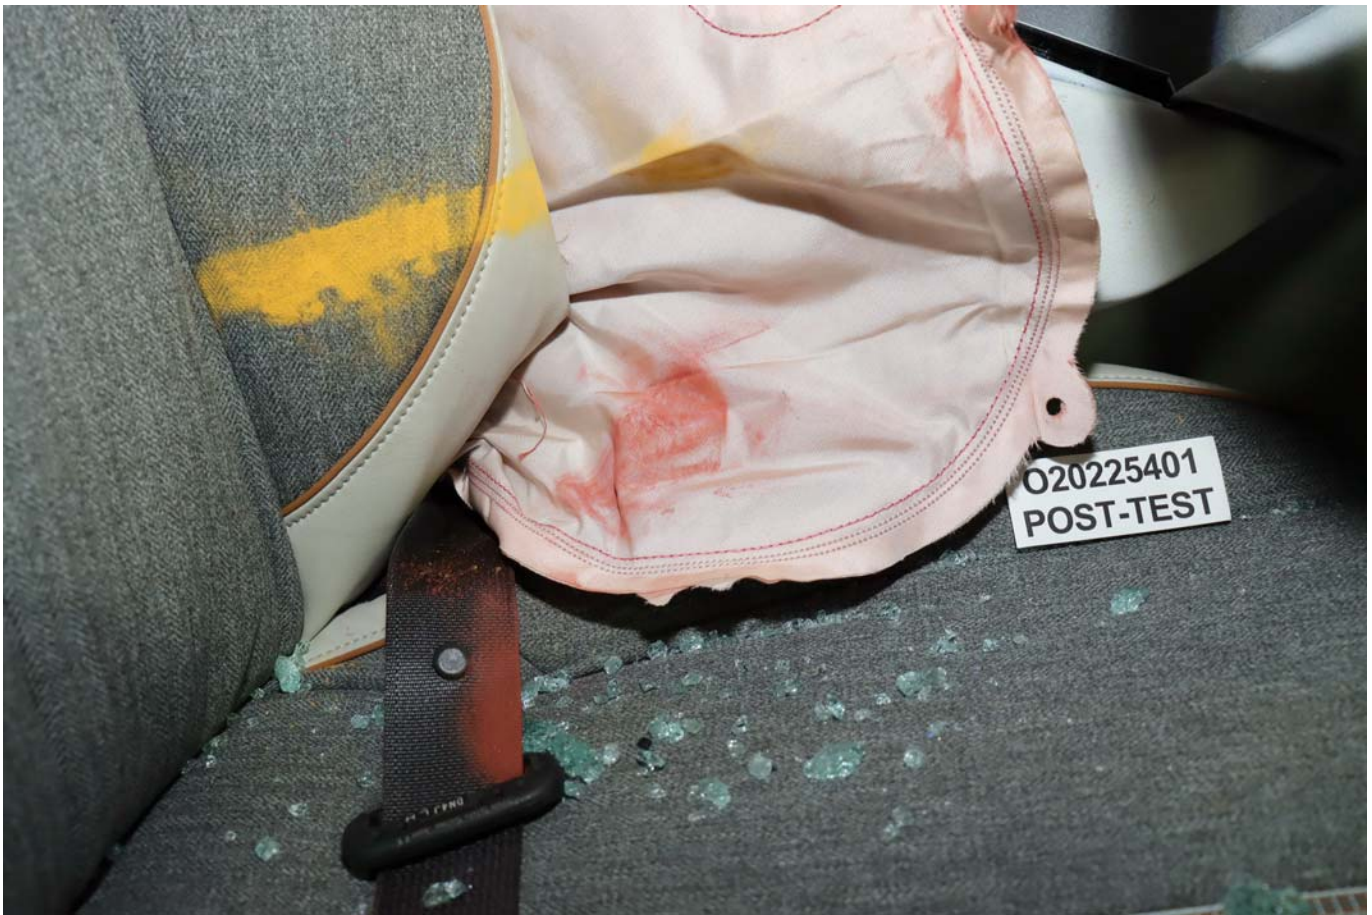
Photo No. 050 - Post-Test Dummy Close-Up Pelvis Contact with Vehicle Interior View

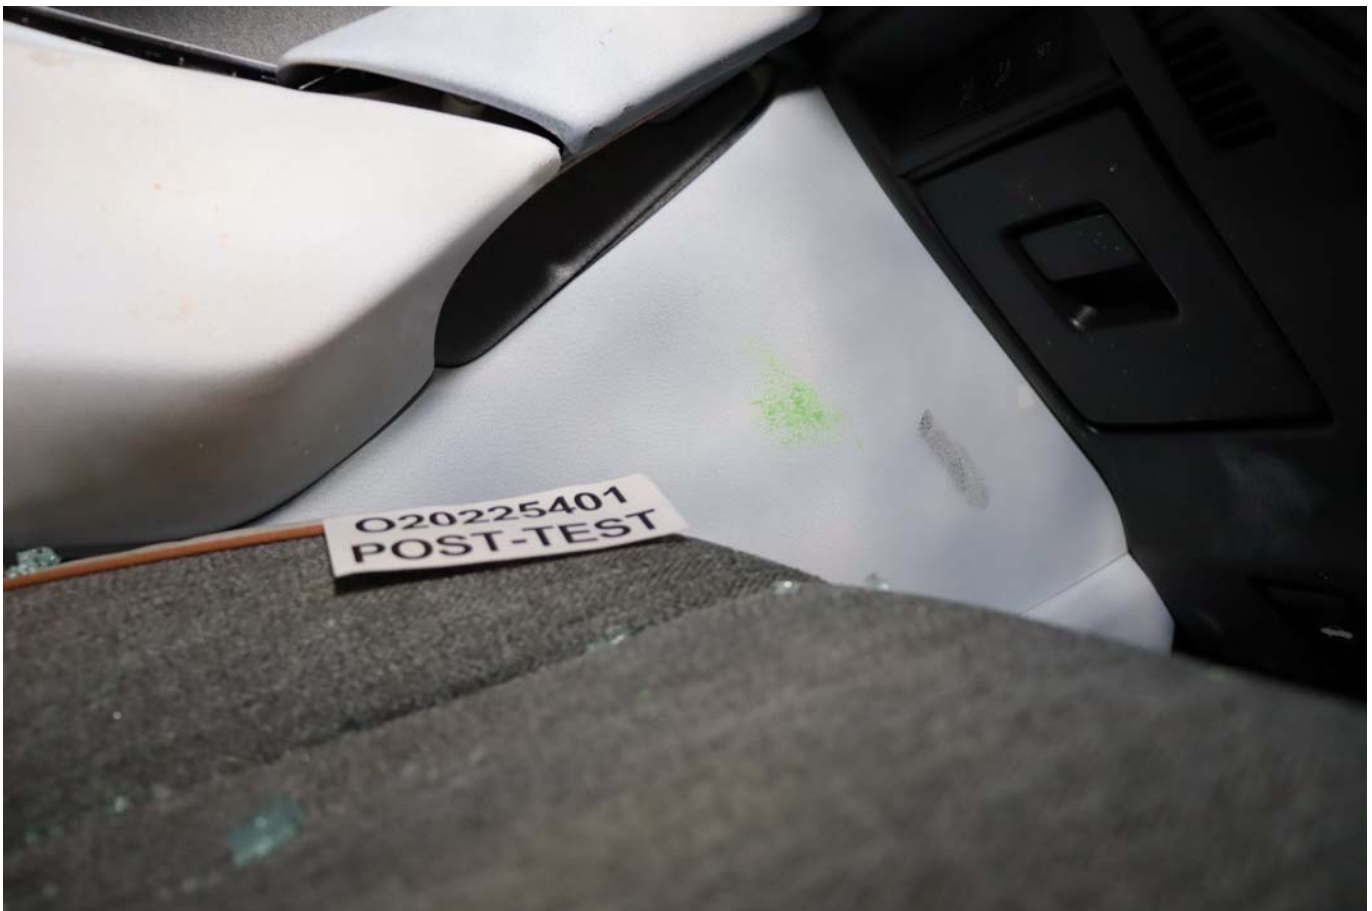
Photo No. 051 - Post-Test Dummy Close-Up Pelvis Contact with Side Air Bag View

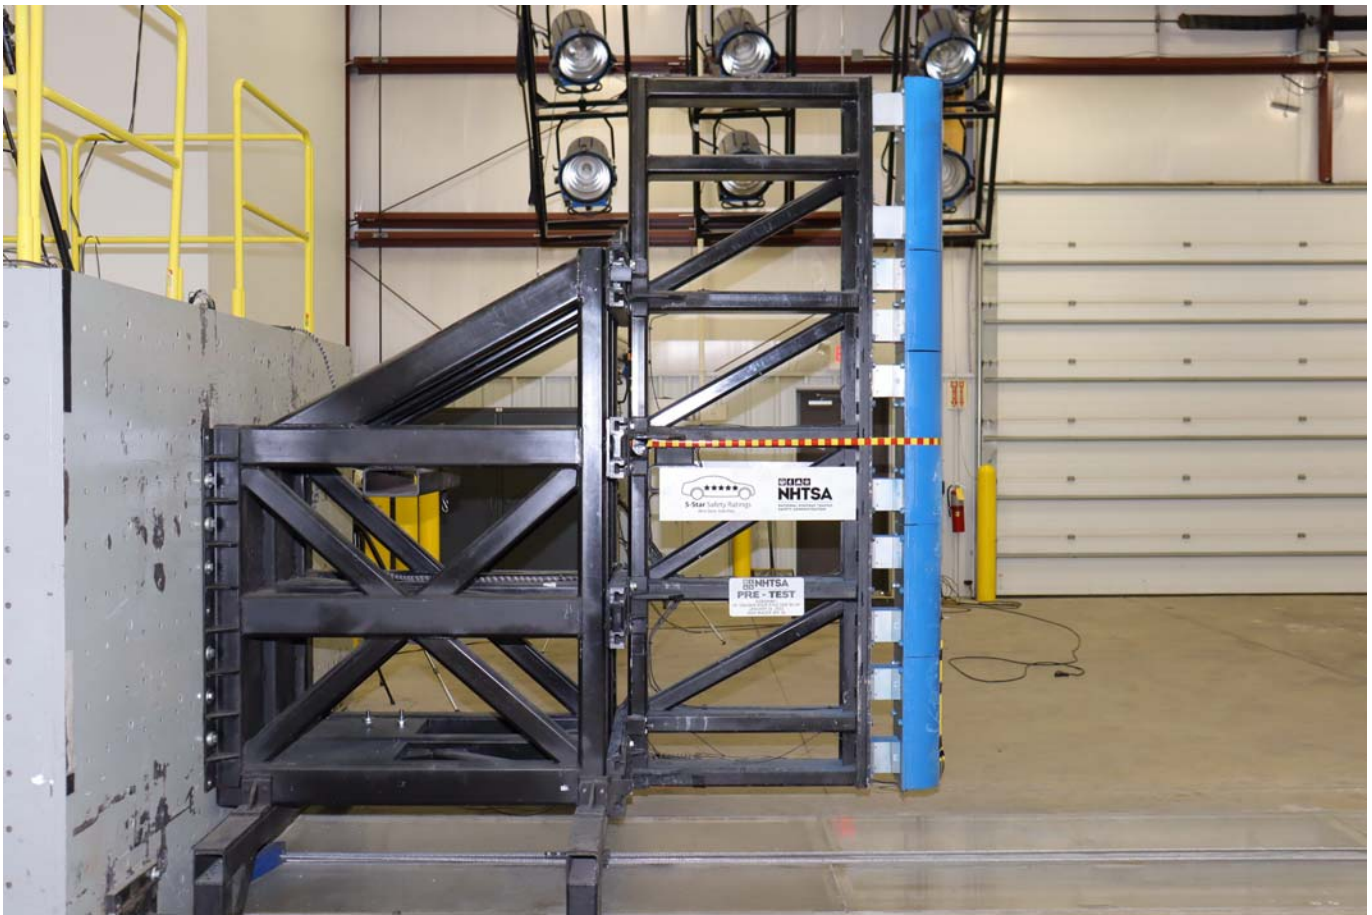
Photo No. 060 - Post-Test Pole Barrier Front View

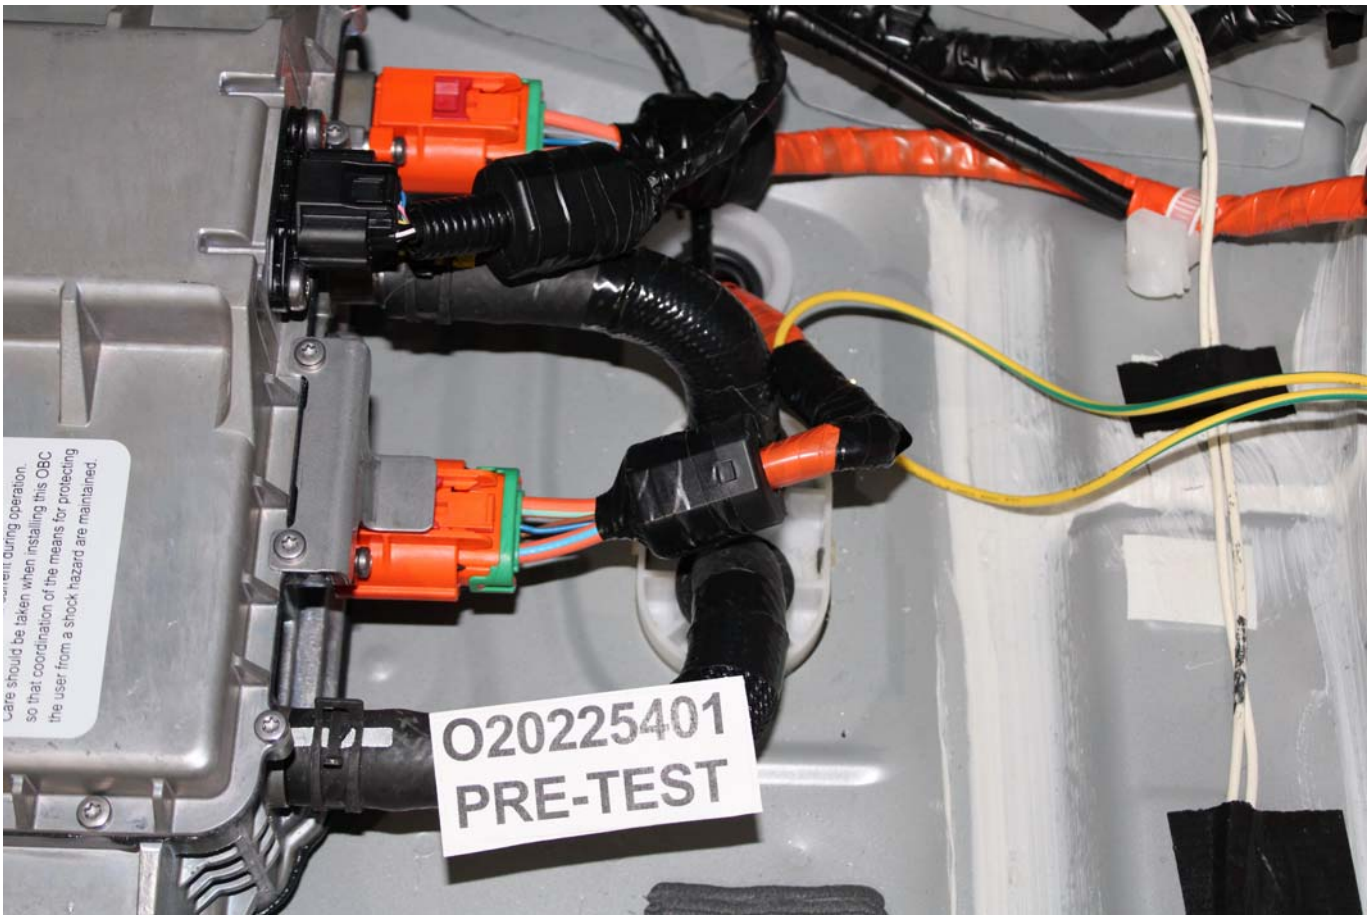
Photo No. 305-21 - Pre-Impact View of Ground Lead Attached

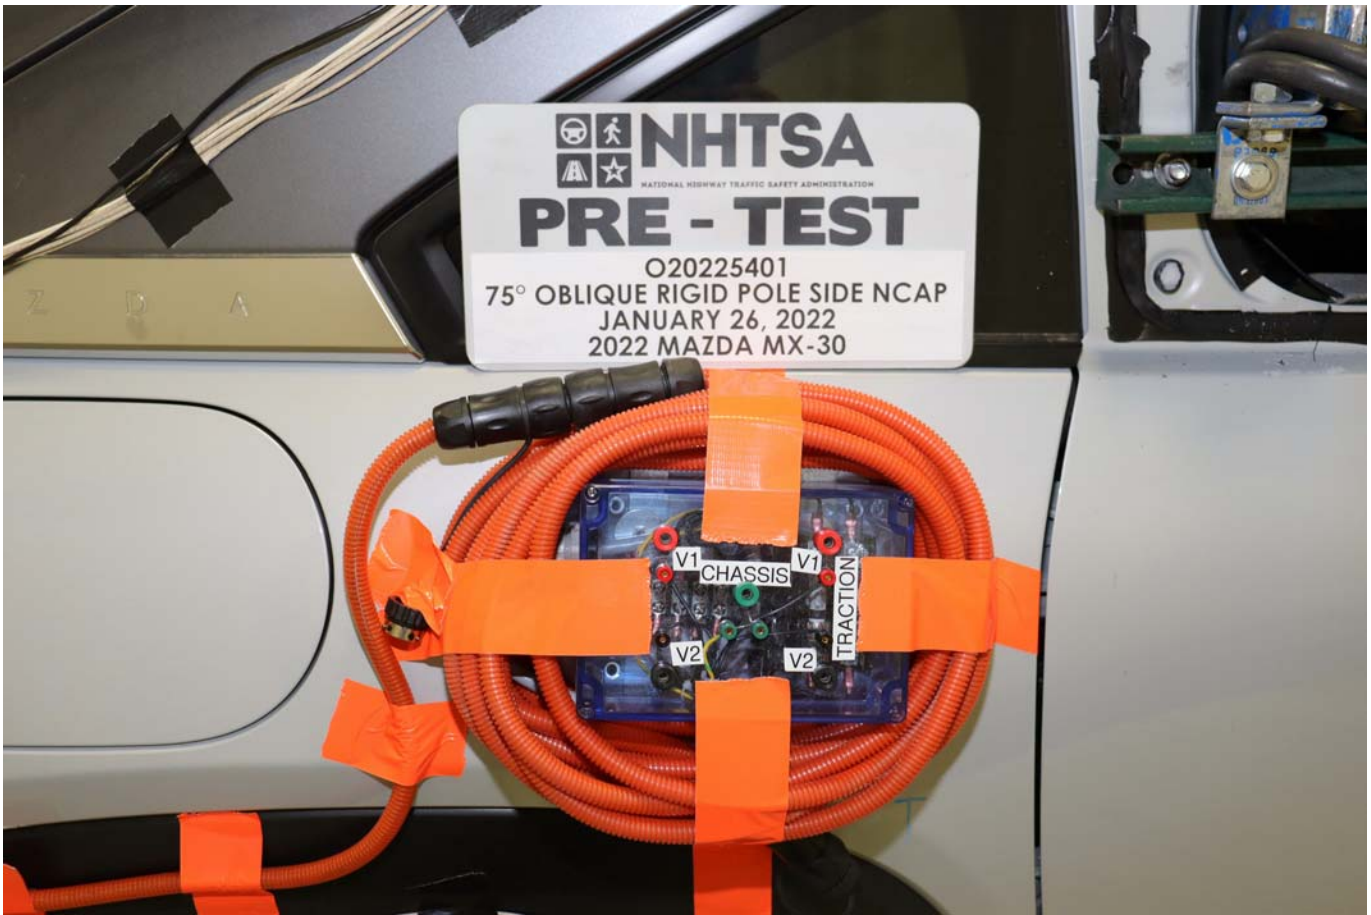
Photo No. 305-23 - Pre-Impact Close-Up View of High Voltage Leads Attached

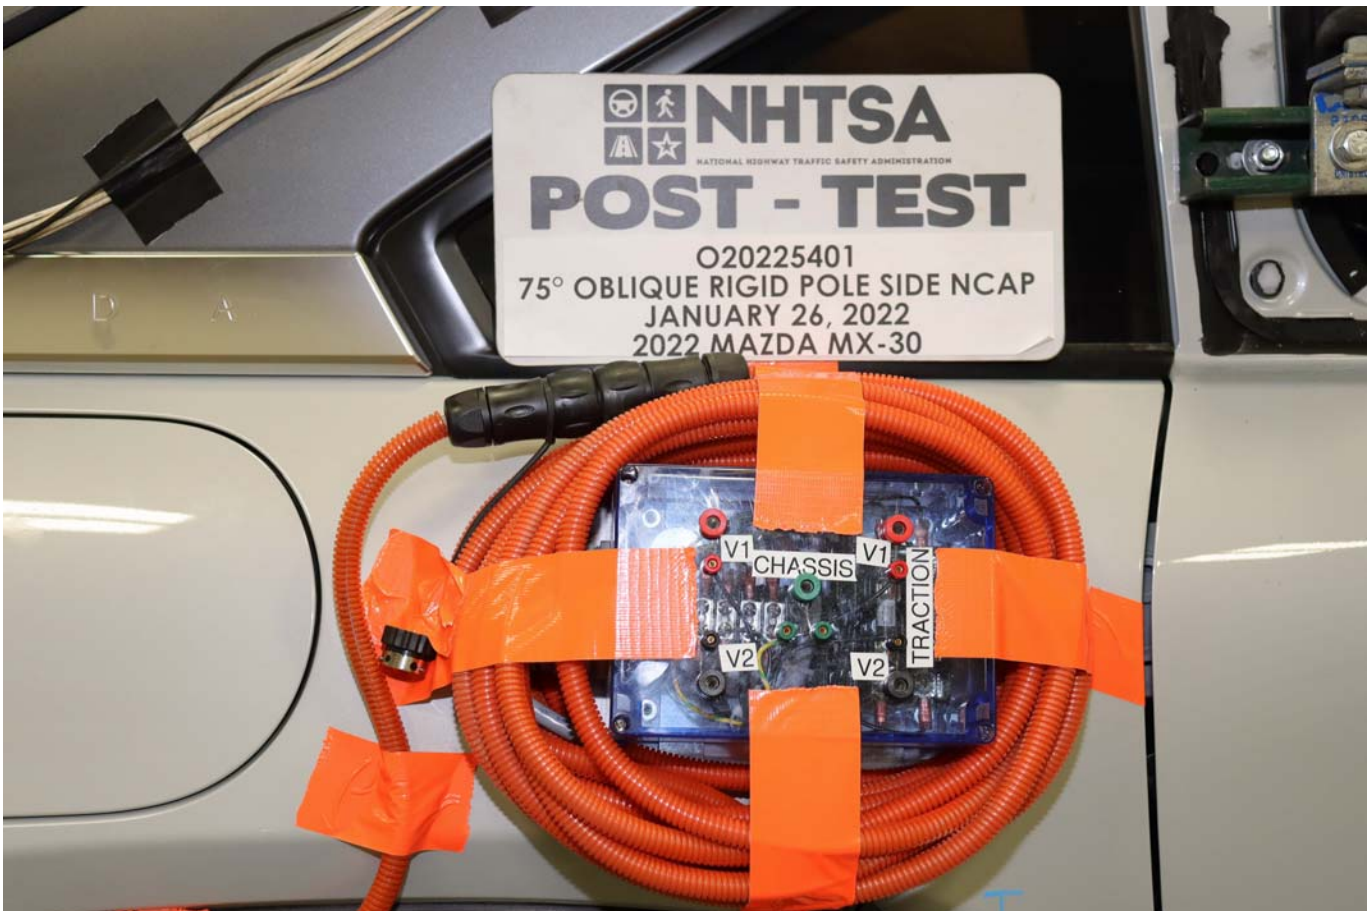
Photo No. 305-24 - Pre-Impact View of Installed Test Interface Port

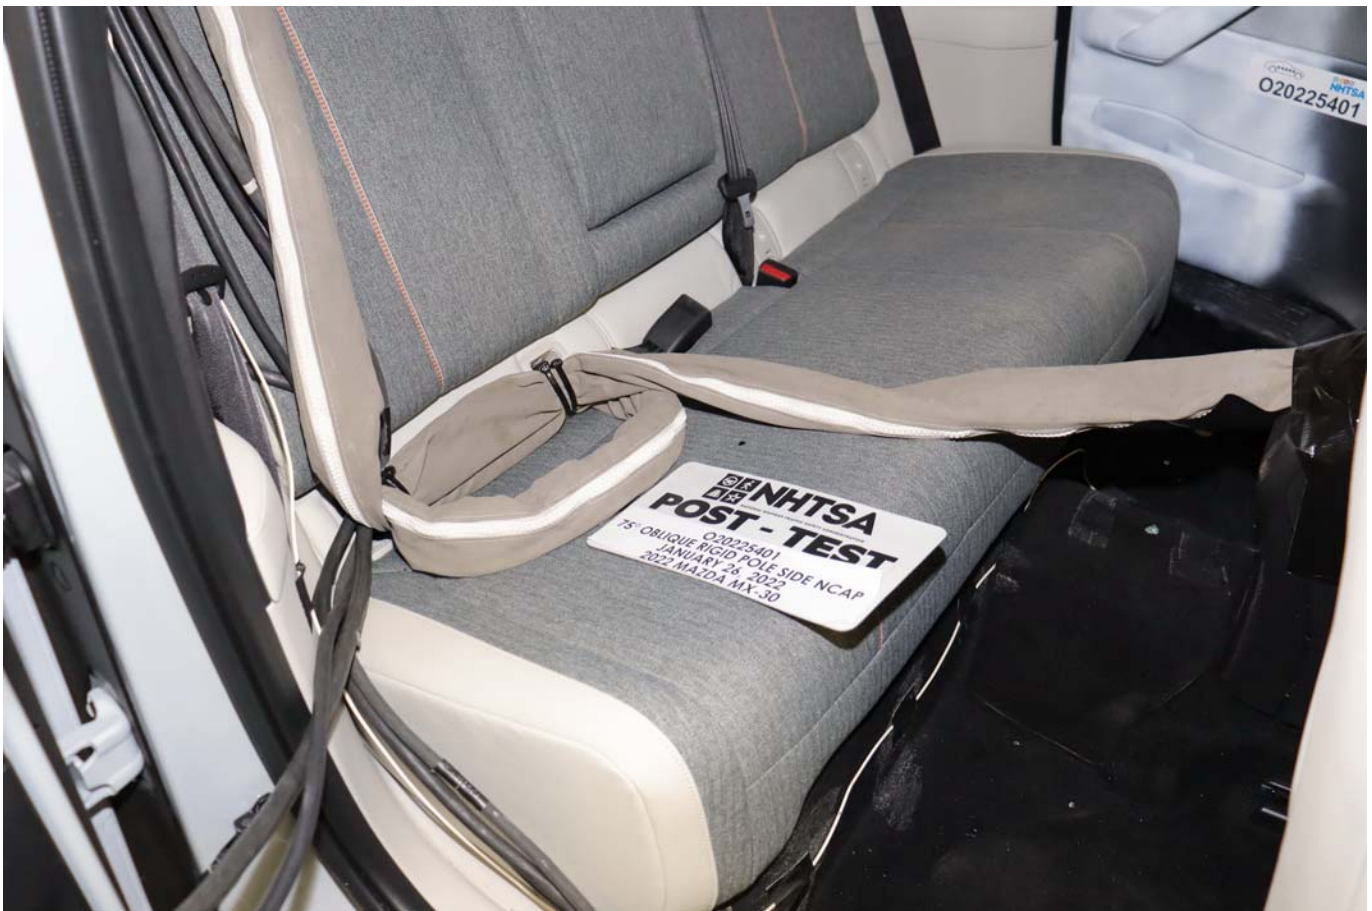
Photo No. 305-32 - Pre-Impact View of the Vehicle Passenger Compartment Adjacent to Propulsion Battery
